Report: TAB REPORT
Function: Test, Adjust, & Balance
Date: 02/29/2024

PROJECT
02-26-24 CAVA - CHICAGO, IL (WICKER PARK)

Project: 02-26-24 CAVA - CHICAGO, IL (WICKER PARK)

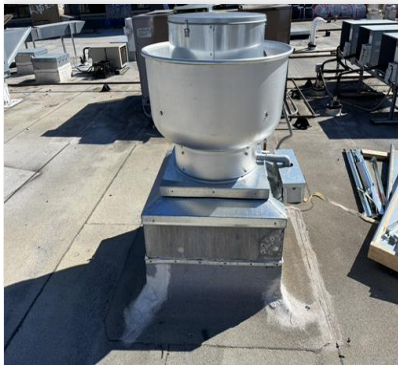
**Nohingekit
02/28/2024**

Fan is properly hinged and supported when hinged fully back for grease duct access (for Halton fans, ensure the base mounted disconnect is not hitting the fan base/curb when fully hinged back)

Fail

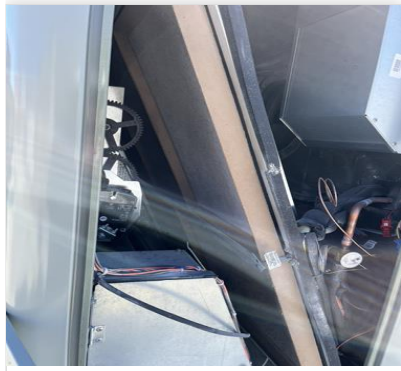
Filters
02/28/2024

Evaporator coil filters are properly installed with specified MERV rating

Fail

NEED FINAL FILTERS INSTALLED
