**Report: TAB REPORT**  
**Function: Test, Adjust, & Balance**  
**Date: 02/29/2024**

**PROJECT**  
**02-26-24 CAVA - CHICAGO, IL (WICKER PARK)**

Project: 02-26-24 CAVA - CHICAGO, IL (WICKER PARK)

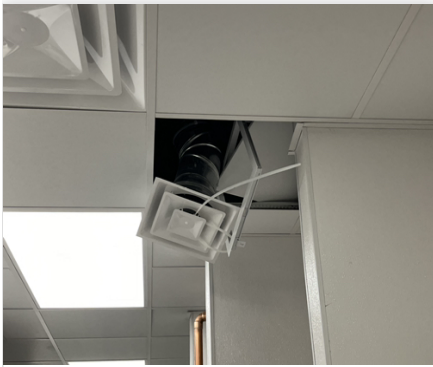
**Extradiffuser  
02/29/2024**

**Issue Name :** EF2 extra diffuser  
**Description :** An extra diffuser was found above ceiling for the mop sink that was not on any plans. Tech will read out the exhaust as is.  
**Created By :** National TAB                      **Assigned To :** National TAB - Jacob Davidson  
**Status :** Open  
**Priority :**    **Asset Tag :**  
**Originated Date :** 02/29/2024 - Jacob Davidson - National TAB

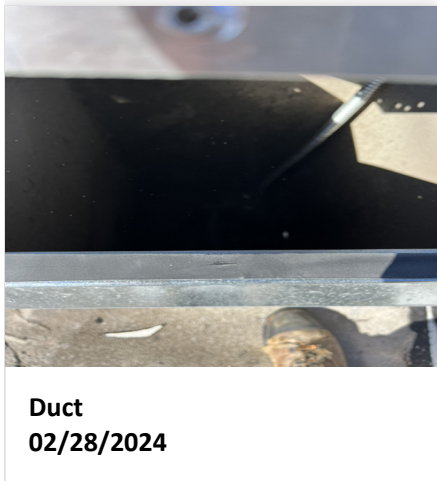
**Issue Name :** EF2 no backdraft damper  
**Description :** EF2 has no backdraft damper installed.  
**Created By :** National TAB                      **Assigned To :** National TAB - Jacob Davidson  
**Status :** Open  
**Priority :**    **Asset Tag :**  
**Originated Date :** 02/28/2024 - Jacob Davidson - National TAB

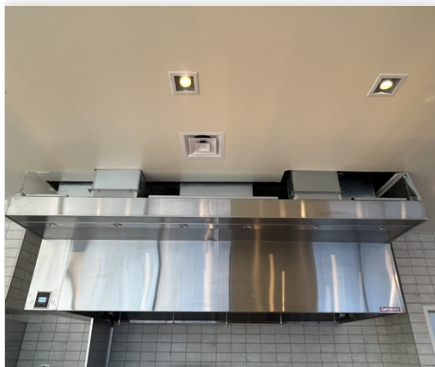
**Spaceabovehood  
02/26/2024**

**Issue Name :** HD1 space above hood needs to be sealed  
**Description :** Space above the hood isn't sealed and is open to the attic space. This will interfere with getting accurate building pressure  
**Created By :** National TAB                      **Assigned To :** National TAB - Jacob Davidson  
**Status :** Open  
**Priority :** Low                                      **Asset Tag :**  
**Originated Date :** 02/26/2024 - Jacob Davidson - National TAB

- **02/27/2024 National TAB - Jacob Davidson**
  - Spoke to GC and parts for the rest of the hood are on order. If needed, plastic can cover the space temporarily for testing.

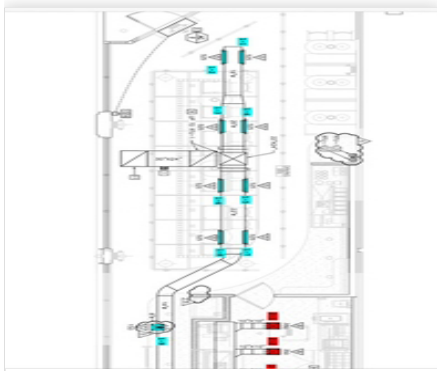
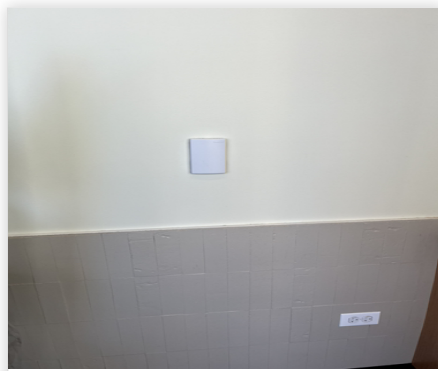
**Plans**  
02/29/2024

**Issue Name :** RTU1 missing humidity sensor in space  
**Description :** RTU1 is scheduled for humidity control but there is no humidity sensor in the space where the plans call for it.  
**Created By :** National TAB                      **Assigned To :** National TAB - Jacob Davidson  
**Status :** Open  
**Priority :** Medium                                      **Asset Tag :**  
**Originated Date :** 02/29/2024 - Jacob Davidson - National TAB

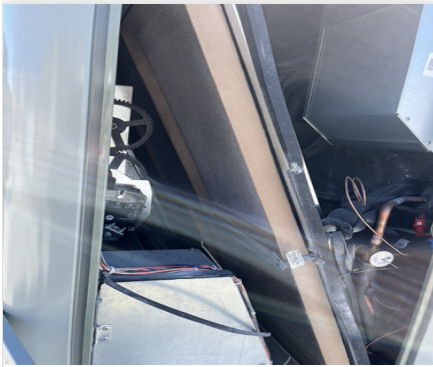
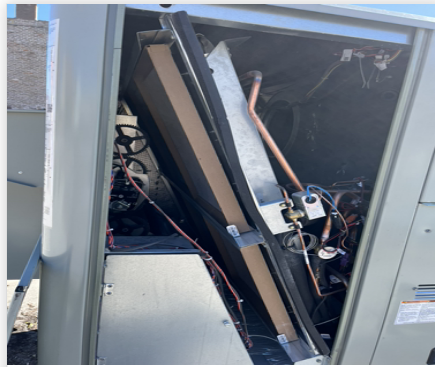
**RTU2(1)**  
**02/28/2024**

**Issue Name :** RTU1/RTU2 final filters needed  
**Description :** RTU1 and RTU2 need their final MERV pleated filters. Both units take 3 16X24X2 filters and 2 18X24X2 filters.  
**Created By :** National TAB                      **Assigned To :** National TAB - Jacob Davidson  
**Status :** Open  
**Priority :**    **Asset Tag :**  
**Originated Date :** 02/28/2024 - Jacob Davidson - National TAB

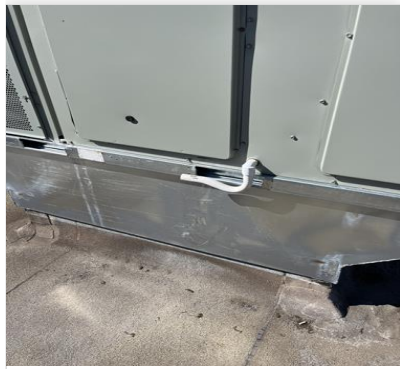
**Ptrap**  
**02/28/2024**

Condensate line drains away from unit to a approved roof drain

Fail

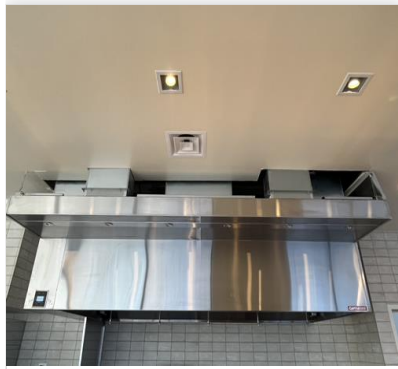
**Hoodwrap**  
**02/29/2024**

Ceiling Wrappers are installed and the ceiling grid is fixed to the top of the ceiling wrappers Fail

Parts of ceiling wrapper were either damaged or stolen. They are on order to replace.
