**Report: TAB REPORT**  
**Function: Test, Adjust, & Balance**  
**Date: 08/01/2024**

**PROJECT**  
**06-17-24 CAVA YUKON, OK (10TH ST)**

Project: 06-17-24 CAVA YUKON, OK (10TH ST)

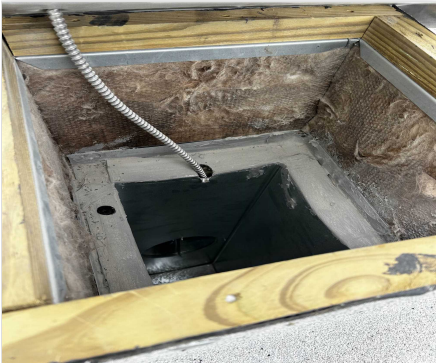
**Issue Name :** EF2  
**Description :** BACK DRAFT DAMPER IS NOT INSTALLED  
**Created By :** National TAB                      **Assigned To :** National TAB - Will Turnbough  
**Status :** Open  
**Priority :** Medium                      **Asset Tag :**  
**Originated Date :** 06/18/2024 - Kristopher Passley - National TAB

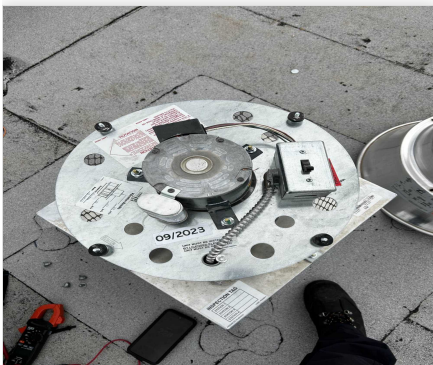
**Issue Name :** EF2 - AIRFLOW  
**Description :** FAN IS ON HIGH AIRFLOW, NO FAN SPEED CONTROLLER INSTALLED. RECOMMEND INSTALLED SPEED CONTROLLER TO BRING FAN INTO DESIGN.  
**Created By :** National TAB      **Assigned To :** National TAB - Will Turnbough  
**Status :** Open  
**Priority :** Urgent      **Asset Tag :**  
**Originated Date :** 06/19/2024 - Kristopher Passley - National TAB

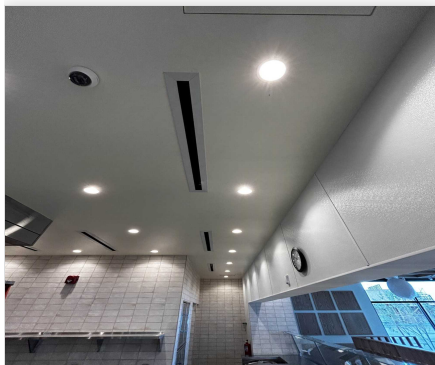
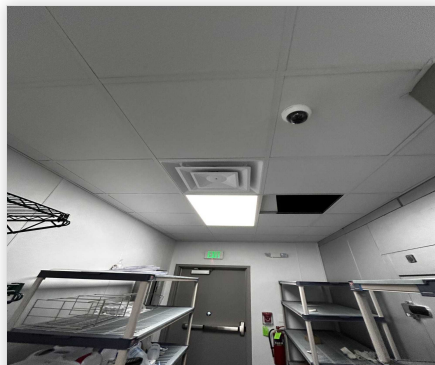
**Issue Name :** RTU-1 KITCHEN DIFFUSERS  
**Description :** KITCHEN DIFFUSERS 1-1,1-2,1-3 and 1-8 HAVE CLOSED DAMPERS THAT ARE INACCESSIBLE. NEED MECHANICAL TO OPEN OR CHECK FOR BLOCKAGE.  
**Created By :** National TAB  
**Assigned To :** National TAB - Will Turnbough  
**Status :** Open  
**Priority :** Urgent  
**Asset Tag :**  
**Originated Date :** 06/20/2024 - Kristopher Passley - National TAB
