**Report: TAB REPORT**  
**Function: Test, Adjust, & Balance**  
**Date: 08/01/2024**

**PROJECT**  
**06-17-24 CAVA YUKON, OK (10TH ST)**

Project: 06-17-24 CAVA YUKON, OK (10TH ST)

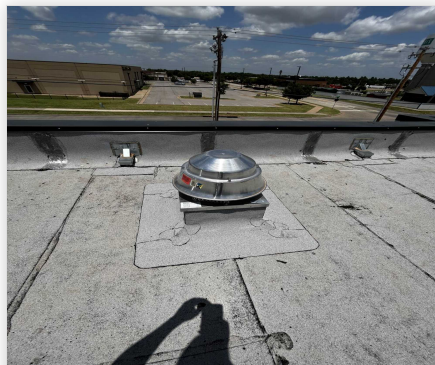
**Issue Name :** EF2 - AIRFLOW  
**Description :** FAN IS ON HIGH AIRFLOW, NO FAN SPEED CONTROLLER INSTALLED. RECOMMEND INSTALLED SPEED CONTROLLER TO BRING FAN INTO DESIGN.  
**Created By :** National TAB                      **Assigned To :** National TAB - Will Turnbough  
**Status :** Open  
**Priority :** Urgent                                      **Asset Tag :**  
**Originated Date :** 06/19/2024 - Kristopher Passley - National TAB
