**Report: TAB REPORT**  
**Function: Test, Adjust, & Balance**  
**Date: 08/01/2024**

**PROJECT**  
**06-17-24 CAVA YUKON, OK (10TH ST)**

Project: 06-17-24 CAVA YUKON, OK (10TH ST)

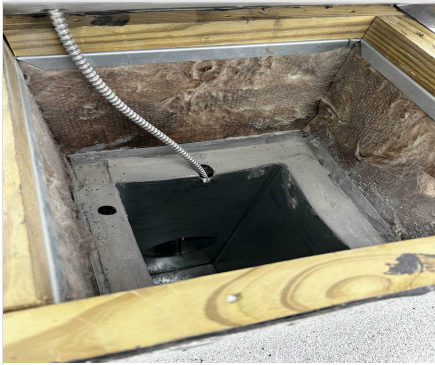
**Issue Name :** EF2  
**Description :** BACK DRAFT DAMPER IS NOT INSTALLED  
**Created By :** National TAB                      **Assigned To :** National TAB - Will Turnbough  
**Status :** Open  
**Priority :** Medium                                      **Asset Tag :**  
**Originated Date :** 06/18/2024 - Kristopher Passley - National TAB

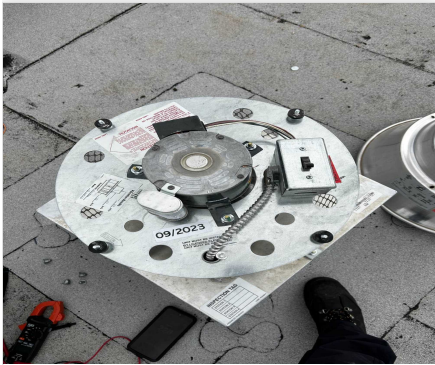
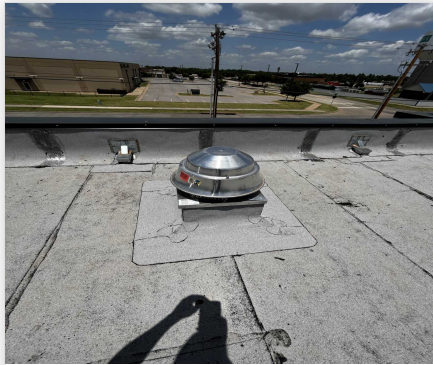
**Issue Name :** EF2 - AIRFLOW  
**Description :** FAN IS ON HIGH AIRFLOW, NO FAN SPEED CONTROLLER INSTALLED. RECOMMEND INSTALLED SPEED CONTROLLER TO BRING FAN INTO DESIGN.  
**Created By :** National TAB                      **Assigned To :** National TAB - Will Turnbough  
**Status :** Open  
**Priority :** Urgent                                      **Asset Tag :**  
**Originated Date :** 06/19/2024 - Kristopher Passley - National TAB

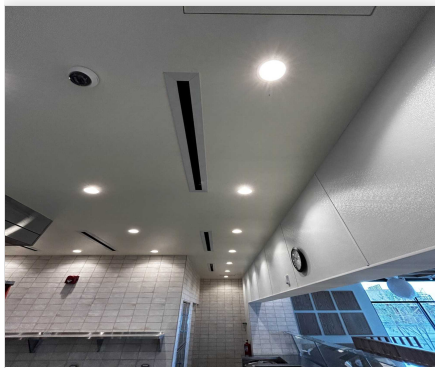
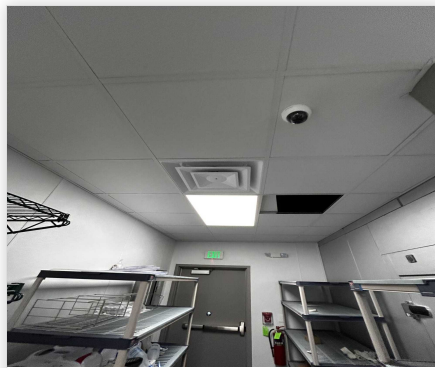
**Issue Name :** RTU-1 KITCHEN DIFFUSERS  
**Description :** KITCHEN DIFFUSERS 1-1,1-2,1-3 and 1-8 HAVE CLOSED DAMPERS THAT ARE INACCESSIBLE. NEED MECHANICAL TO OPEN OR CHECK FOR BLOCKAGE.  
**Created By :** National TAB                      **Assigned To :** National TAB - Will Turnbough  
**Status :** Open  
**Priority :** Urgent                                      **Asset Tag :**  
**Originated Date :** 06/20/2024 - Kristopher Passley - National TAB

RTU 1, DIFFUSER 1-8 HAS A FLEX DUCT WITH A LARGER THAN 90 DEGREE ELBOW.

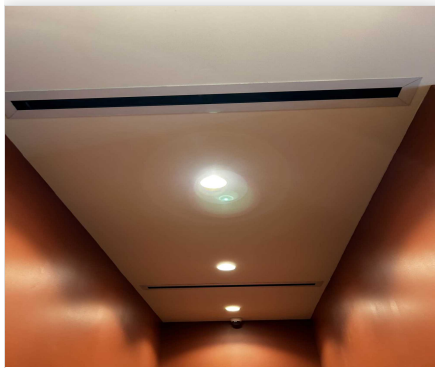
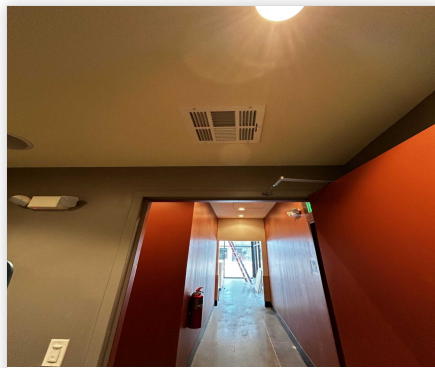
**Issue Name :** RTU-2 DIFFUSERS  
**Description :** RESTROOM AND HALLWAY DIFFUSERS 2-11, 2-12 and 2-14 HAVE CLOSED DAMPERS THAT ARE INACCESSIBLE. NEED MECHANICAL TO OPEN DAMPER OR CHECK FOR BLOCKAGE.  
**Created By :** National TAB                      **Assigned To :** National TAB - Will Turnbough  
**Status :** Open  
**Priority :** Urgent                                      **Asset Tag :**  
**Originated Date :** 06/20/2024 - Kristopher Passley - National TAB
