Report: FINAL TAB REPORT
Function: Test, Adjust, & Balance
Date: 7/14/2022

PROJECT
07-11 CULVERS - ANGOLA, IN

2207 N WAYNE STREET

ANGOLA, IN 46703

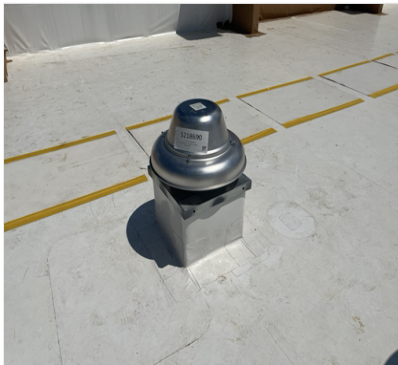
PRV-1

Unit Data		
	Design	Actual
MFG	ACCUREX	CAPTIVE AIRE
Model Num	XRED-095-D	DR12HFA
Serial Num	-	5218690
Type	DOWNBLAST	DOWNBLAST
Configuration	HORIZONTAL	VERTICAL

Test Data		
	Design	Actual
CFM	300	304
Fan RPM	1479	991
Fan Rotation	-	CCW
Motor RPM	-	991
System SetPt	-	54%
RL Voltage	-	119
RL Amperage	-	0.5
Total ESP	0.5"	0.21"
Fan Inlet SP	-	-0.21"
Fan Discharge SP	-	ATM

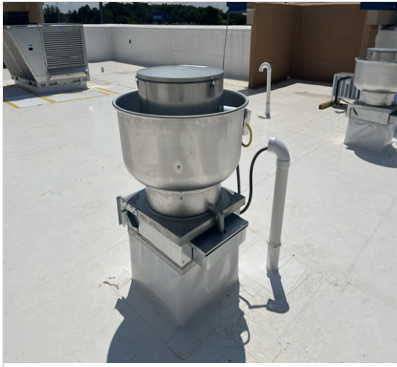
PRV-2

Unit Data		
	Design	Actual
MFG	ACCUREX	CAPTIVE AIRE
Model Num	XRUB-160XP-15	DU85HFA
Serial Num	-	5218690
Type	UPBLAST	UPBLAST
Configuration	VERTICAL	VERTICAL

Test Data		
	Design	Actual
CFM	1500	1458
Fan RPM	2411	1147
Fan Rotation	-	CCW
Motor RPM	-	1147
RL Voltage	-	209/210/210
RL Amperage	-	1.9/1.9/1.9
Suction ESP	-	-0.83"
Discharge ESP	-	ATM
Total ESP	2.337"	0.83"

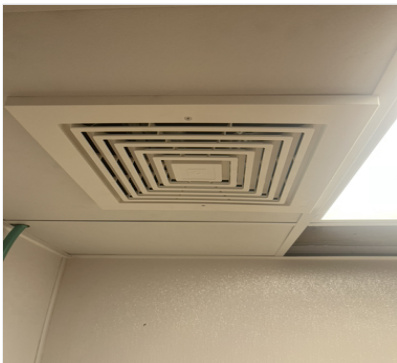
EF-1A

Unit Data		
	Design	Actual
MFG	ACCUREX	CAPTIVE AIRE
Model Num	XCR-B80	CFA 100CA
Serial Num	-	5218690
Type	CEILING	CEILING
Configuration	VERTICAL	VERTICAL

Test Data		
	Design	Actual
CFM	75	76
Fan RPM	885	DD
Fan Rotation	-	CCW
Motor RPM	-	DD
RL Voltage	-	119
RL Amperage	-	0.34
Suction ESP	-	ATM
Discharge ESP	-	0.09"
Total ESP	0.125"	0.09"

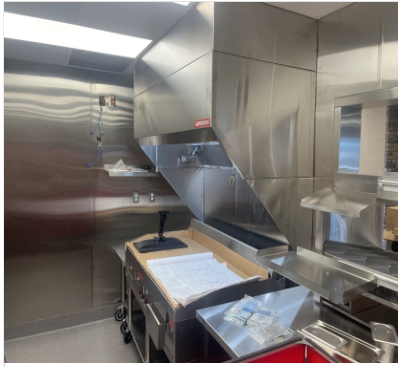
HOOD 1

Unit Data		
	Design	Actual
MFG	ACCUREX	CAPTIVE AIRE
Model Num	XGEP-64-S	3347 BD-2
Job / Serial Num	-	5218690
Type	TYPE I LOW PROXIMITY	TYPE I LOW PROFILE
Hood length	64"	66"
Hood Width	23"	33"

Test Data Exhaust		
	Design	Actual
Filter Type	GREASE GRABBER	CAPTRATE SOLO
Filter Size 1	16X16	16X16
Filter Qty 1	4	4
Filter AK factor size 1	1.53	1.62
Filter Total AK Area	6.12	6.48
Filter1 FPM	-	219
Filter2 FPM	-	226
Filter3 FPM	-	235
Filter4 FPM	-	218
Filter Ave FPM(corr)	-	225
CFM	-	1458

Performance Data		
	Design	Actual
Smoke Generation Type	-	45 SEC SMOKE EMITTER
Hood Capture %	-	100%
End Panels Installed (Y/N)	-	YES

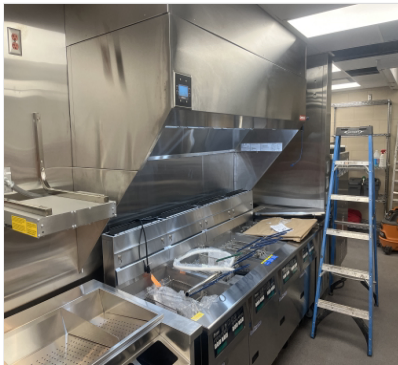
HOOD 2

Unit Data		
	Design	Actual
MFG	ACCUREX	CAPTIVE AIRE
Model Num	XXEP-83-S	3347 BD-2
Job / Serial Num	-	5218690
Type	TYPE I LOW PROXIMITY	TYPE I LOW PROFILE
Hood length	83"	84"
Hood Width	23"	33"

Performance Data		
	Design	Actual
Smoke Generation Type	-	45 SEC SMOKE EMITTER
Hood Capture %	-	100%
End Panels Installed (Y/N)	-	YES

Test Data Exhaust		
	Design	Actual
Filter Type	X-TRACTOR	CAPTRATE SOLO
Filter Size 1	16X16	16X16
Filter Qty 1	5	5
Filter AK factor size 1	1.53	1.62
Filter Total AK Area	7.65	8.1
Filter1 FPM	-	189
Filter2 FPM	-	198
Filter3 FPM	-	194
Filter4 FPM	-	194
Filter5 FPM	-	170
Filter Ave FPM(corr)	-	189
CFM	-	1531
