Report: FINAL TAB REPORT
Function: Test, Adjust, & Balance
Date: 7/18/2022

PROJECT
07-11 CULVERS - ANGOLA, IN

Project: 07-11 CULVERS - ANGOLA, IN

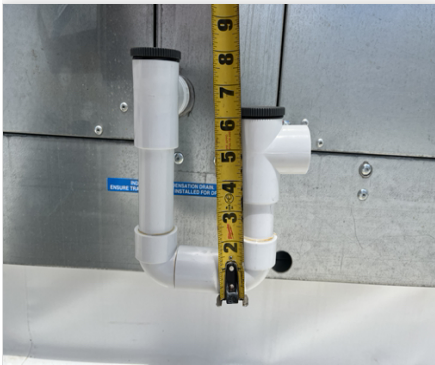
FuselTb19772e9f45f42658f709a
2bae88d222.jpeg

Issue Name : DOAS condensate drain size.

Description : Due to high fan suction pressure on both units, recommend distance between inlet and outlet increased for condensate drains from 2" to 4" to help units efficiently drain.

- **07/14/2022** **National TAB - Will Turnbough**
 - Recommend Captive Aire advise based on their experience if this is required.

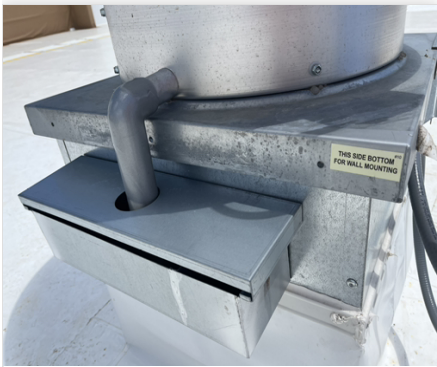
FuselT5d7911699c164576acdf77
b0bceaff4d.jpeg

Issue Name : PRV-2 and PRV-3 not secured to curb

Description : Recommend fans are secured to their curbs with screws.

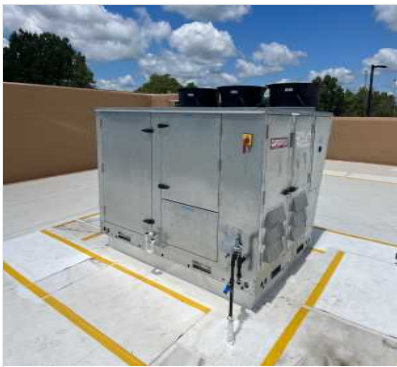
RTU-2 (Kitchen) has slight vibration above 40 HZ. Set to 57 HZ. CAS is aware of this issue.
