**Report: FINAL TAB REPORT**  
**Function: Test, Adjust, & Balance**  
**Date: 7/14/2022**

**PROJECT**  
**07-11 CULVERS - ANGOLA, IN**

# National TAB

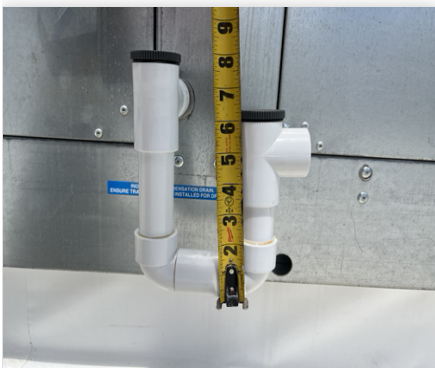
FuselTb19772e9f45f42658f709a  
2bae88d222.jpeg

**Issue Name :** DOAS condensate drain size.

**Description :** Due to high fan suction pressure on both units, recommend distance between inlet and outlet increased for condensate drains from 2" to 4" to help units efficiently drain.

- **07/14/2022**    **National TAB - Will Turnbough**
  - Recommend Captive Aire advise based on their experience if this is required.

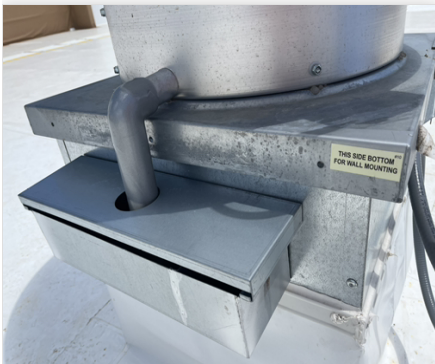
FuselT5d7911699c164576acdf77  
b0bceaff4d.jpeg

**Issue Name :** PRV-2 and PRV-3 not secured to curb

**Description :** Recommend fans are secured to their curbs with screws.

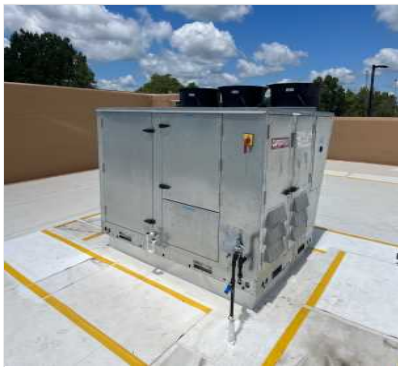
RTU-2 (Kitchen) has slight vibration above 40 HZ. Set to 57 HZ. CAS is aware of this issue.

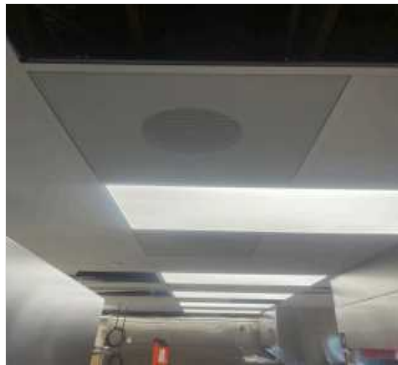
Screenshot\_2022\_07\_14\_101311.png

Perforated diffusers are installed on the cook line? (4-ways will disrupt hood capture) Yes

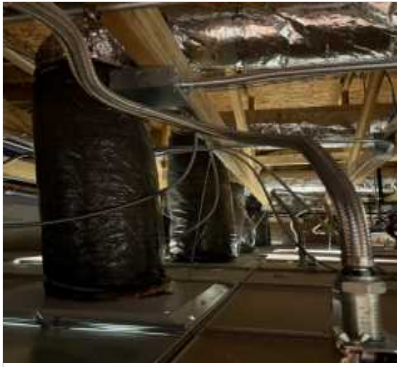
Screenshot\_2022\_07\_14\_101  
444.png

On the cookline diffusers neck is there 18" (12" minimum) straight rigid duct run attached? Yes

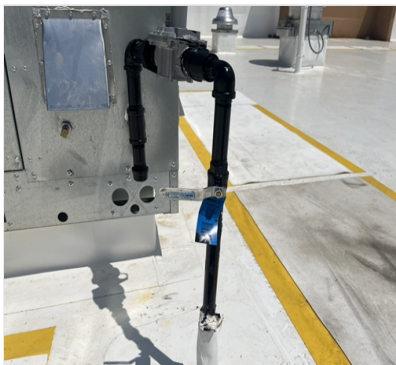
FuseIT5af68fabled6f4d2e9d27  
65c05ff752cb.jpeg

Economizers are assembled and functional?	Yes
Thermostat wire run from OCP on the RTU to the Ec terminal at the thermostat? If no, jumper can be installed from R to OCP temporarily. (The economizers will not open without OCP being energized.)	Captive Aire DOAS units installed.
Motors are all operating below the FLA rating?	Yes
Are belts tight?	NA, all direct drive units.
If direct drive unit is the speed controller working.	Yes
Is gas piping installed and valves turned on?	No, building does not yet have gas.

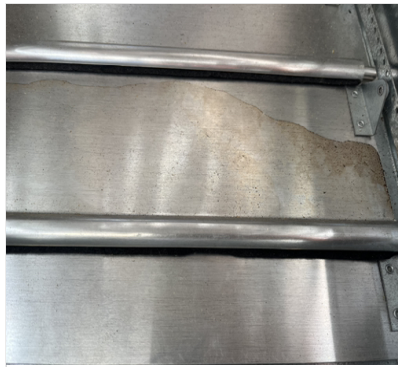
FuseITe0507750871540ecb11  
2e6523444619d.jpeg

For restroom fan(s) is the back draft damper installed and can it fully open?

Yes
