**Report: TEST - FINAL TAB REPORT
Function: Test, Adjust, & Balance
Date: 8/24/2022**

**PROJECT
07-11 CULVERS - ANGOLA, IN**

Project: 07-11 CULVERS - ANGOLA, IN

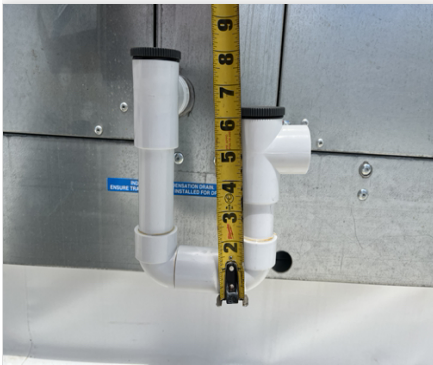
Issue Name : DOAS condensate drain size.

Description : Due to high fan suction pressure on both units, recommend distance between inlet and outlet increased for condensate drains from 2" to 4" to help units efficiently drain.

- **07/14/2022** **National TAB - Will Turnbough**
 - Recommend Captive Aire advise based on their experience if this is required.

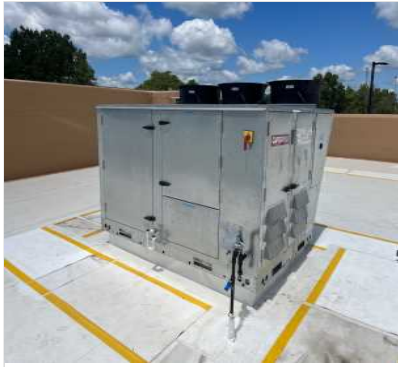
Description : RTU-2 (kitchen) has vibration. CAS is aware and inspected blower wheel.

RTU-2 (Kitchen) has slight vibration above 40 HZ. Set to 57 HZ. CAS is aware of this issue.

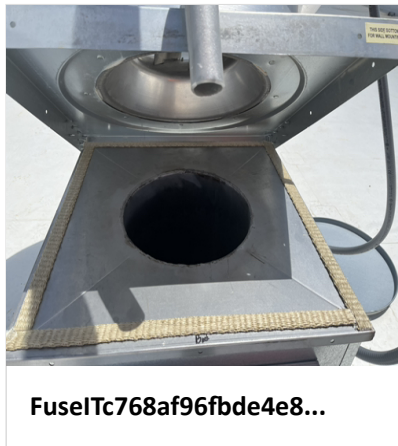
Lean grease rated fans back. Is grease duct installation adequate and is duct ran all the way to the base of the fan?

Yes
