Report: FINAL TAB REPORT
Function: Test, Adjust, & Balance
Date: 7/14/2022

PROJECT
07-11 CULVERS - ANGOLA, IN

Project: 07-11 CULVERS - ANGOLA, IN

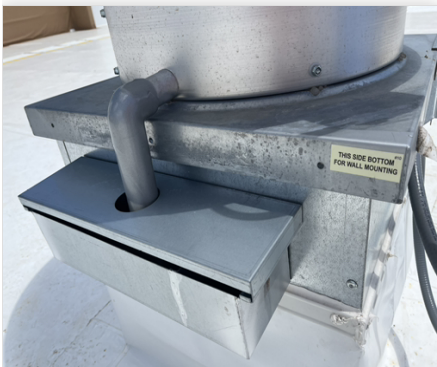
Issue Name : PRV-2 and PRV-3 not secured to curb

Description : Recommend fans are secured to their curbs with screws.
