Report: FINAL TAB REPORT
Function: Test, Adjust, & Balance
Date: 7/14/2022

PROJECT
07-11 CULVERS - ANGOLA, IN

Project: 07-11 CULVERS - ANGOLA, IN

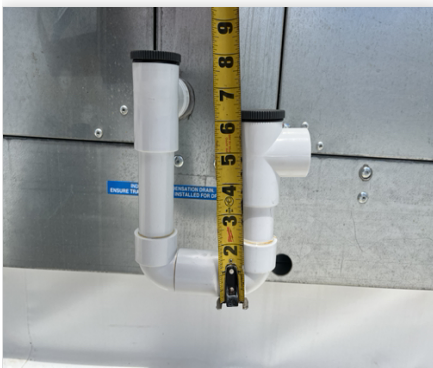
FuselTb19772e9f45f42658f709a
2bae88d222.jpeg

Issue Name : DOAS condensate drain size.

Description : Due to high fan suction pressure on both units, recommend distance between inlet and outlet increased for condensate drains from 2" to 4" to help units efficiently drain.

- **07/14/2022** **National TAB - Will Turnbough**
 - Recommend Captive Aire advise based on their experience if this is required.
