Report: FINAL TAB REPORT
Function: Test, Adjust, & Balance
Date: 7/14/2022

PROJECT
07-11 CULVERS - ANGOLA, IN

Project: 07-11 CULVERS - ANGOLA, IN

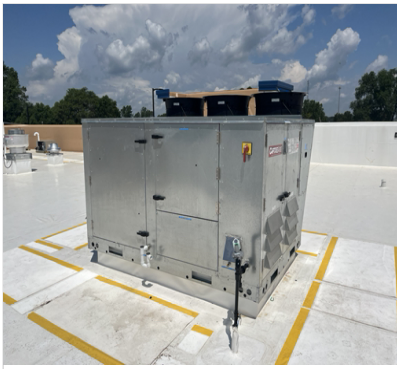
RTU-1

Unit Data		
	Design	Actual
MFG	LENNOX	CAPTIVE AIRE
Serial Num	-	5218690
Model Num	LGH240H4B	CASRTU3-1.400-24-20T-DOAS
Type	RTU	RTU
Configuration	VERTICAL	VERTICAL
Num OA Filters 1	-	4
OA Filter Size 1	-	16X20
Num Final Filter 1	-	8
Final Filter Size 1	-	20X25X2
Num Final Filter 2	-	NA
Final Filter Size 2	-	NA

Test Data		
	Design	Actual
SF CFM	6300	6092
SF RPM	-	1814
RA CFM	4625	4392
OA CFM	1675	1700
RL Voltage	-	211
RL Amperage	-	24.1
SF Rotation	-	CCW
RA Damper Position	-	NA
Min OA Damper Position	-	4.3V
Min OA Damper Type	-	ECONOMIZER
OA Enthalpy Setpt	-	NA
Brake Horse Power	-	9.92

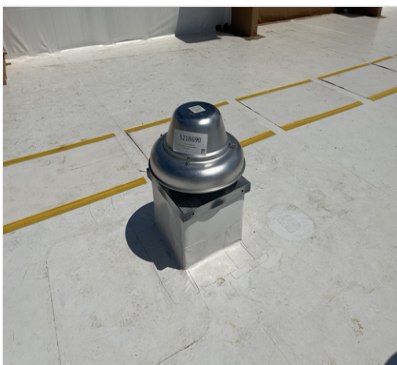
PRV-1

Unit Data		
	Design	Actual
MFG	ACCUREX	CAPTIVE AIRE
Model Num	XRED-095-D	DR12HFA
Serial Num	-	5218690
Type	DOWNBLAST	DOWNBLAST
Configuration	HORIZONTAL	VERTICAL

Test Data		
	Design	Actual
CFM	300	304
Fan RPM	1479	991
Fan Rotation	-	CCW
Motor RPM	-	991
System SetPt	-	54%
RL Voltage	-	119
RL Amperage	-	0.5
Total ESP	0.5"	0.21"
Fan Inlet SP	-	-0.21"
Fan Discharge SP	-	ATM

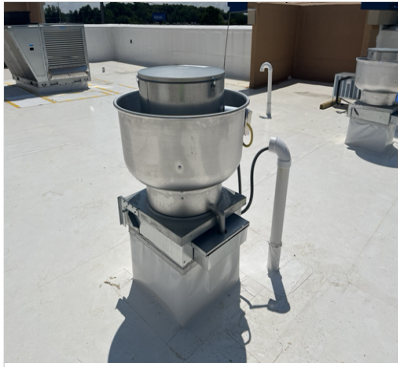
PRV-2

Unit Data		
	Design	Actual
MFG	ACCUREX	CAPTIVE AIRE
Model Num	XRUB-160XP-15	DU85HFA
Serial Num	-	5218690
Type	UPBLAST	UPBLAST
Configuration	VERTICAL	VERTICAL

Test Data		
	Design	Actual
CFM	1500	1458
Fan RPM	2411	1147
Fan Rotation	-	CCW
Motor RPM	-	1147
RL Voltage	-	209/210/210
RL Amperage	-	1.9/1.9/1.9
Suction ESP	-	-0.83"
Discharge ESP	-	ATM
Total ESP	2.337"	0.83"

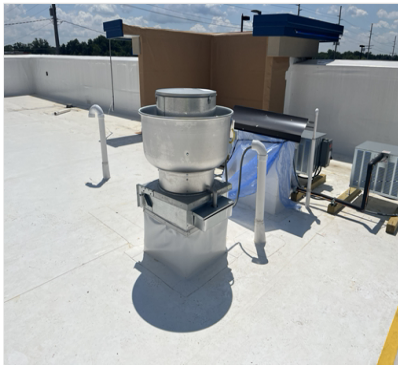
PRV-3

Unit Data		
	Design	Actual
MFG	ACCUREX	CAPTIVE AIRE
Model Num	XRUB-140-7	DU85HFA
Serial Num	-	5218690
Type	UPBLAST	UPBLAST
Configuration	VERTICAL	VERTICAL

Test Data		
	Design	Actual
CFM	1500	1531
Fan RPM	1377	1118
Fan Rotation	-	CCW
Motor RPM	-	1118
RL Voltage	-	210/210/209
RL Amperage	-	2.0/1.9/2.0
Suction ESP	-	-0.71"
Discharge ESP	-	ATM
Total ESP	1.0"	0.71"

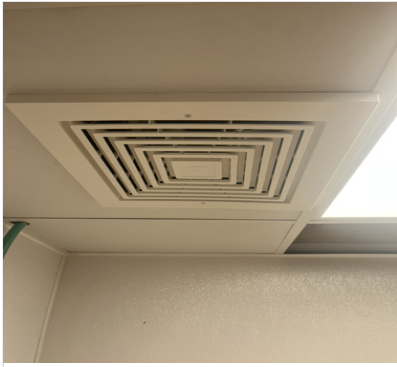
EF-1A

Unit Data		
	Design	Actual
MFG	ACCUREX	CAPTIVE AIRE
Model Num	XCR-B80	CFA 100CA
Serial Num	-	5218690
Type	CEILING	CEILING
Configuration	VERTICAL	VERTICAL

Test Data		
	Design	Actual
CFM	75	76
Fan RPM	885	DD
Fan Rotation	-	CCW
Motor RPM	-	DD
RL Voltage	-	119
RL Amperage	-	0.34
Suction ESP	-	ATM
Discharge ESP	-	0.09"
Total ESP	0.125"	0.09"

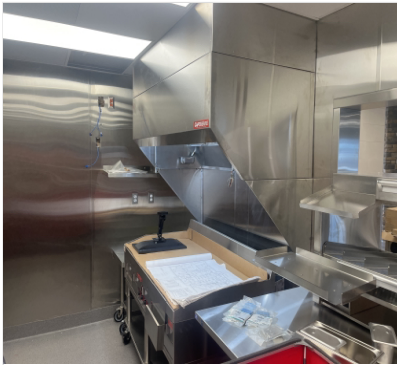
HOOD 1

Unit Data		
	Design	Actual
MFG	ACCUREX	CAPTIVE AIRE
Model Num	XGEP-64-S	3347 BD-2
Job / Serial Num	-	5218690
Type	TYPE I LOW PROXIMITY	TYPE I LOW PROFILE
Hood length	64"	66"
Hood Width	23"	33"

Test Data Exhaust		
	Design	Actual
Filter Type	GREASE GRABBER	CAPTRATE SOLO
Filter Size 1	16X16	16X16
Filter Qty 1	4	4
Filter AK factor size 1	1.53	1.62
Filter Total AK Area	6.12	6.48
Filter1 FPM	-	219
Filter2 FPM	-	226
Filter3 FPM	-	235
Filter4 FPM	-	218
Filter Ave FPM(corr)	-	225
CFM	-	1458

Performance Data		
	Design	Actual
Smoke Generation Type	-	45 SEC SMOKE EMITTER
Hood Capture %	-	100%
End Panels Installed (Y/N)	-	YES

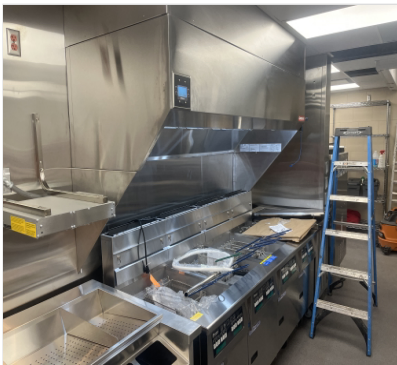
HOOD 2

Unit Data		
	Design	Actual
MFG	ACCUREX	CAPTIVE AIRE
Model Num	XXEP-83-S	3347 BD-2
Job / Serial Num	-	5218690
Type	TYPE I LOW PROXIMITY	TYPE I LOW PROFILE
Hood length	83"	84"
Hood Width	23"	33"

Performance Data		
	Design	Actual
Smoke Generation Type	-	45 SEC SMOKE EMITTER
Hood Capture %	-	100%
End Panels Installed (Y/N)	-	YES

Test Data Exhaust		
	Design	Actual
Filter Type	X-TRACTOR	CAPTRATE SOLO
Filter Size 1	16X16	16X16
Filter Qty 1	5	5
Filter AK factor size 1	1.53	1.62
Filter Total AK Area	7.65	8.1
Filter1 FPM	-	189
Filter2 FPM	-	198
Filter3 FPM	-	194
Filter4 FPM	-	194
Filter5 FPM	-	170
Filter Ave FPM(corr)	-	189
CFM	-	1531
