Report: FINAL TAB REPORT
Function: Test, Adjust, & Balance
Date: 7/14/2022

PROJECT
07-11 CULVERS - ANGOLA, IN

Project: 07-11 CULVERS - ANGOLA, IN

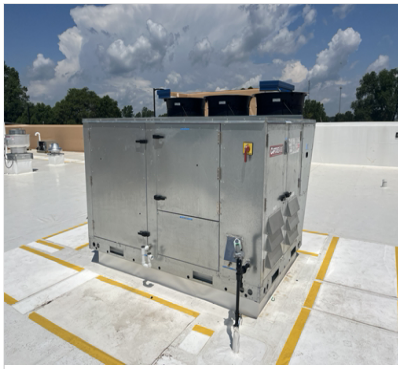
RTU-1

Unit Data		
	Design	Actual
MFG	LENNOX	CAPTIVE AIRE
Serial Num	-	5218690
Model Num	LGH240H4B	CASRTU3-1.400-24-20T-DOAS
Type	RTU	RTU
Configuration	VERTICAL	VERTICAL
Num OA Filters 1	-	4
OA Filter Size 1	-	16X20
Num Final Filter 1	-	8
Final Filter Size 1	-	20X25X2
Num Final Filter 2	-	NA
Final Filter Size 2	-	NA

Test Data		
	Design	Actual
SF CFM	6300	6092
SF RPM	-	1814
RA CFM	4625	4392
OA CFM	1675	1700
RL Voltage	-	211
RL Amperage	-	24.1
SF Rotation	-	CCW
RA Damper Position	-	NA
Min OA Damper Position	-	4.3V
Min OA Damper Type	-	ECONOMIZER
OA Enthalpy Setpt	-	NA
Brake Horse Power	-	9.92

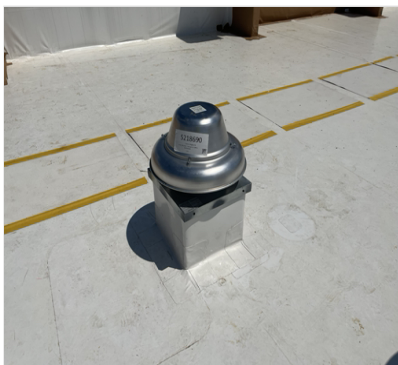
PRV-1

Unit Data		
	Design	Actual
MFG	ACCUREX	CAPTIVE AIRE
Model Num	XRED-095-D	DR12HFA
Serial Num	-	5218690
Type	DOWNBLAST	DOWNBLAST
Configuration	HORIZONTAL	VERTICAL

Test Data		
	Design	Actual
CFM	300	304
Fan RPM	1479	991
Fan Rotation	-	CCW
Motor RPM	-	991
System SetPt	-	54%
RL Voltage	-	119
RL Amperage	-	0.5
Total ESP	0.5"	0.21"
Fan Inlet SP	-	-0.21"
Fan Discharge SP	-	ATM

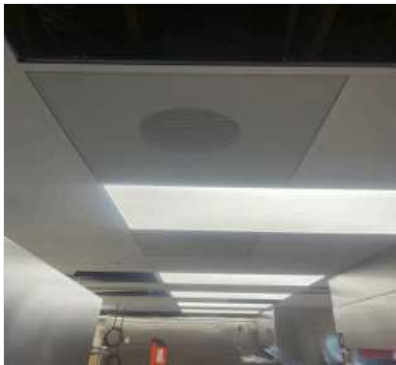
Perforated diffusers are installed on the cook line? (4-ways will disrupt hood capture) Yes

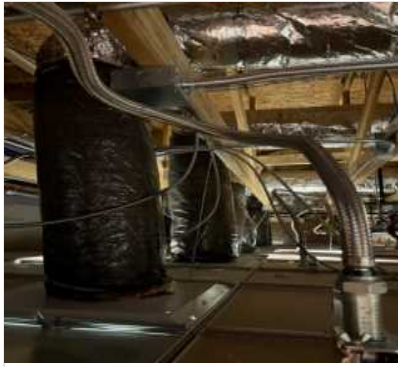
On the cookline diffusers neck is there 18" (12" minimum) straight rigid duct run attached? Yes
