Report: FINAL TAB REPORT
Function: Test, Adjust, & Balance
Date: 7/14/2022

PROJECT
07-11 CULVERS - ANGOLA, IN

Project: 07-11 CULVERS - ANGOLA, IN

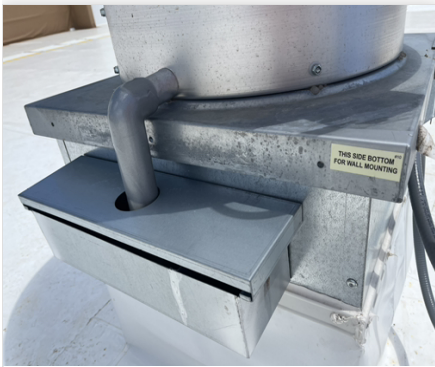
FuselT5d7911699c164576acdf77
b0bceaff4d.jpeg

Issue Name : PRV-2 and PRV-3 not secured to curb

Description : Recommend fans are secured to their curbs with screws.

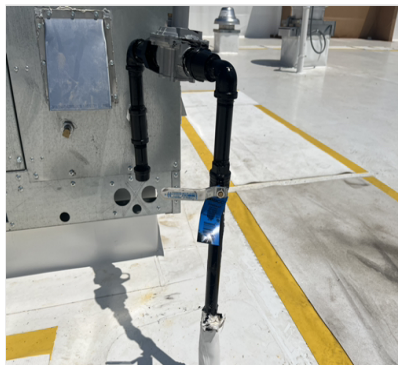
FuseIT5af68fabled6f4d2e9d27
65c05ff752cb.jpeg

Economizers are assembled and functional?	Yes
Thermostat wire run from OCP on the RTU to the Ec terminal at the thermostat? If no, jumper can be installed from R to OCP temporarily. (The economizers will not open without OCP being energized.)	Captive Aire DOAS units installed.
Motors are all operating below the FLA rating?	Yes
Are belts tight?	NA, all direct drive units.
If direct drive unit is the speed controller working.	Yes
Is gas piping installed and valves turned on?	No, building does not yet have gas.

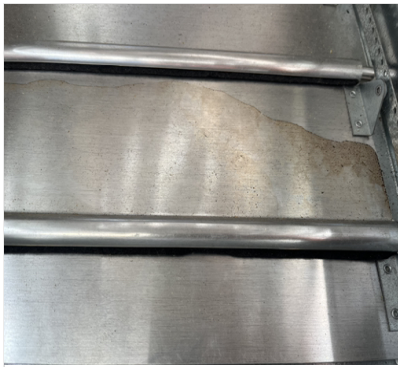
FuseITe0507750871540ecb11
2e6523444619d.jpeg

For restroom fan(s) is the back draft damper installed and can it fully open?

Yes
