Report: TAB REPORT
Function: Test, Adjust, & Balance
Date: 06/19/2024

06-10-24 PENN STATION - FORT. MILL, SC

C&T DESIGN
4025 PORT UNION RD.
FAIRFIELD, OH 45014

Project Summary

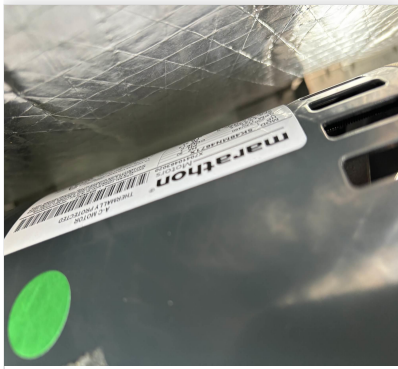
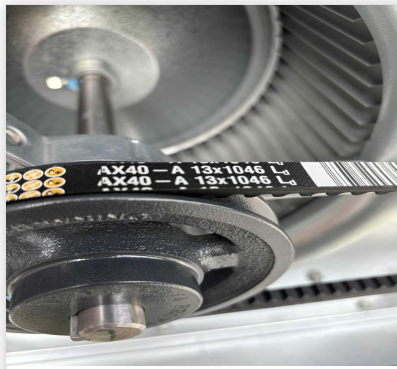
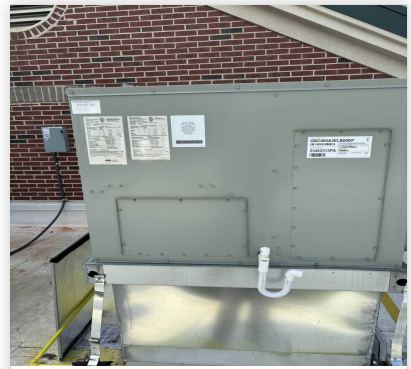
RTU-1 Yes

Asset: RTU1

Unit Data		
	Design	Actual
MFG	LENNOX	TRANE
Serial Num	-	23462384PA
Model Num	ZGA060S4BM1P	GBC060A3ELB0D000
Type	RTU	RTU
Configuration	VERTICAL	VERTICAL
Num OA Filters 1	-	1
OA Filter Size 1	-	10X24X1
Num Final Filter 1	-	4
Final Filter Size 1	-	16X16X2
Num Final Filter 2	-	NA
Final Filter Size 2	-	NA

Test Data		
	Design	Actual
SF CFM	2000	1957
SF RPM	-	1195F/1731M
RA CFM	1400	1410
OA CFM	600	547
RL Voltage	-	210/212/208
RL Amperage	-	3.8/3.9/3.7
SF Rotation	-	CCW
SF System SetPt	-	CONTANT HIGH
RA Damper Position	-	NA
Min OA Damper Position	-	20% /1.3" OPEN
Min OA Damper Type	-	MANUAL
OA Enthalpy Setpt	-	NA

General		
	Design	Actual
Fan Rotation Correct	-	Yes
Unit Filters Clean	-	Yes
Condensate Drain Installed	-	Yes

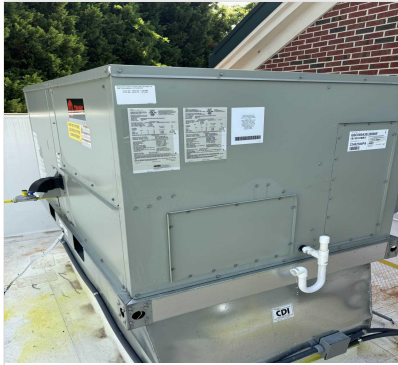
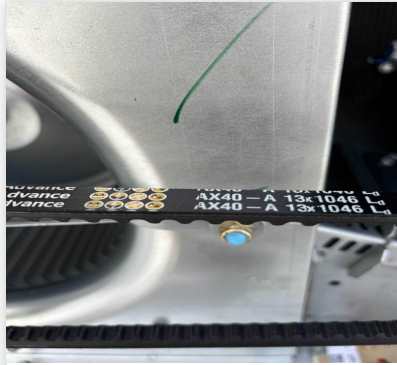
RTU-2

Asset: RTU2

Unit Data		
	Design	Actual
MFG	LENNOX	LENNOX
Serial Num	-	23462313PA
Model Num	ZGA060S4BM1P	GBC060A3ELB0
Type	RTU	RTU
Configuration	VERTICAL	VERTICAL
Num OA Filters 1	-	1
OA Filter Size 1	-	10X24
Num Final Filter 1	-	4
Final Filter Size 1	-	16X16X2
Num Final Filter 2	-	NA
Final Filter Size 2	-	NA

Test Data		
	Design	Actual
SF CFM	2000	1994
SF RPM	-	1184F/1722M
RA CFM	1400	1425
OA CFM	600	569
RL Voltage	-	210/212/208
RL Amperage	-	3.7/3/7/3.9
SF Rotation	-	CCW
SF System SetPt	-	NA
RA Damper Position	-	NA
Min OA Damper Position	-	20%/1.3" OPEN
Min OA Damper Type	-	MANUALLY SET
OA Enthalpy Setpt	-	NA

General		
	Design	Actual
Fan Rotation Correct	-	YES
Unit Filters Clean	-	YES
Condensate Drain Installed	-	YES

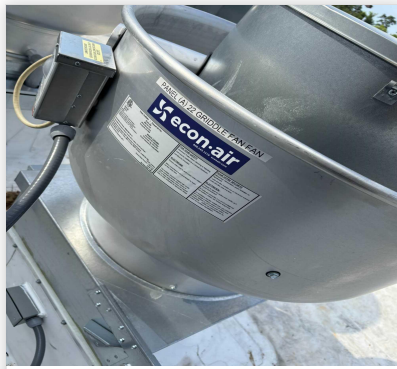
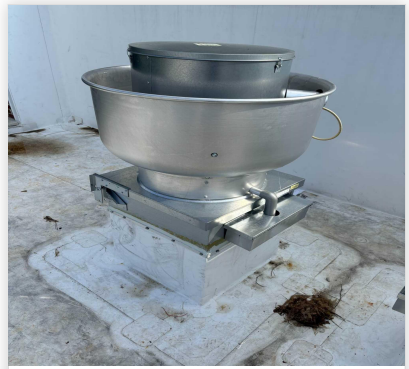
KEF-1

Asset: KEF1

Unit Data		
	Design	Actual
MFG	CAPTIVEAIRE	CAPTIVEAIRE
Model Num	DU85HFA	EADU85H
Serial Num	-	6351107
Type	UPBLAST	UPBLAST
Configuration	VERTICAL	VERTICAL

Test Data		
	Design	Actual
CFM	850	808
Fan RPM	1144	DD
Fan Rotation	-	CCW
Motor RPM	-	DD
System SetPt	-	60%
RL Voltage	-	119
RL Amperage	-	4.0
Total ESP	1.150"	1.01"
Fan Inlet SP	-	-1.01"
Fan Discharge SP	-	ATM

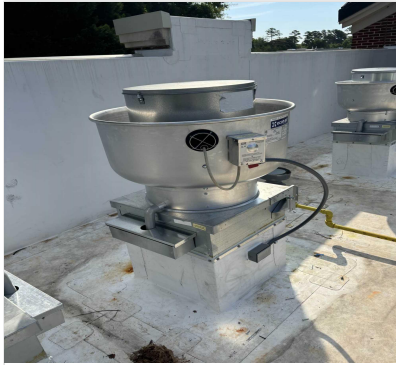
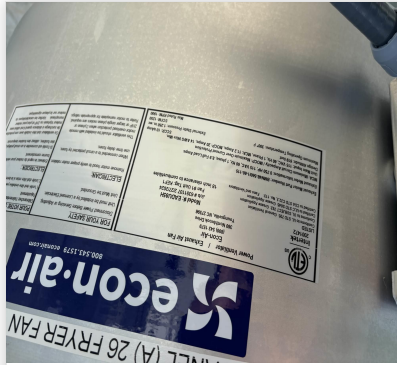
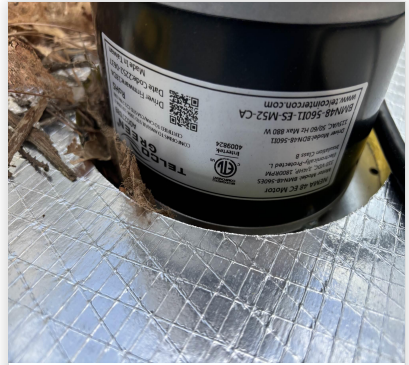
KEF-2

Asset: KEF2

Unit Data		
	Design	Actual
MFG	CAPTIVEAIRE	CAPTIVEAIRE
Model Num	DU33HFA	DU33HFA
Serial Num	-	6351107
Type	UPBLAST	UPBLAST
Configuration	VERTICAL	VERTICAL

Test Data		
	Design	Actual
CFM	600	588
Fan RPM	1360	DD
Fan Rotation	-	CCW
Motor RPM	-	DD
System SetPt	-	40%
RL Voltage	-	120
RL Amperage	-	1.86
Total ESP	0.600"	0.71"
Fan Inlet SP	-	-0.71"
Fan Discharge SP	-	ATM

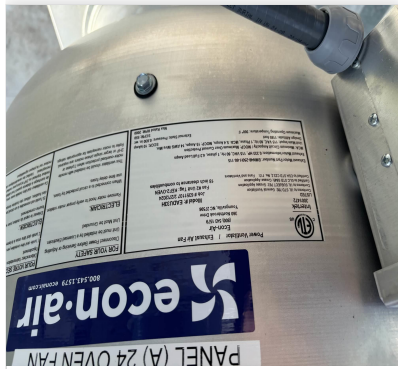
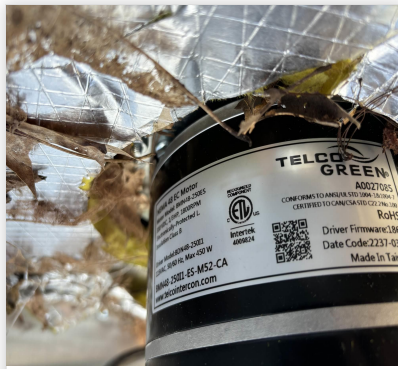
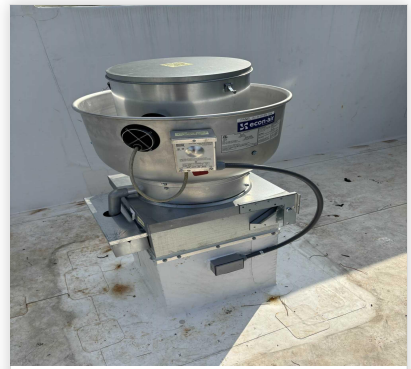
KEF-3

Asset: KEF3

Unit Data		
	Design	Actual
MFG	CAPTIVEAIRE	CAPTIVEAIRE
Model Num	DU85HFA	DU85HFA
Serial Num	-	6351107
Type	UPBLAST	UPBLAST
Configuration	VERTICAL	VERTICAL

Test Data		
	Design	Actual
CFM	1120	1153
Fan RPM	1215	DD
Fan Rotation	-	CCW
Motor RPM	-	DD
System SetPt	-	70%
RL Voltage	-	120
RL Amperage	-	4.81
Total ESP	1.150"	1.17"
Fan Inlet SP	-	-1.17"
Fan Discharge SP	-	ATM

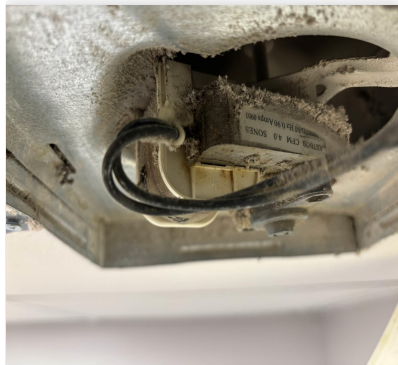
EF-4

Asset: EF4

Unit Data		
	Design	Actual
MFG	NA	NA
Model Num	NA	NA
Serial Num	-	NA
Type	-	ceiling
Configuration	-	Horizontal

Test Data		
	Design	Actual
CFM	75	72
Fan RPM	-	NA
Fan Rotation	-	CCW
Motor RPM	-	NA
System SetPt	-	High
RL Voltage	-	122
RL Amperage	-	0.86
Total ESP	-	Na
Fan Inlet SP	-	Na
Fan Discharge SP	-	Na

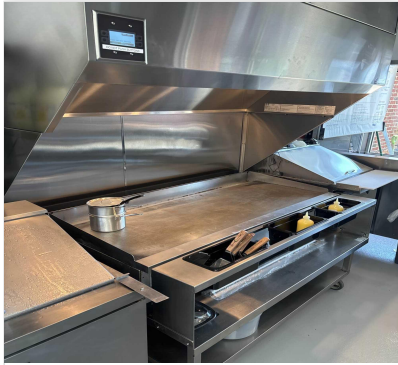
HD-3

Asset: HD3

Unit Data		
	Design	Actual
MFG	CAPTIVEAIRE	CAPTIVEAIRE
Model Num	3650 ELPX - 246 ACPSP ONLY	3650 ELPX - 246 ACPSP ONLY
Job / Serial Num	-	6351107
Type	TYPE I CANOPY	TYPE I CANOPY
Hood length	72"	72"
Hood Width	36"	36"
Supply Plenum Type	-	ACPSP
Supply Plenum Width	14"	14"
Supply Plenum Length	72"	72"

Test Data Exhaust		
	Design	Actual
Filter Type	CAPTRATE SOLO	CAPTRATE SOLO
Filter Size 1	16X16	16X16
Filter Qty 1	4	4
Filter AK factor size 1	1.62	1.62
Filter Total AK Area	6.48	6.48
Filter1 FPM	-	225
Filter2 FPM	-	190
Filter3 FPM	-	191
Filter4 FPM	-	195
Filter Ave FPM(corr)	-	178
CFM	1120	1153

Test Data Supply		
	Design	Actual
Total AK Area	7	7
Kv factor (Vel)	0.89	0.89
Num of Readings	-	6
Reading1 FPM	-	165
Reading2 FPM	-	157
Reading3 FPM	-	177
Reading4 FPM	-	175
Reading5 FPM	-	160
Reading6 FPM	-	152
Reading7 FPM	-	
Reading8 FPM	-	
Reading9 FPM	-	
Reading10 FPM	-	
Reading11 FPM	-	
Reading12 FPM	-	
Reading13 FPM	-	
Reading14 FPM	-	
Ave FPM(corr)	-	146
CFM	1000	1023
