**Report: TAB REPORT**  
**Function: Test, Adjust, & Balance**  
**Date: 01/30/2024**

## 12-25-23 MEZEH HAMILTON TOWNSHIP, NJ

209 Marketplace Boulevard Block 2613, Lot 38

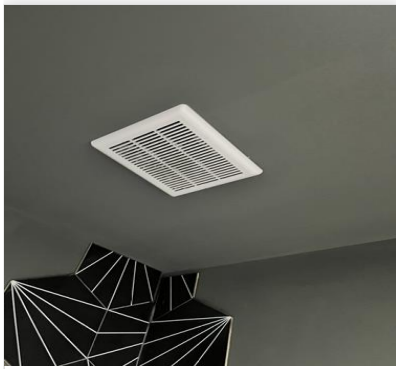
**EF-2**  
**01/30/2024**

| <b>Description :</b> | Both restroom ceiling exhaust fans are only rated for 80 CFM base on the unit tag information. Recommend having Engineer on File review unit information and test data. | | |
