**Report: TAB REPORT**  
**Function: Test, Adjust, & Balance**  
**Date: 01/30/2024**

**12-25-23 MEZEH HAMILTON TOWNSHIP, NJ**

Mezeh Mediterranean Grill  
3975 FAIR RIDE DR  
SUITE 430  
FAIRFAX, VA 22033

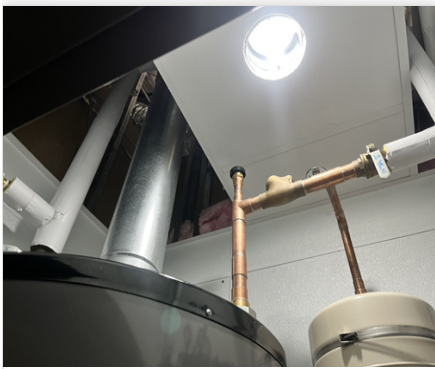
Water\_heater\_vent.jpe..  
01/30/2024

**Issue Name :** EF-4 is not installed  
**Description :** EF-4 is not installed. There is a vent for the water heater in place.Recommend having Engineer on file and Mezah review to approval.  
**Created By :** National TAB                      **Assigned To :** National TAB - David Annan  
**Status :** Open  
**Priority :**    **Asset Tag :**  
**Originated Date :** 01/30/2024 - David Annan - National TAB
