Report: Test and Balance  
Date: 8/16/2019

**PROJECT**  
**CHICK-FIL-A #02795 - LUMBERTON, NC (REVIVE)**

230 JACKSON CT  
LUMBERTON, NC 28358

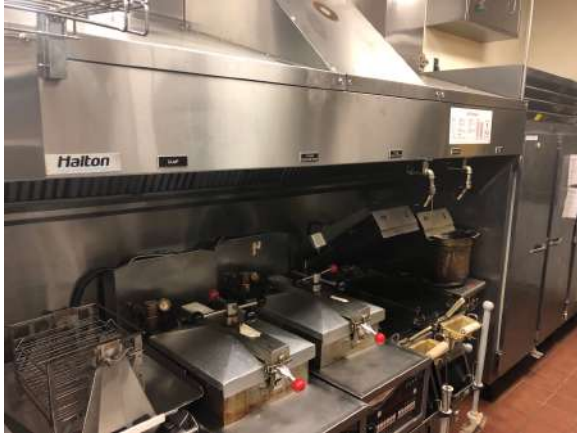
HD1R

HIGH	EF-2 belt is near failure and needs to be replaced. It is installed as a 4L280
HIGH	Hood 1R has a small range that is sticking outside of the hood. Recommend that this be moved fully under the hood.
HIGH	AC-3 Mesh OA filters are not installed.
LOW	AC5 in the Play area was not running and had to be jumpered on. Recommend fan runs constantly. Recommend troubleshooting with OEM to determine why unit is cycling on and off.
LOW	AC-2 Prodigy board cover is loose. Does not appear to be causing any major issues but recommend repairing if possible.
LOW	AC-3 blower door insulation is coming loose. Recommend repairing.
INFO	Major area of complaint was the kitchen. Initially the temperatures were measured throughout the kitchen as an average of 75 F. Kitchen AC-1 was initially programmed for 76 cooling temperature. This stat as well as the others were programmed for standard CFA settings of 73. After balancing was completed the space achieved this temperature. When forced into full cooling the temperature throughout the kitchen was between 69-71.

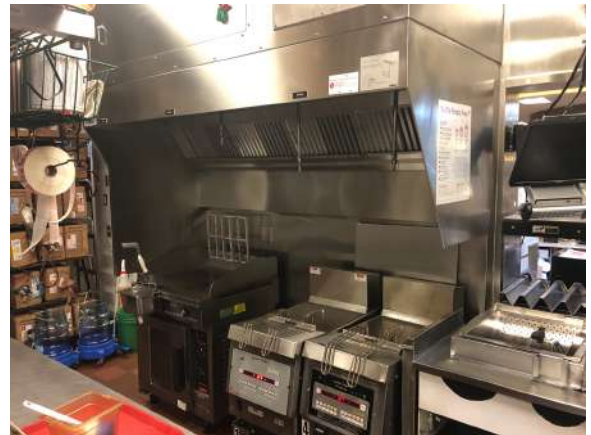
HD3

Notes: [1] Capture Jet Speed controller is maximized, can see no obstructions at inlet. Cleaned dirt buildup at inlet.  
 [2] Hood Capture is only 95%, loss is on the left side of the hood by griddle. It is caused by a combination of high side capture jet flow and low Hood capture jet flow.

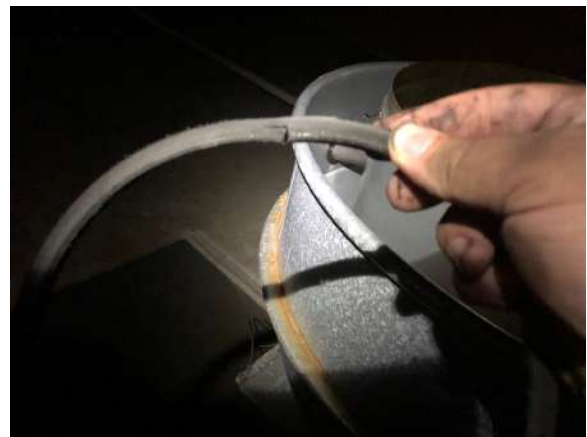
EF2 Belt

Notes: [1] Belt is damaged and needs to be replaced

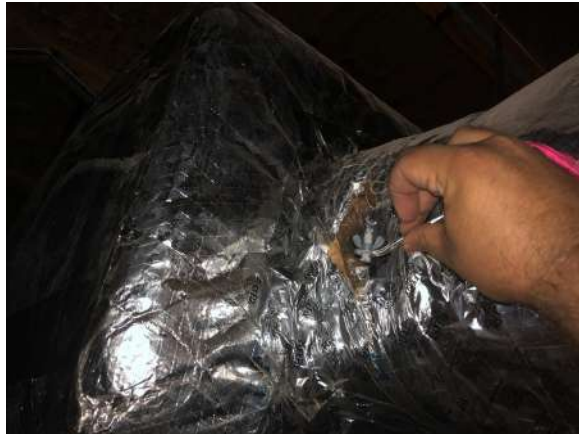
Broken Damper

Asset	Area Served	Notes
SGRD5	DINING	[1] Damper handle is broken. Unable to close damper down to decrease flow to diffuser.

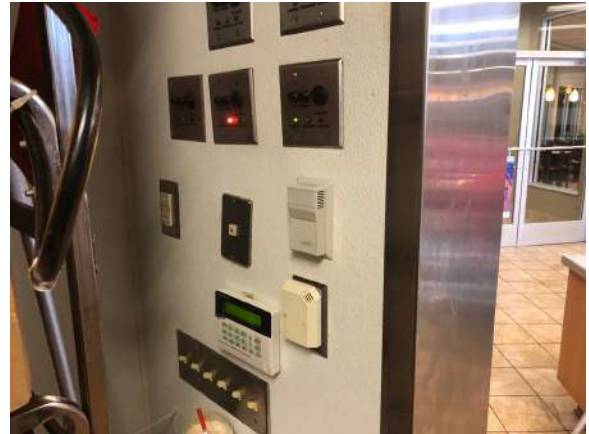
AC1 Sensors

- Notes:
- [1] Missing top half of OA ECONOMIZER
  - [2] OA Filters are clogged with dirt
  - [3] Alarm (91) Outdoor Enth Sensor A7
  - [4] Damper is Set to 28% but the OA damper seems to be in the closed position.
  - [5] With current dirty filters still installed, nothing blocked off. Discharge 60.2F 88% Hum, return 68.4F 85% Hum, MA 74.1F 72%. OA total is 2644
  - [6] OA total with clogged OA filters removed is 6048
  - [7] OA Temp is 78.5F 72%

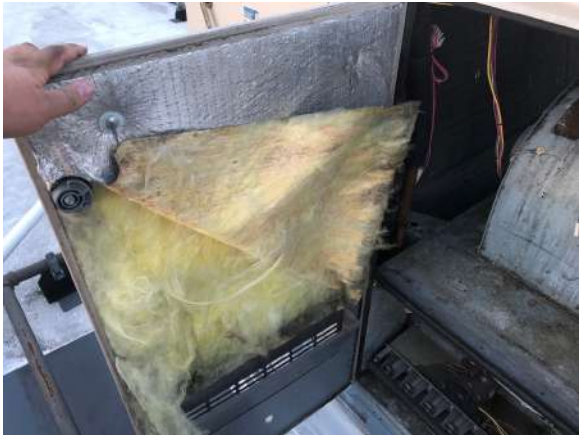
# AC3 Insulation Issue

- Notes:
- [1] No OA Filters Installed
  - [2] Motor sticker inaccessible, motor data taken from unit sticker
  - [3] The OA blades were taped shut, removed tape and set OA on high side to account for lack of filters. Tape replaced after setting to ensure building pressure didn't not get to high
  - [4] Insulation coming of motor compartment door

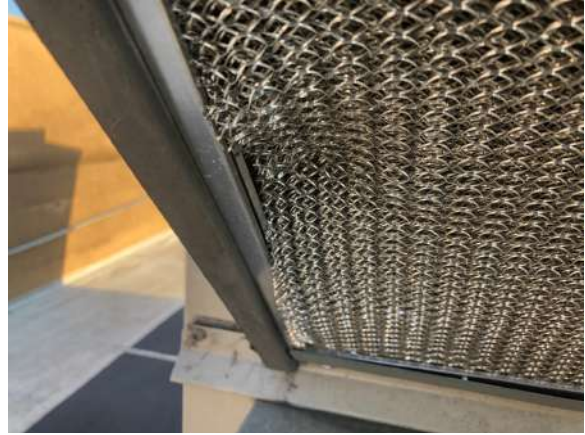
AC2 OA Filter Dmg

- Notes: [1] Motor sticker not accessible, motor data take. From unit sticker  
 [2] Prodigy board is coming off board, see picture  
 [3] OA Filter slightly damaged

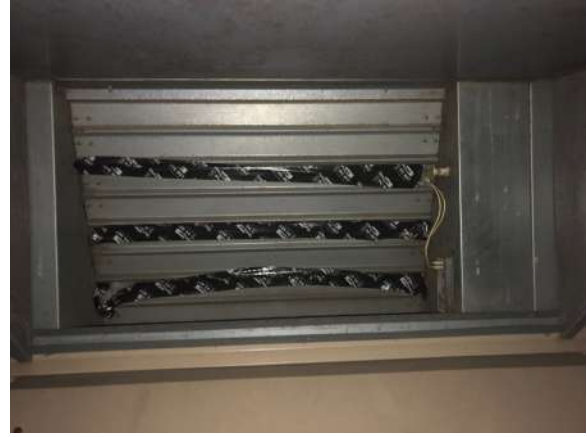
AC3 OA Damper

INFO	AC-3 economizer was taped shut initially (see pictures). The tape was removed and the OA was set. This was re-set to closed position and tape reinstalled until AC-1 economizer is repaired to prevent a overly positive pressure.
------	--
