Report: TAB Report
Function: Test, Adjust, & Balance
Date: 08/01/2024

06-24-24 WAWA #5413 SARASOTA, FL

Wawa
260 West Baltimore Pike
Wawa, PA 19063

National TAB

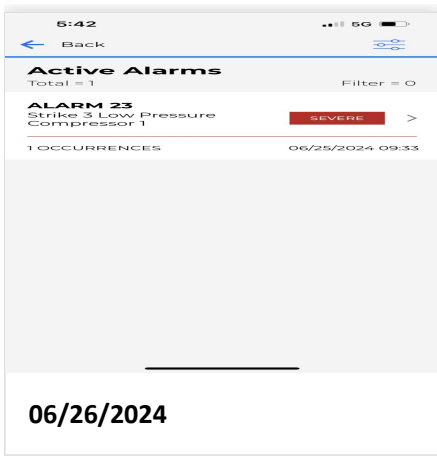
Issue Name : RTU 1 - compressor 1 fault
Description : RTU 1 has a persistent error on the CORE interface, stating that compressor 1 is not running as intended. Recommend inspecting compressor for possible damage.
Created By : National TAB **Assigned To :** National TAB - Mark Johnson
Status : Open
Priority : High **Asset Tag :**
Originated Date : 06/26/2024 - Mark Johnson - National TAB

- **08/05/2024 National TAB - Stephen Tassinaro**
 - MC was working on resolving compressor issues when NTi was on site 8/1.

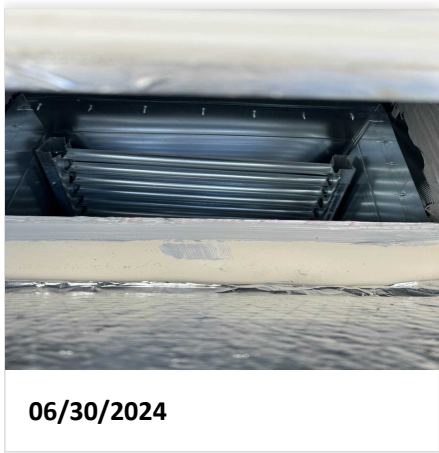
Issue Name : RTU turning vane installation
Description : The turning vanes located in the supply drops of the RTUs are not fully installed, sitting loose inside the duct. Recommend installing.
Created By : National TAB **Assigned To :** National TAB - Mark Johnson
Status : Open
Priority : Low **Asset Tag :**
Originated Date : 06/30/2024 - Mark Johnson - National TAB

- **08/05/2024 National TAB - Stephen Tassinaro**
 - Turning vanes are confirmed to be screwed into the ducts. However, they do not appear to smoothly transition the air around the 90 degree turns. Recommend EOR review.
