Report: TAB Report
Function: Test, Adjust, & Balance
Date: 06/27/2024

06-24-24 WAWA #5413 SARASOTA, FL

7707 24TH COURT E

Project: 06-24-24 WAWA #5413 SARASOTA, FL

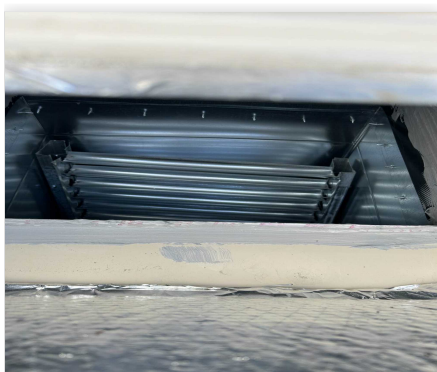
Issue Name : RTU turning vane installation
Description : The turning vanes located in the supply drops of the RTUs are not fully installed, sitting loose inside the duct. Recommend installing.
Created By : National TAB **Assigned To :** National TAB - Mark Johnson
Status : Open
Priority : Low **Asset Tag :**
Originated Date : 06/30/2024 - Mark Johnson - National TAB

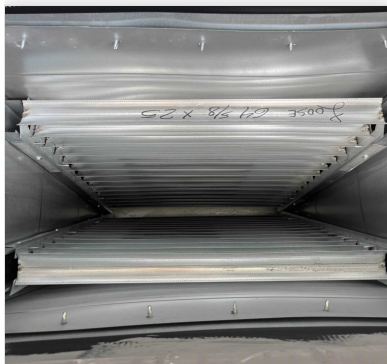
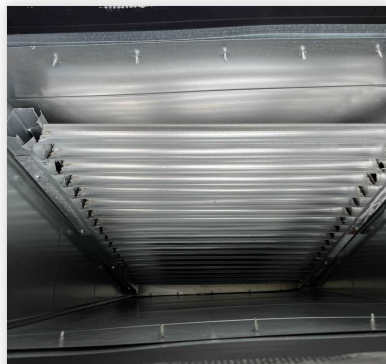
- **08/05/2024 National TAB - Stephen Tassinaro**
 - Turning vanes are confirmed to be screwed into the ducts. However, they do not appear to smoothly transition the air around the 90 degree turns. Recommend EOR review.
