**Report: TAB Report**  
**Function: Test, Adjust, & Balance**  
**Date: 11/11/2024**  
**Completed By: National TAB**

**PROJECT**  
**10-21-24 WAWA #5413 SARASOTA, FL**

# National TAB

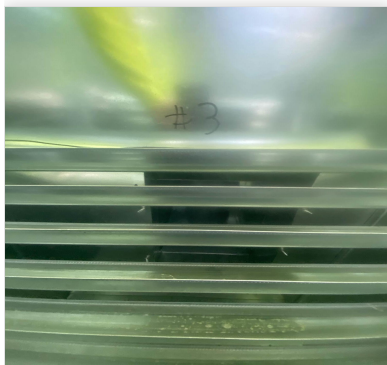
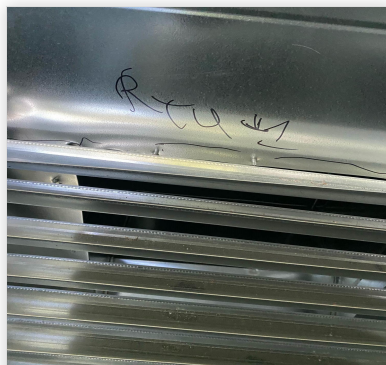
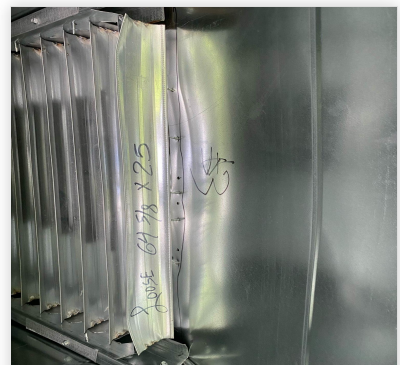
- **11/11/2024 National TAB - Will Turnbough**
  - General contractor sent images showing positioning of the turning vanes. The location of the turning vanes is unorthodox as they are not located in the elbow of a 90 degree transition however they do help to guide air into the branches on the plenum drop. Airflow is within design so no further changes are necessary.

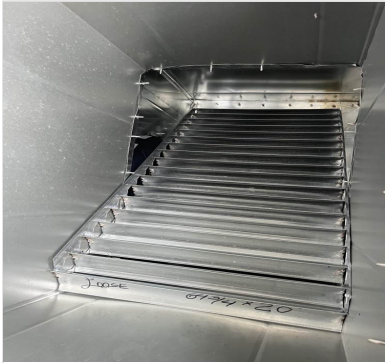
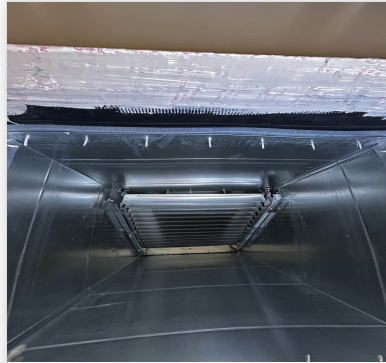
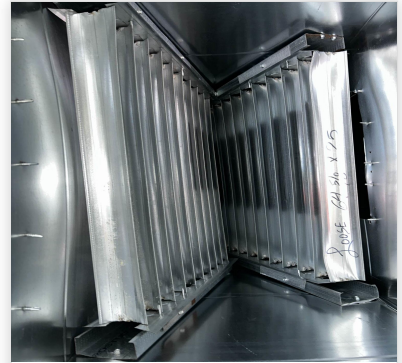
- Issue is still present. Turning vanes appear to be secured to duct but do not transition the air around the 90 degree turns for all units.

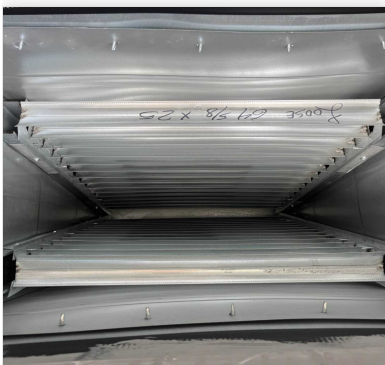
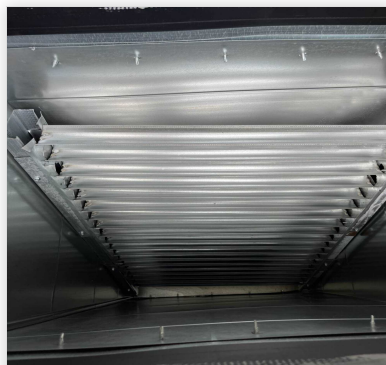
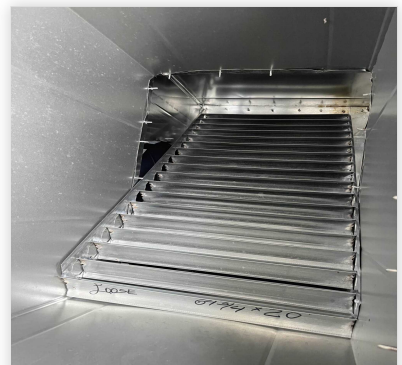
- Turning vanes are confirmed to be screwed into the ducts. However, they do not appear to smoothly transition the air around the 90 degree turns. Recommend EOR review.

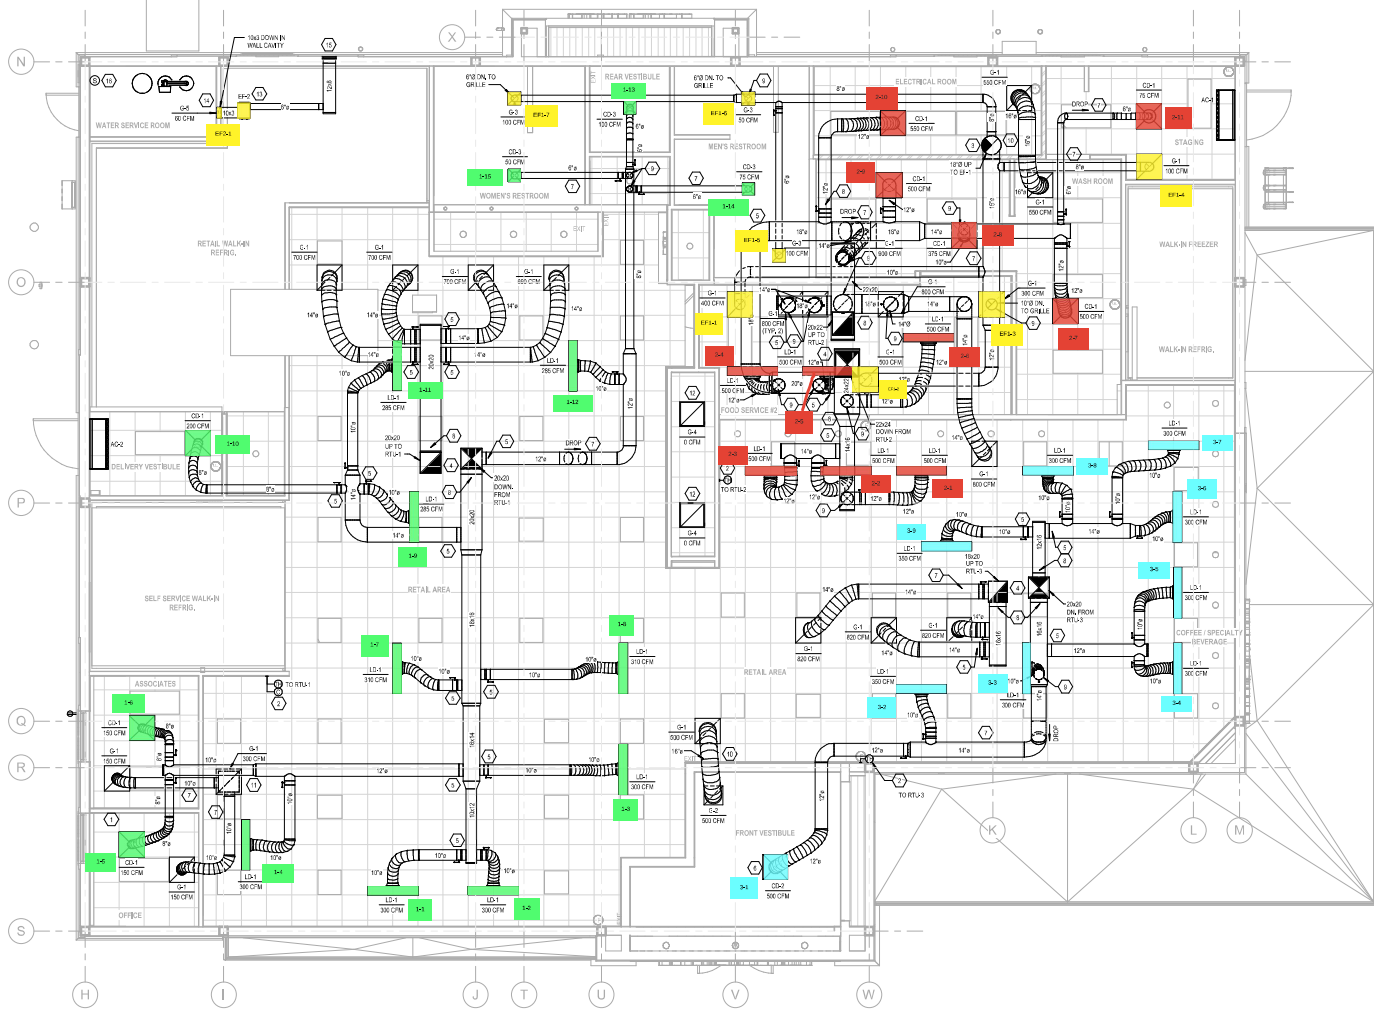
**M1.0**

1 HVAC FLOOR PLAN  
1/4" = 1'-0"
