Report: TAB Report
Function: Test, Adjust, & Balance
Date: 09/15/2025
Completed By: National TAB

09-08-25 QT - #1123 GREENWOOD, SC

QUIKTRIP
4705 SOUTH 129TH EAST AVENUE
TULSA, OK 74134

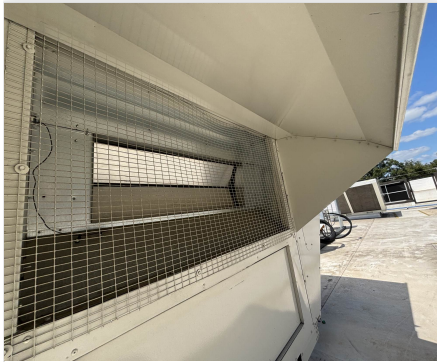
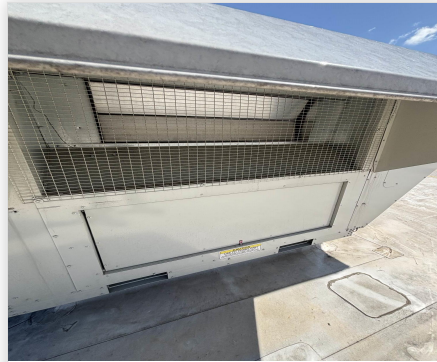
Issue Name : No RTU has their OA filters
Description : None of the RTU's have their OA filters on the outside of the units. OA was still able to be set and marked.
Created By : National TAB **Assigned To :** National TAB - Dan Hertenstein
Status : Open
Priority : Medium **Asset Tag :**
Originated Date : 09/10/2025 - Christian Moller - National TAB

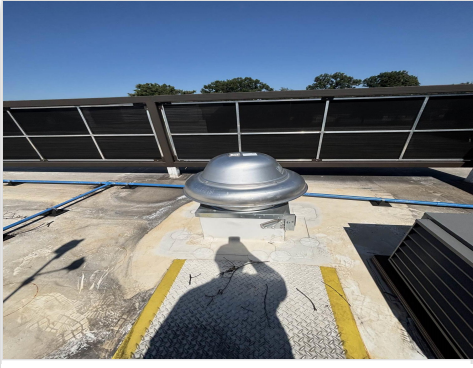
Asset: EF1

Test Data		
	Design	Actual
CFM	750	727
Fan Rotation	-	CCW
System SetPt	-	MEDIUM SPEED
RL Voltage	-	108
RL Amperage	-	5.8
Total ESP	-	0.56"
Fan Inlet SP	-	-0.56"
Fan Discharge SP	-	ATM

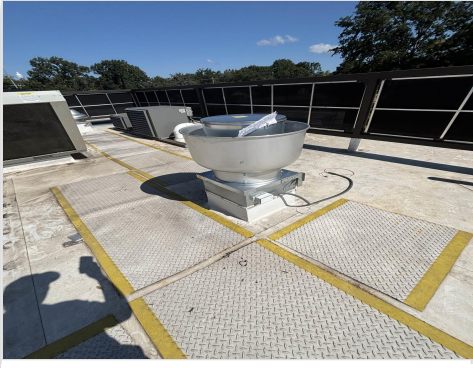
Asset: EF3

Test Data		
	Design	Actual
CFM	1350	1310
Fan Rotation	-	CCW
System SetPt	-	HOOD HMI / 50.8Hz
RL Voltage	-	110
RL Amperage	-	5.4
Total ESP	-	0.75"
Fan Inlet SP	-	-0.75"
Fan Discharge SP	-	ATM

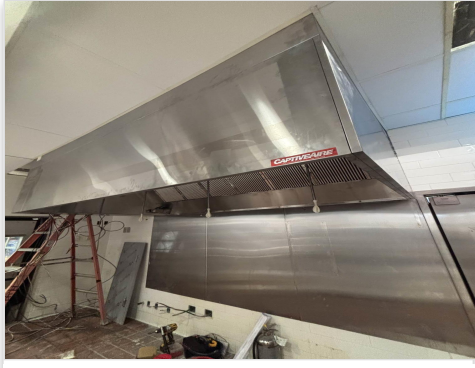
Asset: HD1

Design	Actual
Filter Type	-	BAFFLE
Filter Size 1	-	20x16
Filter Qty 1	-	6
Filter AK factor size 1	-	2.08
Filter Total AK Area	-	12.48
Filter1 FPM	-	107
Filter2 FPM	-	108
Filter3 FPM	-	107
Filter4 FPM	-	98
Filter5 FPM	-	107
Filter6 FPM	-	107
Filter7 FPM	-	
Filter8 FPM	-	
Filter9 FPM	-	
Filter10 FPM	-	
Filter11 FPM	-	
Filter12 FPM	-	
Filter Ave FPM(corr)	-	105
CFM	1350	1310
