**Report: TAB Report**  
**Function: Test, Adjust, & Balance**  
**Date: 09/15/2025**  
**Completed By: National TAB**

**09-08-25 QT - #1123 GREENWOOD, SC**

1138 BYPASS 72 NE

GREENWOOD, SC

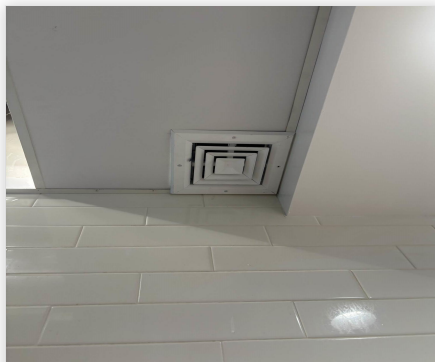
**Issue Name :** EF 1 EGRD 4 too big  
**Description :** The diffuser for the combi oven exhaust is too large. The GC is aware of the problem and has ordered the correct one, CFM was still able to be taken.  
**Created By :** National TAB                      **Assigned To :** National TAB - Dan Hertenstein  
**Status :** Open  
**Priority :** InfoOnly                                      **Asset Tag :** EGRD4  
**Originated Date :** 09/10/2025 - Christian Moller - National TAB

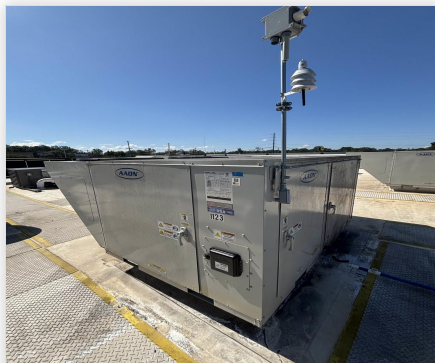
**Issue Name :** Missing two new diffusers for RTU 3  
**Description :** Two of the four new diffusers that go in front of the hood are not installed. GC is aware of the problem and has already ordered the new ones.  
**Created By :** National TAB                      **Assigned To :** National TAB - Dan Hertenstein  
**Status :** Open  
**Priority :** InfoOnly                                      **Asset Tag :** RT-3  
**Originated Date :** 09/10/2025 - Christian Moller - National TAB

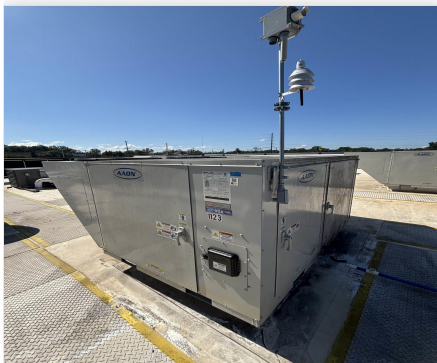
**Issue Name :** RTU 3 overramping at design  
**Description :** At design CFM the unit was overramping (55.8Hz, at 11.6 amps). Airflow was decreased to within FLA, with diffusers in front of hood balanced to +/- 10% of design besides SGRD 1.  
**Created By :** National TAB                      **Assigned To :** National TAB - Dan Hertenstein  
**Status :** Open  
**Priority :** High                                      **Asset Tag :** RT-3  
**Originated Date :** 09/10/2025 - Christian Moller - National TAB

At design CFM the unit was overramping (55.8Hz, at 11.6 amps). Airflow was decreased to within FLA, with diffusers in front of hood balanced to +/- 10% of design besides SGRD 1.

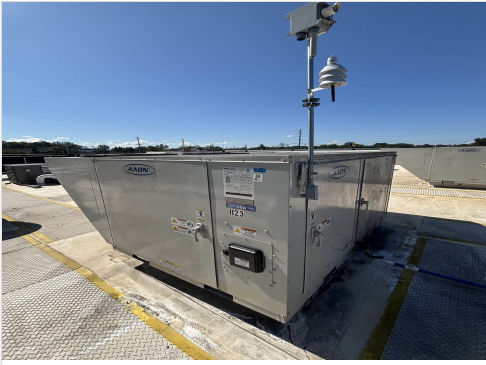
Asset: RT-3

Test Data		
	Design	Actual
SF CFM	4200	3361
RA CFM	3400	2534
OA CFM	800	827
RL Voltage	-	211/210/209
RL Amperage	-	10.6/10.6/10.5
SF System SetPt	-	VFD/50.8Hz
RA Damper Position	-	3.0"
Min OA Damper Position	-	0.5"
Min OA Damper Type	-	ECON

For OA at 354 CFM - OA dampers at 0.25", returns at 3.5".

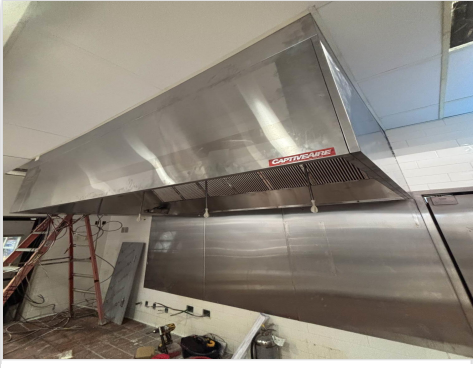
Asset: HD1

Design	Actual
MFG	CAPTIVEAIRE	CAPTIVEAIRE
Model Num	6030 ND-2-F	6030 ND-2
Job / Serial Num	-	7632503
Type	TYPE I CANOPY	TYPE I CANOPY
Hood length	-	122"
Hood Width	-	60"

Design	Actual
Filter Type	-	BAFFLE
Filter Size 1	-	20x16
Filter Qty 1	-	6
Filter AK factor size 1	-	2.08
Filter Total AK Area	-	12.48
Filter1 FPM	-	107
Filter2 FPM	-	108
Filter3 FPM	-	107
Filter4 FPM	-	98
Filter5 FPM	-	107
Filter6 FPM	-	107
Filter Ave FPM(corr)	-	105
CFM	1350	1310

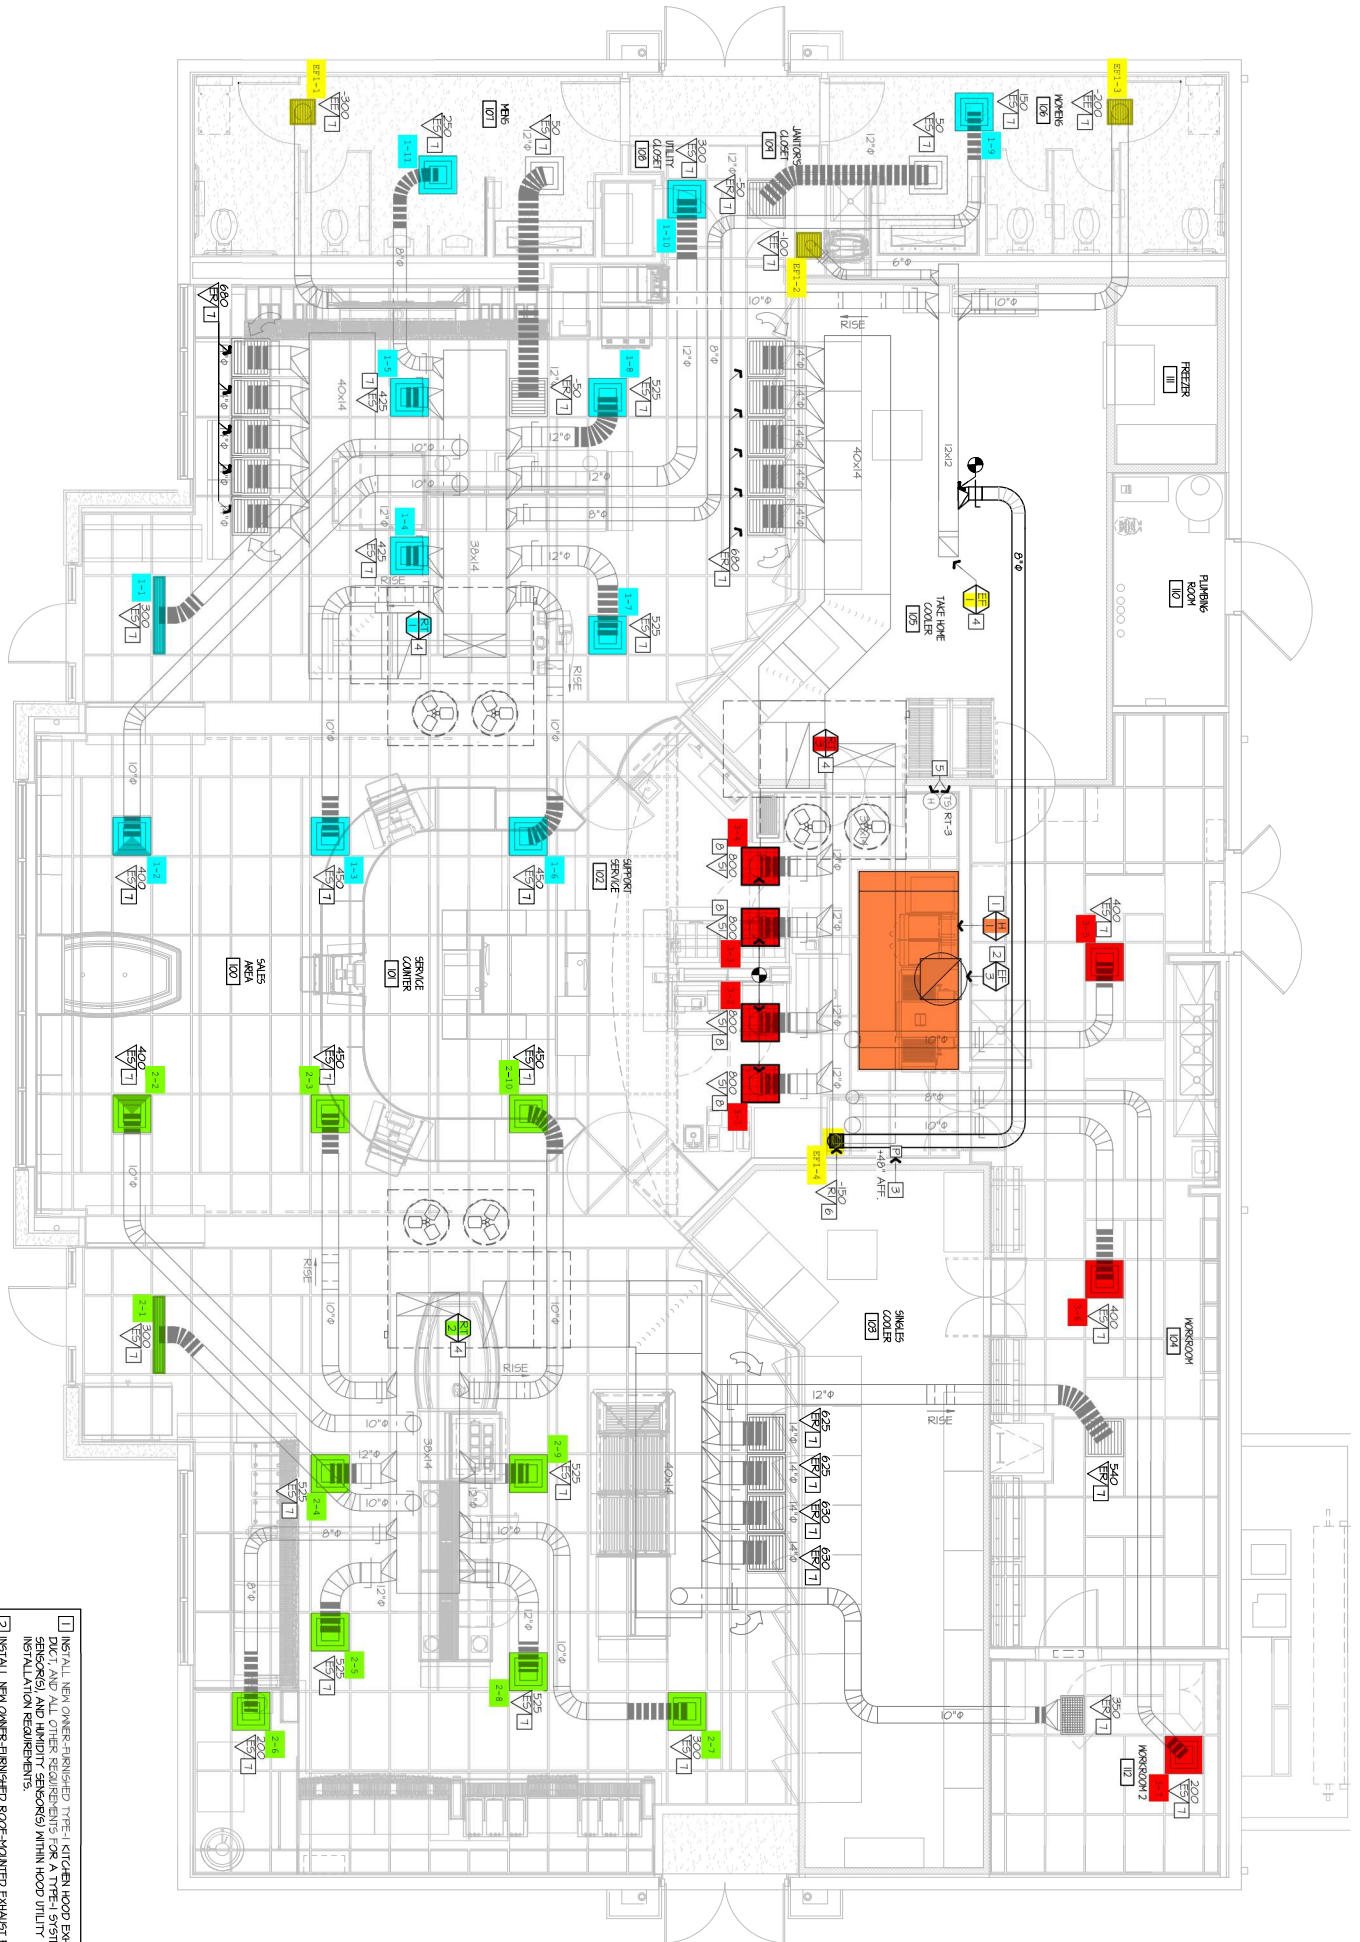
- 1] INSTALL NEW OWNER ARRANGED TYPE-I TYPICAL HOOD EXHAUST FAN FIRE ALARM DETECT AND ALL OTHER REQUIREMENTS FOR A TYPICAL SYSTEM IN THE HOOD SENSORS) AND HANDED) SENSORS) WITHIN HOOD UTILITY CABINET ACCORD TO INSTALLATION REQUIREMENTS.
- 2] INSTALL NEW OWNER-FURNISHED ROOF-MOUNTED EXHAUST FAN IN 121-6
