**Report: FINAL TAB REPORT  
Function: Test, Adjust, & Balance  
Date: 10/11/2022**

## **10-03 FREDDY'S HAMPTON, VA**

Project: 10-03 FREDDY'S HAMPTON, VA

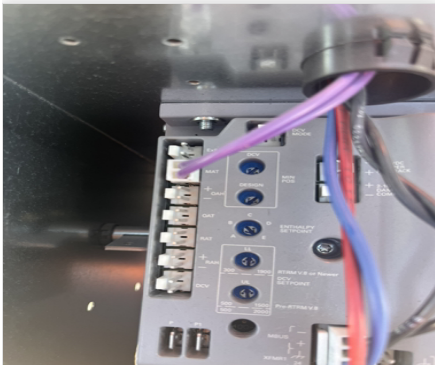
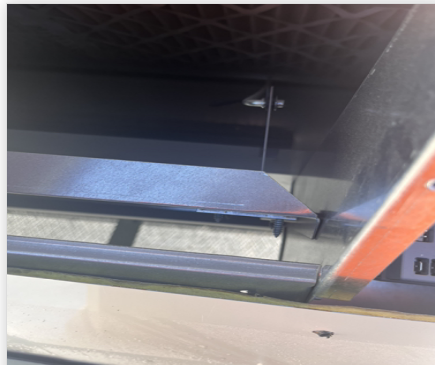
**Issue Name :** HIGH PRIORITY - RTU-1 Economizer not functional

**Description :** Unable to set RTU-1 damper position despite the economizer receiving power. Tried moving damper to closed position the damper did not move.

- **10/11/2022 National TAB - Will Turnbough**
  - Airflow is 1671 CFM out of 900 CFM. Mechanical contractor unable to adjust damper either. Recommend mechanical contractor contact the manufacturer to troubleshoot and resolve.

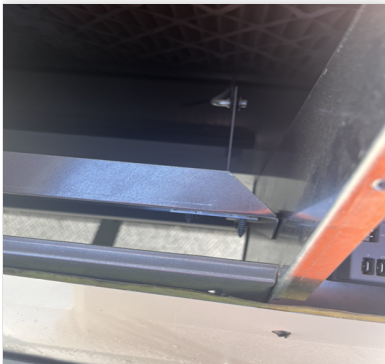
FuselTa54a4243fe7046.jpeg

**Issue Name :** HIGH PRIORITY - RTU-1 Low flow  
**Description :** RTU-1 total flow is about 80% of design. Motor sheave is already at 1 turn out (B belt).  
**Created By :** National TAB **Assigned To :** National TAB - Will Turnbough  
**Status :** Open  
**Originated Date :** 10/05/2022 - David Annan - National TAB

- **10/11/2022 National TAB - Will Turnbough**
  - There is enough amperage on the motor to change pulleys and increase airflow closer to design. But further evaluation of the supply and return ductwork is required first.
- **10/11/2022 National TAB - Will Turnbough**
  - Discharge pressure on the supply side is high indicating restriction. To achieve design airflow requires 1.4" of discharge pressure which is very high. Ductwork is shown on plans as (2) 18" runs which is a 3.5 free area. Requires a velocity of 1430 FPM which is slightly high. Further investigation of the supply ductwork and connection to unit is required.
- **10/06/2022 National TAB - David Annan**
  - Return damper looks slightly restrictive. More investigation needed.

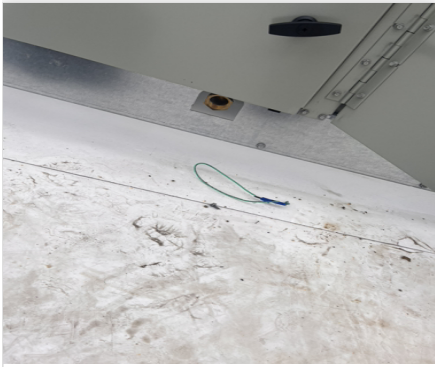
**Issue Name :** LOW PRIORITY - RTU-1 Condensate is not installed-W.I.P

**Description :** RTU-1 condensate line is not installed .

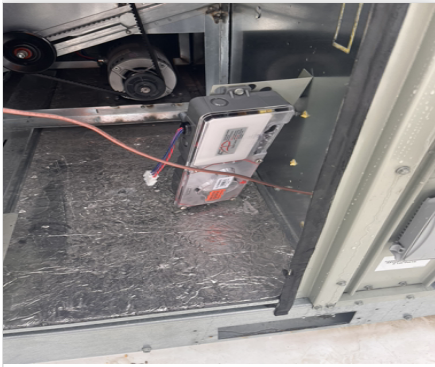
**Issue Name :** LOW PRIORITY - RTU-1 Smoke detector not installed  
**Description :** RTU-1 smoke detector is not installed.  
**Created By :** National TAB                      **Assigned To :** National TAB - Will Turnbough  
**Status :** Open  
**Originated Date :** 10/05/2022 - David Annan - National TAB
