**National TAB
1329 E. KEMPER ROAD
SUITE 4210
CINCINNATI, OH 45246**

**Report: FINAL TAB REPORT
Function: Test, Adjust, & Balance
Date: 10/11/2022**

10-03 FREDDY'S HAMPTON, VA

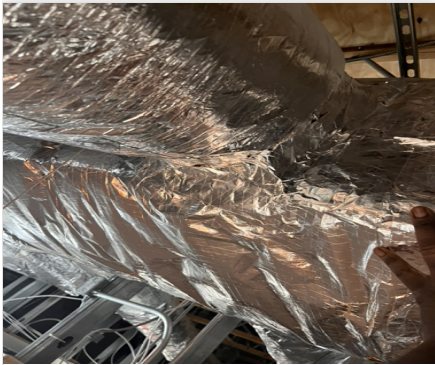
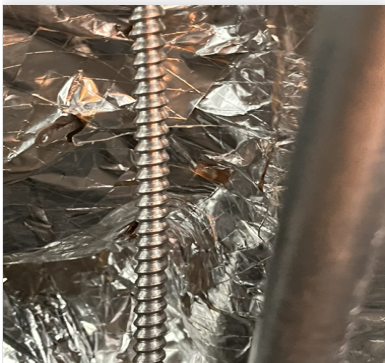
Issue Name : No dampers

Description : DOAS-1 some diffusers do not have any balancing dampers.

- **10/06/2022 National TAB - David Annan**
 - Some diffusers do have dampers.

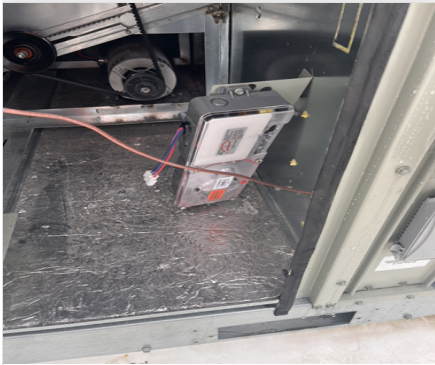
Issue Name : RTU-1 Smoke detector not installed-W.I.P

Description : RTU-1 smoke detector is not installed.
