# PlanGrid Task Report - Sep 6, 2024

Prepared by Ian Fuller

## #368 [UNIT 039] CRITICAL (MISC) – AC#5 pulleys are not aligned

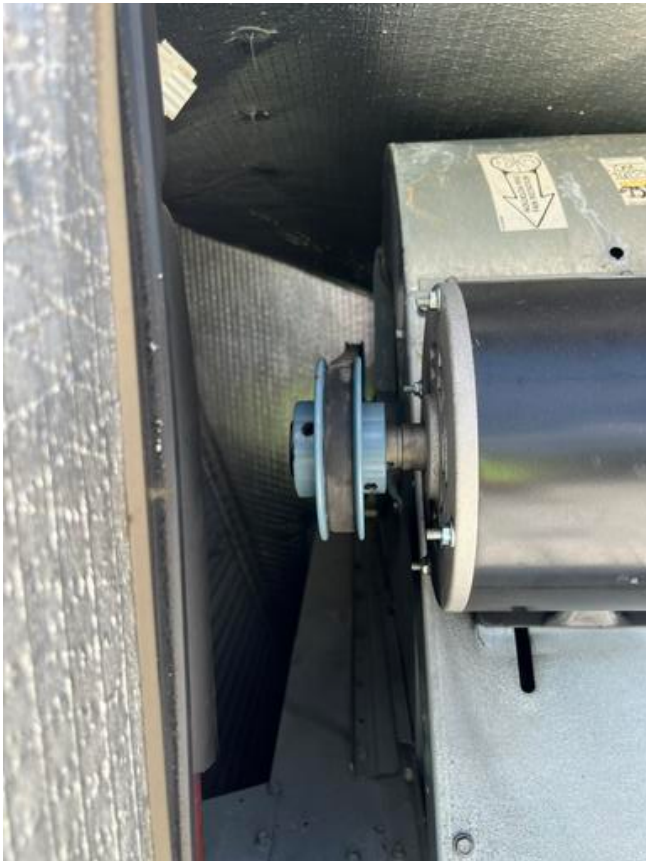
IMG\_8161

Unable to move motor sheave into correct position to align pulleys.

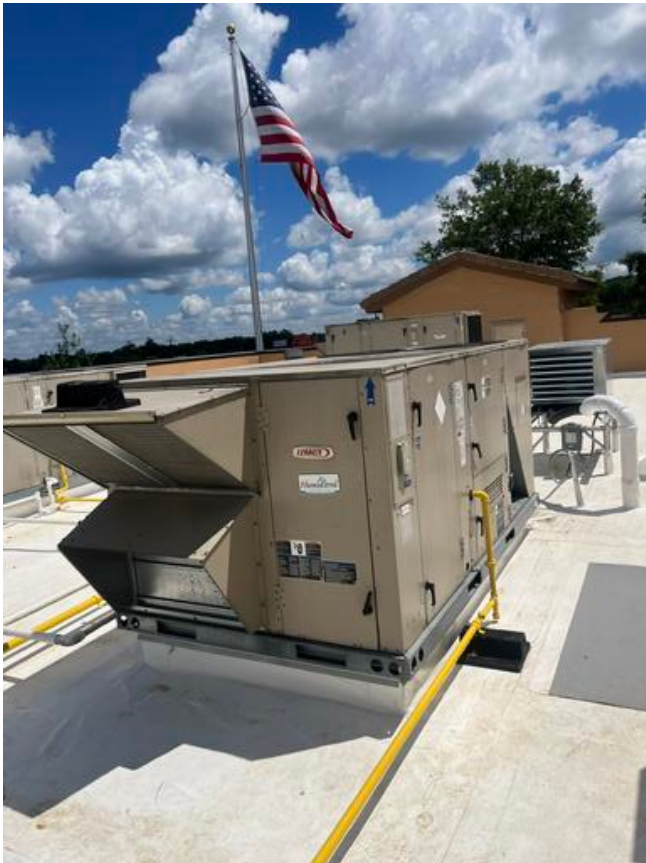
IMG\_8146

## #367 [UNIT 039] CRITICAL (MISC) – AC#3 Prodigy Board is not functional

Unable to set outside air or change any setting on unit. Replacement Prodigy Board has been ordered.

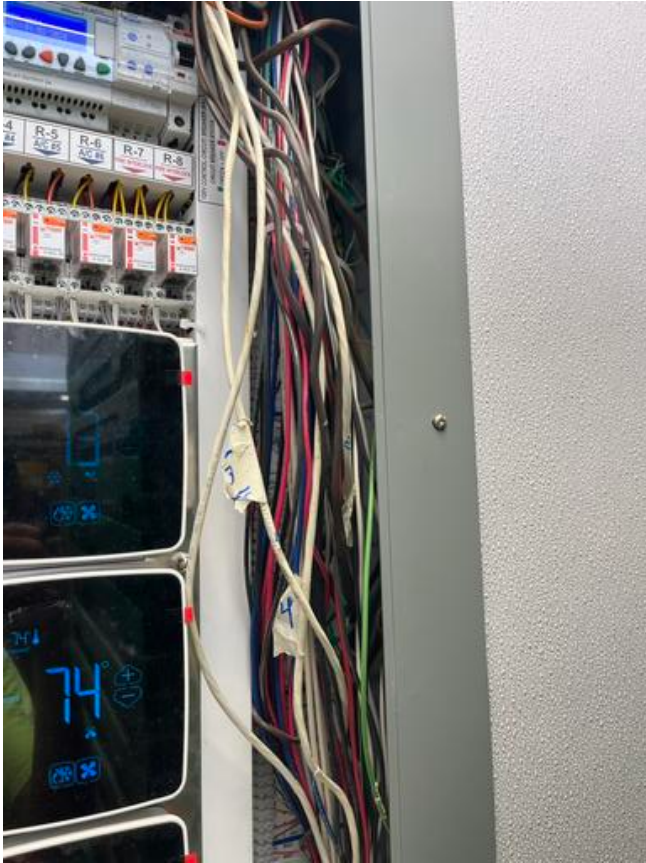
IMG\_8180  
Ian Fuller  
Aug 22, 2024 5:00 PM

## #365 [CNTL 093] Wire / cable management.

Wiring does not use correct cable management and is at extra risk of damage (beam clamps+bridal rings, wire loops for future service, runs perpendicular or parallel to structure supports).

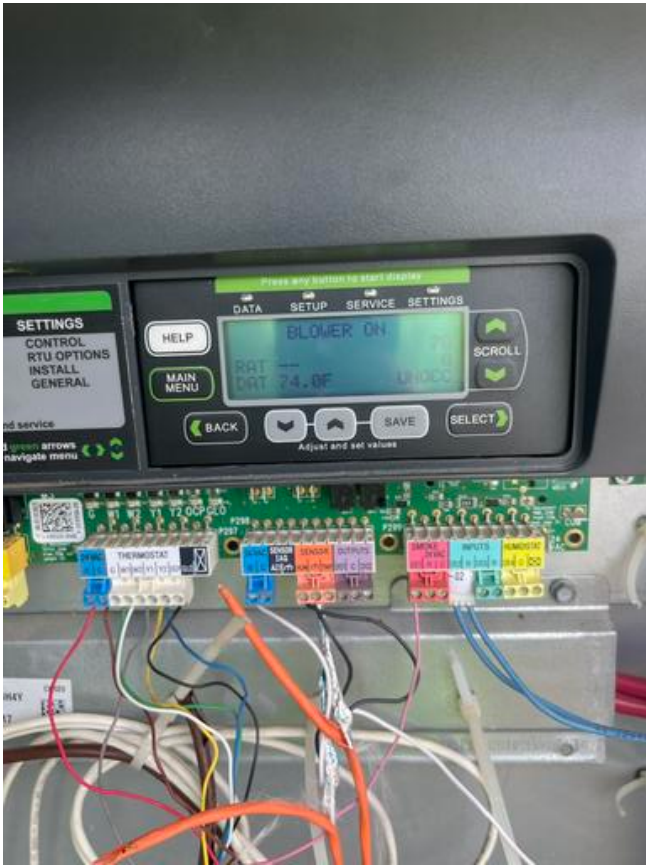
IMG\_8141

## #363 [CNTL 107] (MISC) Units are not wired for occupancy

Units are currently not wired for occupancy. Jumper between P1 and R with occupancy wire ran from P.

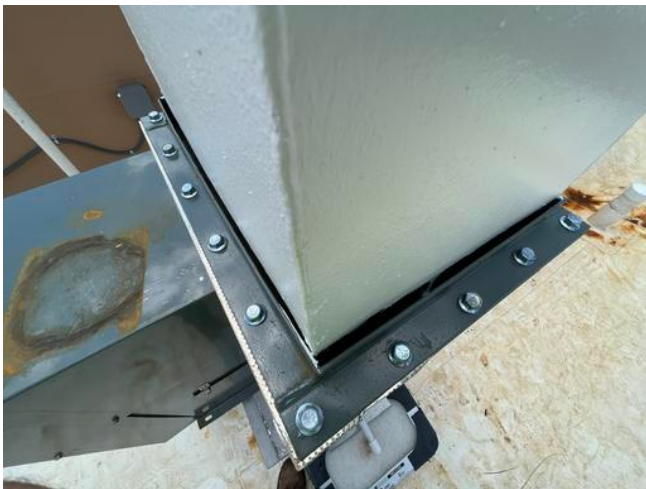
IMG\_8167

## #360 [EXHA 123] Exhaust fan discharge nozzle.

Exhaust fan discharge nozzle is not welded to discharge flange.

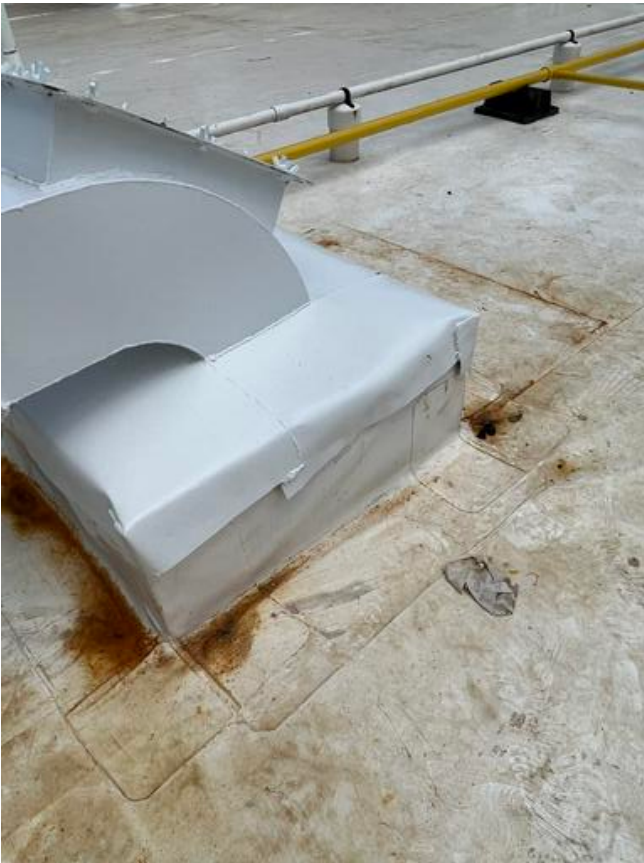
IMG\_8169

## #359 [EXHA 128] Grease exhaust duct curb cap.

Grease duct curb cap is to be screwed at all corners along with a full perimeter weld between curb cap and duct.

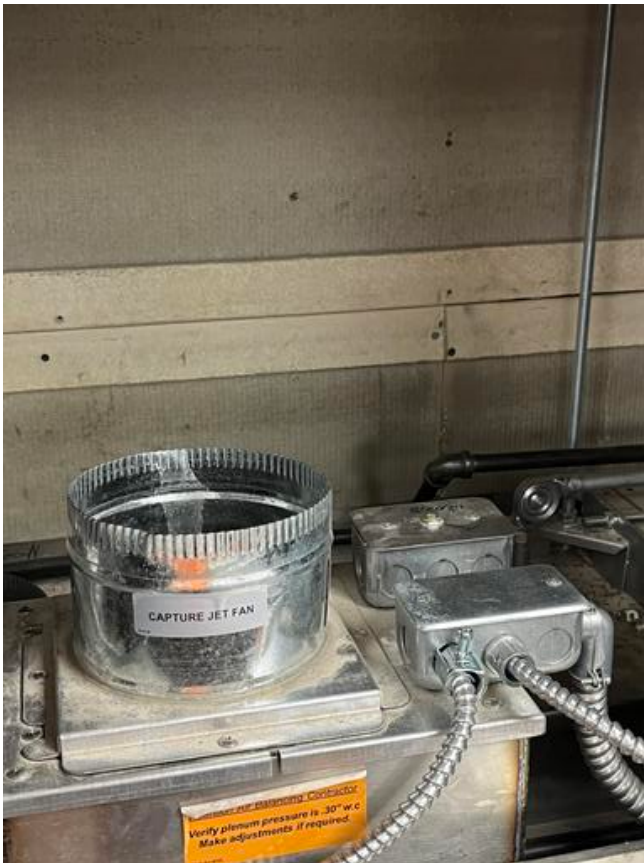
IMG\_8191

## #358 [HOOD 141] CaptureJet piping.

CaptureJet duct is to be hard piped and sealed at seams up to intake grilles. Intake grilles are to remain unobstructed and removable by Operator for cleaning.

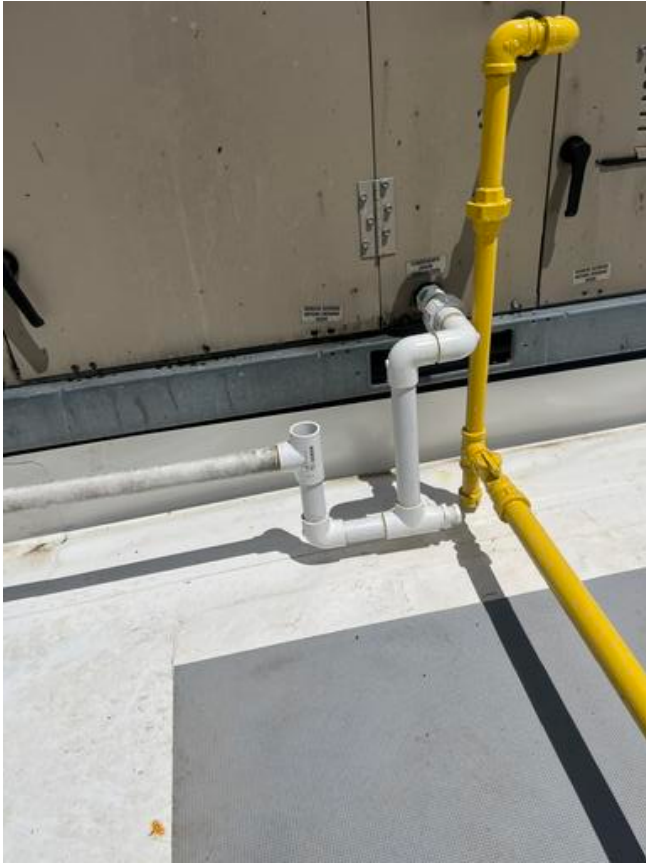
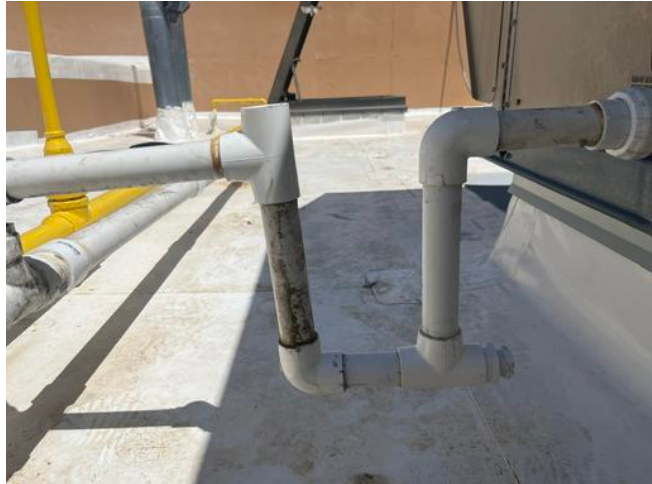
IMG\_8145  
**Ian Fuller**  
Aug 22, 2024 5:02 PM

## #357 [UNIT 167] Condensate piping construction.

Equipment condensate piping or p-trap is not constructed per normal CFA specifications. Union needs to be installed on both sides of P-trap. AC#1 P Trap does not have 2" difference in P-trap height.

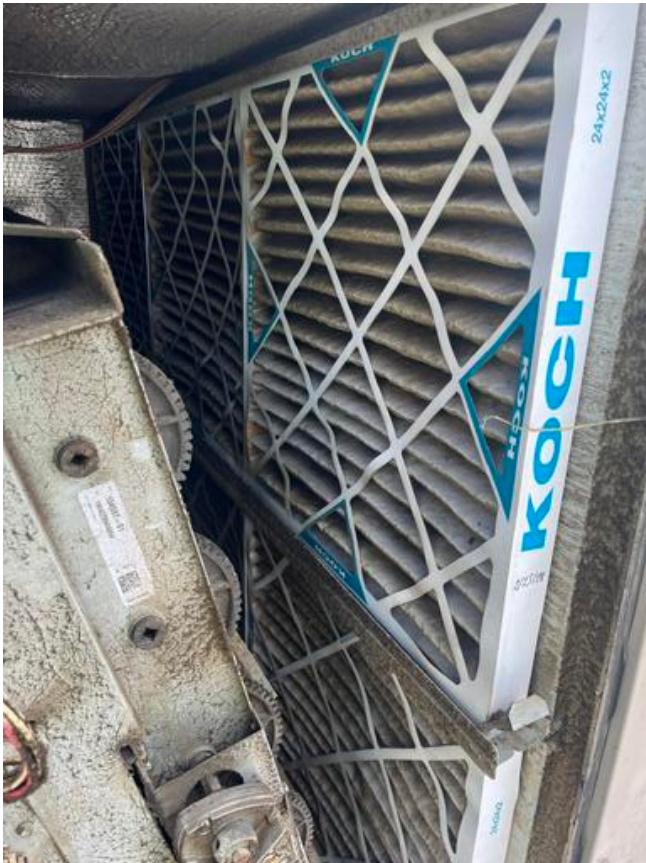
IMG\_8140

## #356 [UNIT 172] Filters to be changed.

Filters are dirty in AC#1.They need to be changed with extra set provided per specification.

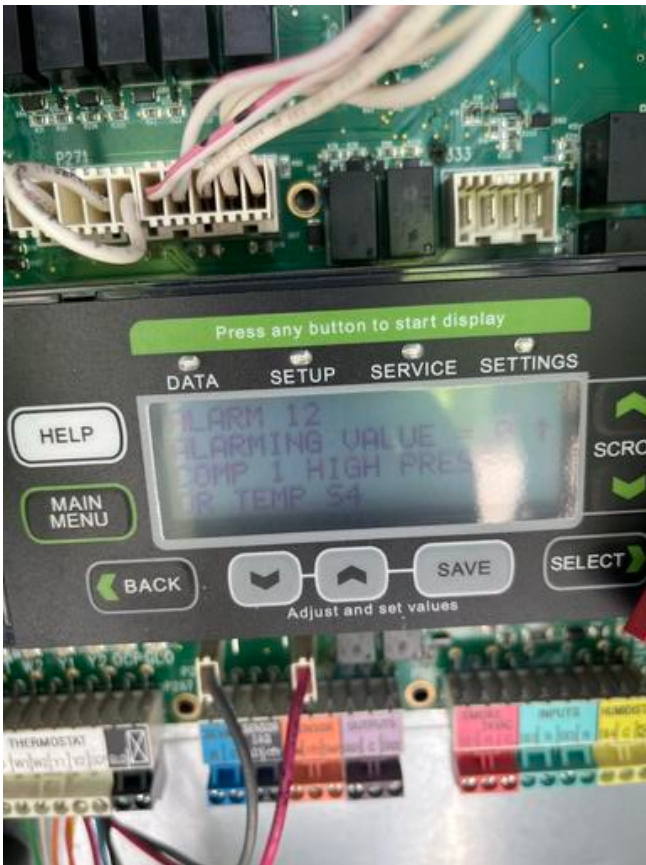
IMG\_8156

## #355 [UNIT 173] (MISC) AC#5 alarm

<b>Status</b> Open	<b>Start Date</b> Aug 20, 2024
<b>Type</b> Planned Work	<b>Created</b> Aug 22, 2024 3:51 PM ianf@nationaltab.com
<b>Description</b> Alarm 12 Comp 1 High Pressure.	<b>Last Updated</b> Aug 22, 2024 5:03 PM
