**Report: TAB Report**  
**Function: Test, Adjust, & Balance**  
**Date: 03/12/2025**  
**Completed By: National TAB**

**PROJECT**  
**03-10-25 CHIPOTLE #5020 HARRISONBURG,**  
**VA**

Project: 03-10-25 CHIPOTLE #5020 HARRISONBURG, VA

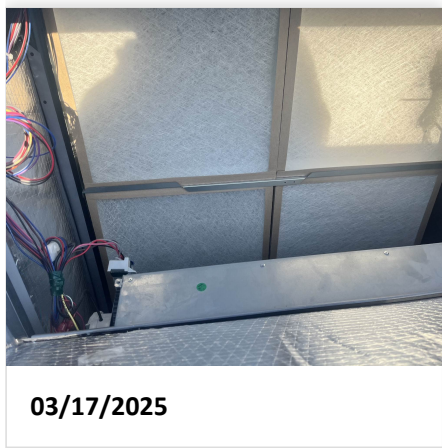
**Issue Name :** Construction Filters still installed  
**Description :** Construction Filters are still installed in RTU-1 and RTU-2. Recommend that pleated filters with a MERV rating of 8 or higher be installed prior to stores opening.  
**Created By :** National TAB                      **Assigned To :** National TAB - David Annan  
**Status :** Open  
**Priority :** Low                                      **Asset Tag :**  
**Originated Date :** 03/17/2025 - David Annan - National TAB

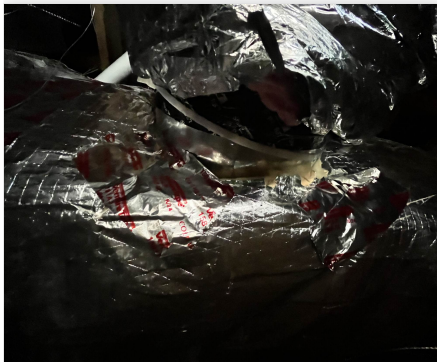
**Issue Name :** RTU-1: Missing damper  
**Description :** There is a missing damper for SGRD 1-7. Unable to complete diffuser balance. Recommend that damper be installed.  
**Created By :** National TAB  
**Status :** Open  
**Priority :** High  
**Assigned To :** National TAB - David Annan  
**Asset Tag :**  
**Originated Date :** 03/17/2025 - David Annan - National TAB

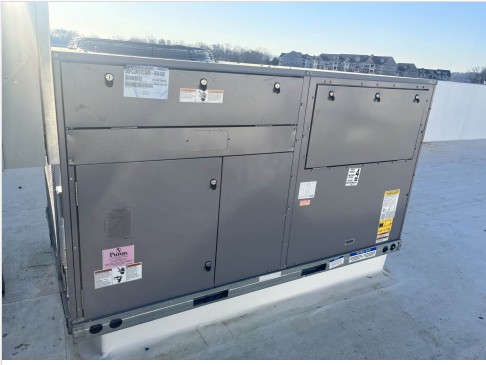
## Unit Data - PHOTO LOG

Asset: RTU2

AREA:DINING

| Unit Data | | |
|---|---|---|
| MFG | CARRIER | CARRIER |
| Model Num | 50HCQ-D12 | 50HCQ-D12C3M5A8W4A0 |

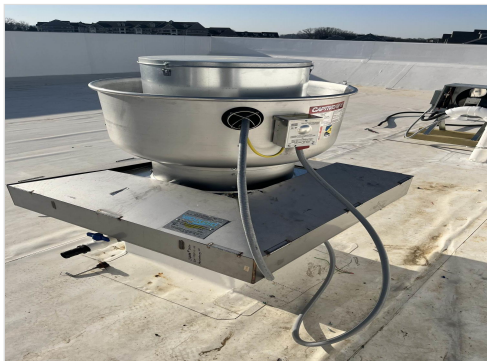
### Unit Data - PHOTO LOG

Asset: EF1

AREA:HOOD

| Unit Data | | |
|---|---|---|
| MFG | CATIVAIRE | CATIVAIRE |
| Model Num | DU8FHFA | DU8FHFA |

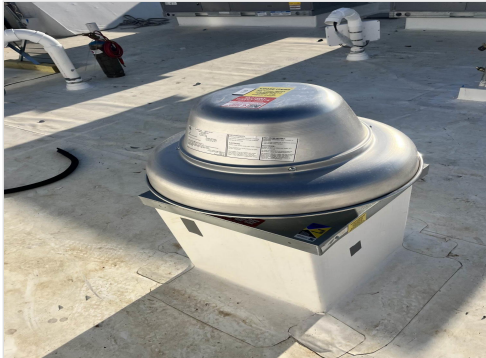
### Unit Data - PHOTO LOG

Asset: EF2

AREA:RESTROOM

| Unit Data | | |
|---|---|---|
| MFG | CAPTIVEAIR | CAPTIVEAIR |
| Model Num | DR12HFA | DR12HFA |
