**Report: TAB Report**  
**Function: Test, Adjust, & Balance**  
**Date: 03/12/2025**  
**Completed By: National TAB**

**03-10-25 CHIPOTLE #5020 HARRISONBURG,  
VA**

1657 STONE SPRING RD

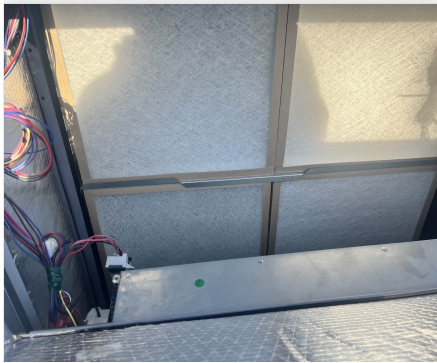
Project Issue File Details

**Issue Name :** Construction Filters still installed  
**Description :** Construction Filters are still installed in RTU-1 and RTU-2. Recommend that pleated filters with a MERV rating of 8 or higher be installed prior to stores opening.  
**Created By :** National TAB                      **Assigned To :** National TAB - David Annan  
**Status :** Open  
**Priority :** Low                                      **Asset Tag :**  
**Originated Date :** 03/17/2025 - David Annan - National TAB

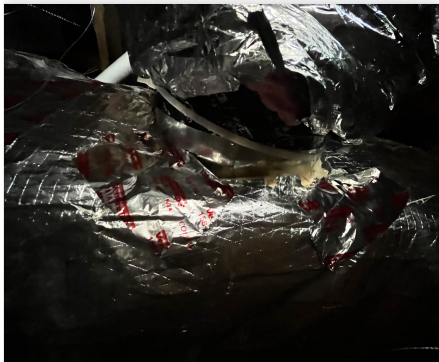
Project Issue File Details

**Issue Name :** RTU-1: Missing damper  
**Description :** There is a missing damper for SGRD 1-7. Unable to complete diffuser balance. Recommend that damper be installed.  
**Created By :** National TAB                      **Assigned To :** National TAB - David Annan  
**Status :** Open  
**Priority :** High                                      **Asset Tag :**  
**Originated Date :** 03/17/2025 - David Annan - National TAB

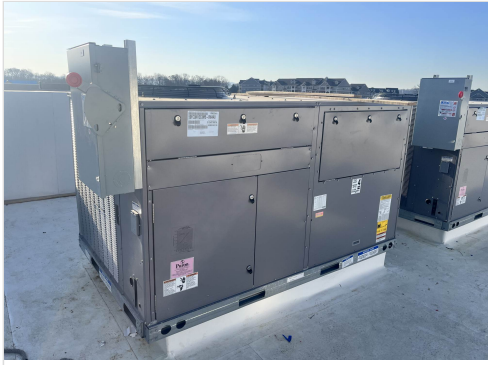
## Unit Data - PHOTO LOG

Unit Data		
	Design	Actual
MFG	CARRIER	CARRIER
Serial Num	-	3124P79976
Model Num	50HCQ-D12	50HCQ-D12C3M5A8W4A0
Type	RTU	RTU
Configuration	VERTICAL	Vertical
Num OA Filters 1	-	1
OA Filter Size 1	-	35X19
Num Final Filter 1	-	4
Final Filter Size 1	-	20X20X2

Test Data		
	Design	Actual
SF CFM	4000	3920
SF RPM	-	1776
RA CFM	3000	2922
OA CFM	1000	998
RL Voltage	-	208/208/209
RL Amperage	-	4.5/4.3/4.0
SF Rotation	-	CCW
RA Damper Position	-	5.4 V
Min OA Damper Position	-	4.6 V
Min OA Damper Type	-	OBD
OA Enthalpy Setpt	-	55 Deg F

General	
	Actual
Fan Rotation Correct	Yes
Unit Filters Clean	Construction Filters
Condensate Drain Installed	Yes

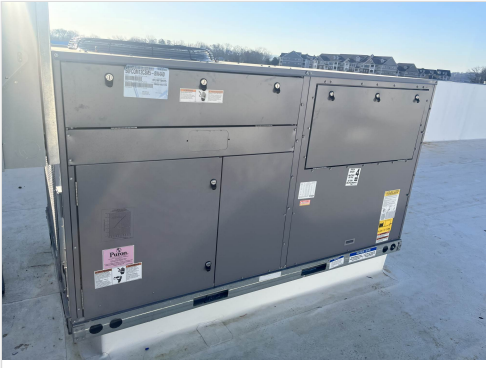
## Unit Data - PHOTO LOG

Unit Data		
	Design	Actual
MFG	CARRIER	CARRIER
Serial Num	-	3124P79975
Model Num	50HCQ-D12	50HCQ-D12C3M5A8W4A0
Type	RTU	RTU
Configuration	VERTICAL	Vertical
Num OA Filters 1	-	1
OA Filter Size 1	-	35X19
Num Final Filter 1	-	4
Final Filter Size 1	-	20X20X2

Test Data		
	Design	Actual
SF CFM	4000	4022
SF RPM	-	1805
RA CFM	2900	2909
OA CFM	1100	1113
RL Voltage	-	208/208/208
RL Amperage	-	4.6/4.8/4.0
SF Rotation	-	CCW
RA Damper Position	-	4.8 V
Min OA Damper Position	-	5.2 V
Min OA Damper Type	-	OBD
OA Enthalpy Setpt	-	55 Deg F

General	
	Actual
Fan Rotation Correct	Yes
Unit Filters Clean	Construction Filters
Condensate Drain Installed	Yes

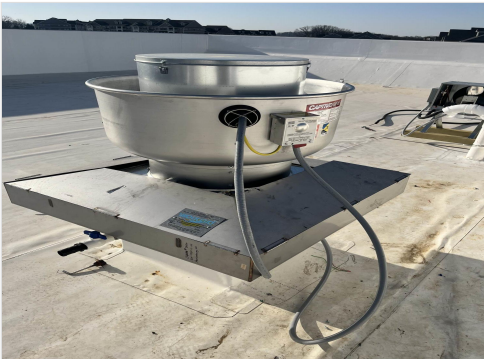
### Unit Data - PHOTO LOG

Unit Data		
	Design	Actual
MFG	CATIVAIRE	CATIVAIRE
Model Num	DU8FHFA	DU8FHFA
Serial Num	-	6715094
Type	UPBLAST	Upblast
Configuration	VERTICAL	Vertical

Test Data		
	Design	Actual
CFM	1900	1928
Fan RPM	1496	1170
Fan Rotation	-	CCW
Motor RPM	-	1170
System SetPt	-	65%
RL Voltage	-	121
RL Amperage	-	2.5
Total ESP	1.200"	0.50"
Fan Inlet SP	-	-0.50"
Fan Discharge SP	-	ATM

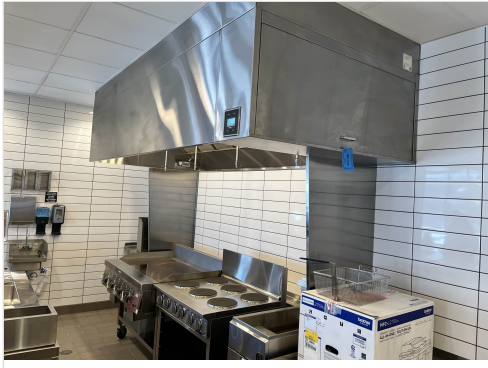
**Unit Data - PHOTO LOG**

Unit Data		
	Design	Actual
MFG	CAPTIVEAIR	CAPTIVEAIR
Model Num	5424 ND-2	5424 ND-2
Job / Serial Num	-	6715094
Type	TYPE I- CANOPY	Type I
Hood length	112"	112"
Hood Width	54"	54"

Test Data Exhaust		
	Design	Actual
Filter Type	CAPTRATE SOLO FILTER	Captrate Solo
Filter Size 1	16X16	16X16
Filter Qty 1	7	7
Filter AK factor size 1	1.62	1.62
Filter Total AK Area	11.34	11.34
Filter1 FPM	-	159
Filter2 FPM	-	163
Filter3 FPM	-	195
Filter4 FPM	-	176
Filter5 FPM	-	174
Filter6 FPM	-	169
Filter7 FPM	-	154
Filter Ave FPM(corr)	-	170
CFM	1900	1928
