Report: TAB REPORT
Function: Test, Adjust, & Balance
Date: 12/19/2024
Completed By: National TAB

PROJECT
12-16-24 CULVERS SAUK CITY, WI

Project: 12-16-24 CULVERS SAUK CITY, WI

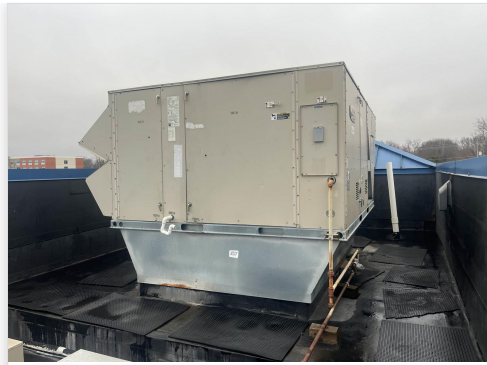
Unit Data - PHOTO LOG

- [1] UNIT INSTALLED ON CURB ADAPTER
- [2] SUPPLY AIRFLOW AT 344 CFM/TON-ACCEPTABLE FLOW.
