Report: TAB Report
Function: Test, Adjust, & Balance
Date: 05/22/2025
Completed By: National TAB

PROJECT
05-19-25 WAWA #7408 INDIANAPOLIS, IN

Project: 05-19-25 WAWA #7408 INDIANAPOLIS, IN

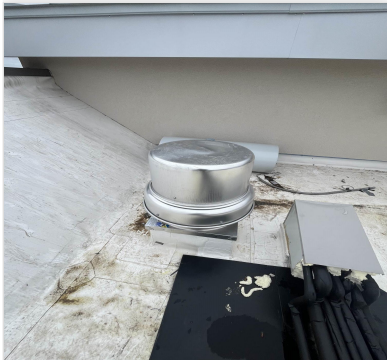
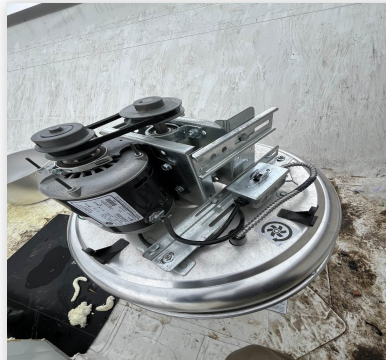
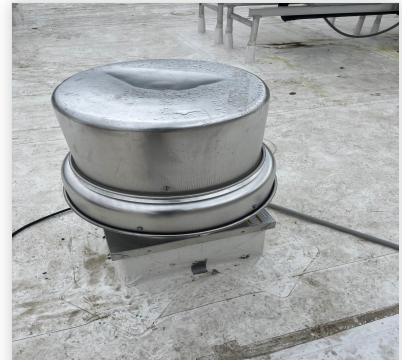
Issue Name : EF-1/EF-2 temporary power
Description : EF-1 and EF-2 are currently running on temporary power. Recommend electrician complete wiring so that these are operable at all times during occupancy.
Created By : National TAB **Assigned To :** National TAB - Dylan Crisman
Status : Open
Priority : High **Asset Tag :**
Originated Date : 05/22/2025 - Dylan Crisman - National TAB

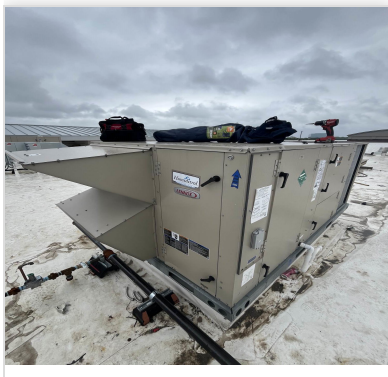
Issue Name : RTU-1 Alarm
Description : RTU-1 alarm for outdoor enthalpy sensor is active. Recommend mechanical/electrician troubleshoot wiring to check for proper landing and voltage.
Created By : National TAB **Assigned To :** National TAB - Dylan Crisman
Status : Open
Priority : Medium **Asset Tag :**
Originated Date : 05/22/2025 - Dylan Crisman - National TAB

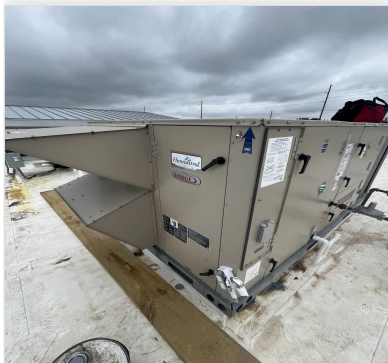
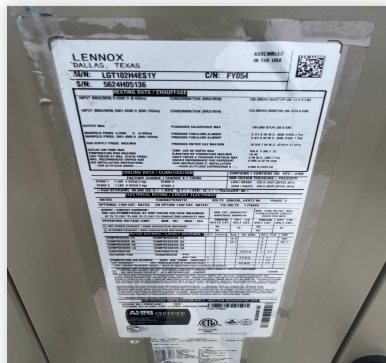
Issue Name : RTU-2 space temperature
Description : RTU-2 space temperature on core app is reading at 91F, recommend mechanical/electrician check and troubleshoot wiring issues for proper landings at space temp sensor to ensure accurate temperature is recorded for units functionality to switch between heating/cooling stages as needed.

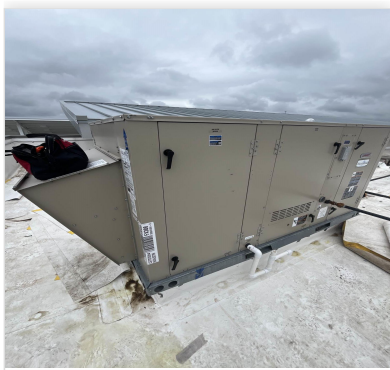
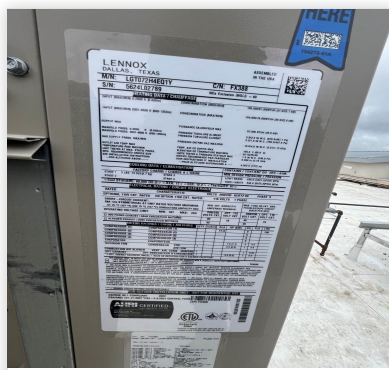
Issue Name : RTU-3 alarm
Description : RTU-3 shows an alarm for relative humidity sensor, recommend mechanical/electrician troubleshoot wiring between unit and space sensor to correct issue. Unit currently does not display humidity percentage on core app.
Created By : National TAB **Assigned To :** National TAB - Dylan Crisman
Status : Open
Priority : High **Asset Tag :**
Originated Date : 05/22/2025 - Dylan Crisman - National TAB

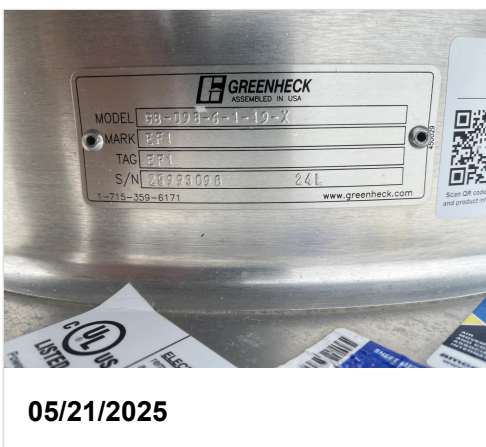
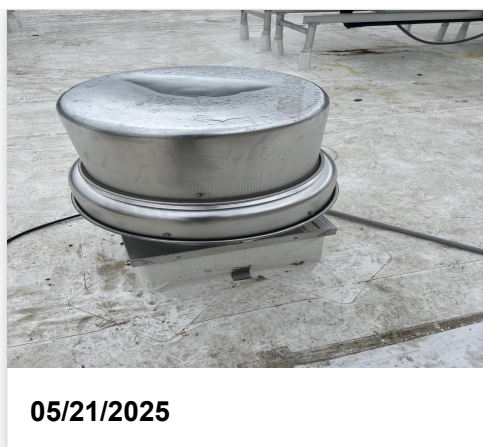
Asset: EF1

Unit Data		
	Design	Actual
MFG	GREENHECK	GREENHECK
Model Num	GB-098-6	GB-098-6-1-19-X
Serial Num	-	25993098
Type	DOWNBLAST	DOWNBLAST
Configuration	VERTICAL	VERTICAL

Test Data		
	Design	Actual
CFM	-	365
Fan RPM	-	927
Fan Rotation	-	CCW
Motor RPM	-	1764
Suction ESP	-	-0.20"
Discharge ESP	-	ATM
Total ESP	-	0.20"

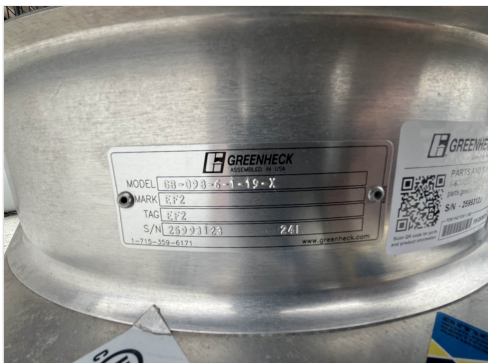
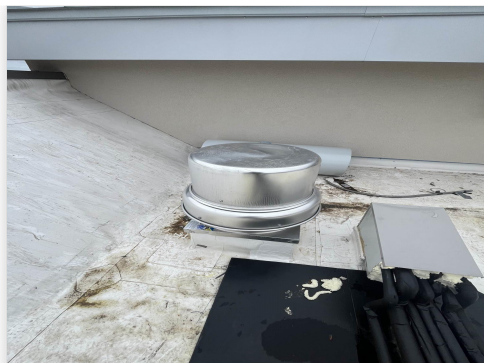
Asset: EF2

Unit Data		
	Design	Actual
MFG	GREENHECK	GREENHECK
Model Num	GB-098-6	GB-098-6-1-19-X
Serial Num	-	25993123
Type	DOWNBLAST	DOWNBLAST
Configuration	VERTICAL	VERTICAL

Test Data		
	Design	Actual
CFM	-	384
Fan RPM	-	1021
Fan Rotation	-	CCW
Motor RPM	-	1170
Suction ESP	-	-0.26"
Discharge ESP	-	ATM
Total ESP	-	0.26"

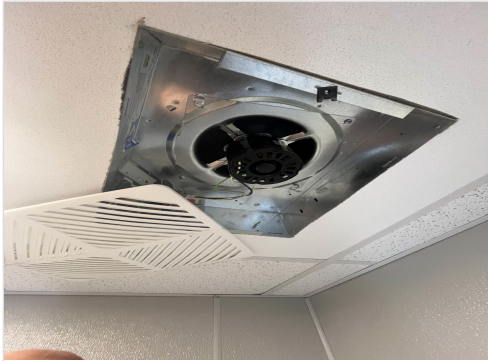
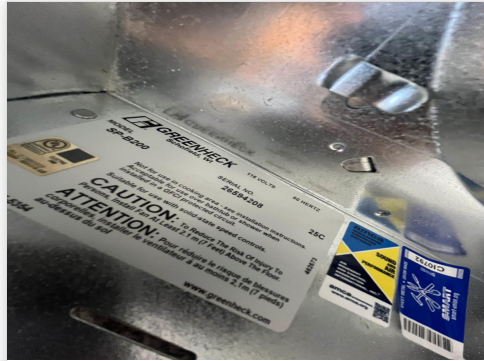
Asset: EF3

Unit Data		
	Design	Actual
MFG	GREENHECK	GREENHECK
Model Num	SP-B200	SP-B200
Serial Num	-	26594208
Type	CEILING	CEILING
Configuration	VERTICAL	VERTICAL

Test Data		
	Design	Actual
CFM	200	202
Fan RPM	-	800
Fan Rotation	-	CCW
Motor RPM	-	800
System SetPt	-	MARKED @ SPEED DIAL
RL Voltage	-	117
RL Amperage	-	2.1/2.2
