**Report: Preliminary Report**  
**Function: Test, Adjust, & Balance**  
**Date: 11/23/2025**  
**Completed By: National TAB**

**PROJECT**  
**11-17-25 WAWA #5454 LEESBURG, FL**

SR 44 & WEST MAIN STREET

LEESBURG , FL

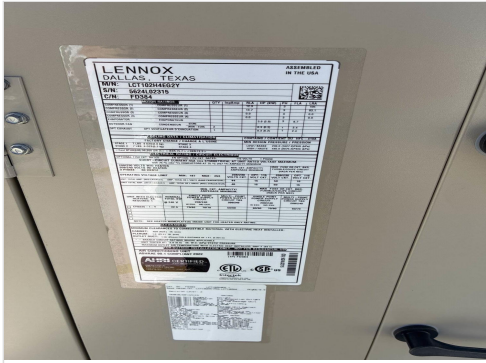
## Unit Data - PHOTO LOG

Unit Data		
	Design	Actual
MFG	LENNOX	LENNOX
Serial Num	-	5624L02315
Model Num	LCT102H4E	LCT102H4EG2Y
Type	RTU	RTU
Configuration	VERTICAL	VERTICAL
Num OA Filters 1	-	1
OA Filter Size 1	-	34x14.125
Num Final Filter 1	-	4
Final Filter Size 1	-	20x25x2

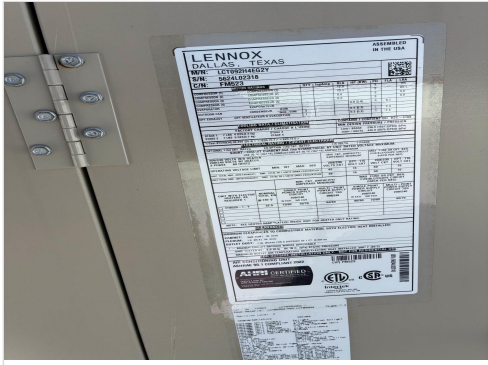
# Unit Data - PHOTO LOG

Unit Data		
	Design	Actual
MFG	LENNOX	LENNOX
Serial Num	-	5624L02318
Model Num	LCT092H4E	LCT092H4ERG2Y
Type	RTU	RTU
Configuration	VERTICAL	VERTICAL
Num OA Filters 1	-	1
OA Filter Size 1	-	34X14.125
Num Final Filter 1	-	4
Final Filter Size 1	-	20X25X2

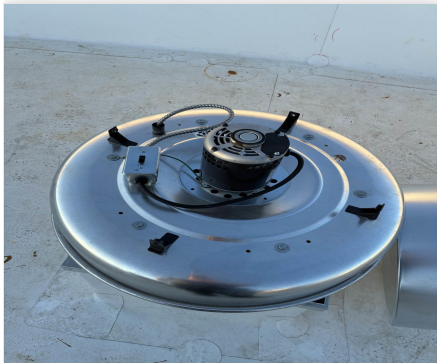
Project Issue File Details

**Issue Name :** EF 1 Motor Driver  
**Description :** Unable to locate a driver for EF 1 in motor compartment or in crawlspaces above ceiling.  
**Created By :** National TAB                      **Assigned To :** National TAB - Dan Hertenstein  
**Status :** Open  
**Priority :** Urgent                                      **Asset Tag :** EF1  
**Originated Date :** 11/18/2025 - Jackson Gunnels - National TAB

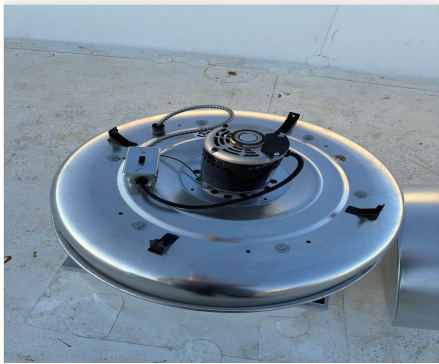
Project Issue File Details

**Issue Name :** EF1 No power  
**Description :** EF1 is not receiving any power.  
**Created By :** National TAB                      **Assigned To :** National TAB - Dan Hertenstein  
**Status :** Open  
**Priority :** Urgent                                      **Asset Tag :** EF1  
**Originated Date :** 11/18/2025 - Jackson Gunnels - National TAB

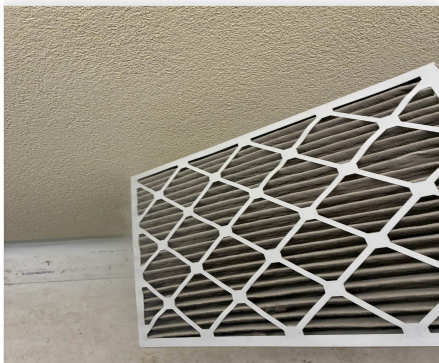
Project Issue File Details

**Issue Name :** Final Air Filters  
**Description :** Final air filters show accumulation of dust. Recommend replacing. Filters removed for TAB  
**Created By :** National TAB                      **Assigned To :** National TAB - Dan Hertenstein  
**Status :** Closed  
**Priority :** Medium                                      **Asset Tag :**  
**Originated Date :** 11/17/2025 - Jackson Gunnels - National TAB

- **11/18/2025 National TAB - Jackson Gunnels**
  - Filters replaced. Issue resolved.
