Report: Prelim Report
Function: Test, Adjust, & Balance
Date: 06/11/2025
Completed By: National TAB

06-09-26 CULVERS WEST CARROLLTON, OH

Project: 06-09-26 CULVERS WEST CARROLLTON, OH

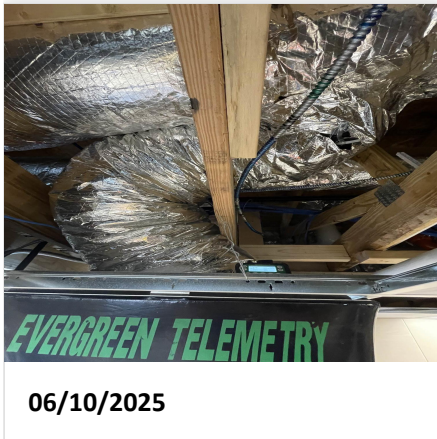
Issue Name : RTU-2 Diffuser 1
Description : Diffuser 1 for RTU-2 is below design due to the flex being kinked. In order to reach the specified spot in the ceiling grid, the flex had to be pulled through small spaces in between trusses. This is pinching and linking the flex and reducing the amount of air that exits the diffuser.
Created By : National TAB **Assigned To :** National TAB - Dan Hertenstein
Status : Open
Priority : High **Asset Tag :**
Originated Date : 06/10/2025 - Jordan Best - National TAB

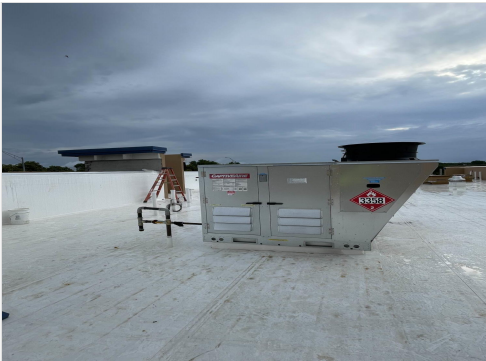
Asset: RTU1

Unit Data		
	Design	Actual
MFG	LENNOX	CAPTIVE-AIRE
Serial Num	-	7272747
Model Num	ENLIGHT	CAS-HVAC3-1.300-24-20T
Type	RTU	RTU
Configuration	VERTICAL	VERTICAL
Num OA Filters 1	-	4
OA Filter Size 1	-	16"X25"X2"
Num Final Filter 1	-	8
Final Filter Size 1	-	20"X25"X2"

Test Data		
	Design	Actual
SF CFM	6150	6262
SF RPM	-	1638
RA CFM	4400	4530
OA CFM	1750	1732
RL Voltage	-	184 VFD
RL Amperage	-	24.1 VFD
SF Rotation	-	CCW
SF System SetPt	-	56 HZ
Min OA Damper Position	-	4.3 VDC
Min OA Damper Type	-	MOTORIZED
OA Enthalpy Setpt	-	DEFAULT

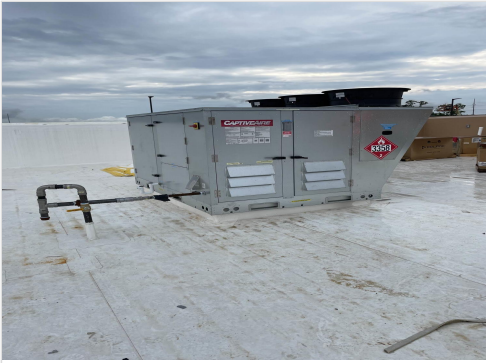
Asset: RTU2

Unit Data		
	Design	Actual
MFG	LENNOX	CAPTIVE-AIRE
Serial Num	-	7272747
Model Num	ENLIGHT	CAS-HVAC3-1.250-24-20T
Type	RTU	RTU
Configuration	VERTIC AL	VERTICAL
Num OA Filters 1	-	4
OA Filter Size 1	-	16"X25"X2"
Num Final Filter 1	-	8
Final Filter Size 1	-	20"X25"X2"

Test Data		
	Design	Actual
SF CFM	6150	6046
SF RPM	-	1608
RA CFM	4450	4357
OA CFM	1700	1689
RL Voltage	-	170 VFD
RL Amperage	-	24.2 VFD
SF Rotation	-	CCW
SF System SetPt	-	55 HZ
Min OA Damper Position	-	4.1 VDC
Min OA Damper Type	-	MOTORIZED
OA Enthalpy Setpt	-	DEFAULT

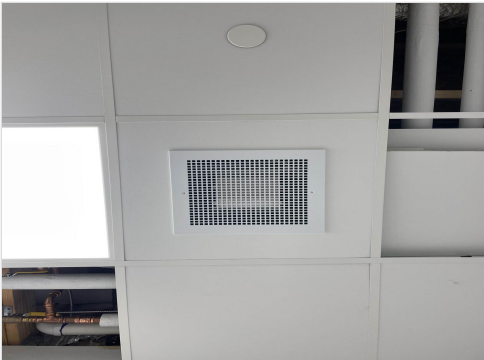
Asset: EF1

Unit Data		
	Design	Actual
MFG	CAPTIVEAIRE	CAPTIVEAIRE
Model Num	CFA 100CA	CFA 100CA
Serial Num	-	7272747
Type	INLINE	INLINE
Configuration	VERTICAL	VERTICAL

Test Data		
	Design	Actual
CFM	75	81
Fan Rotation	-	CCW
System SetPt	-	FIXED SPEED
Fan Discharge SP	-	ATM

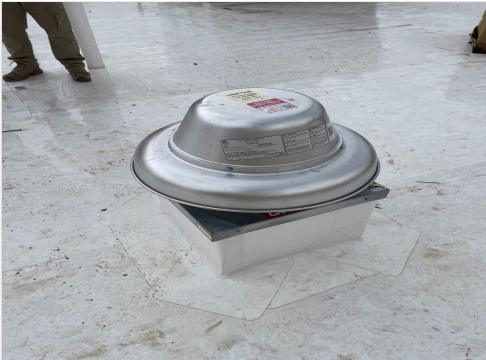
Asset: PRV 1

Unit Data		
	Design	Actual
MFG	CAPTIVEAIRE	CAPTIVEAIRE
Model Num	DR12HFA	DR12HFA
Serial Num	-	7272747
Type	DOWNBLAST	DOWNBLAST
Configuration	VERTICAL	VERTICAL

Test Data		
	Design	Actual
CFM	375	370
Fan RPM	-	1373
Fan Rotation	-	CCW
Motor RPM	-	1373
System SetPt	-	69
Total ESP	.50"	0.24"
Fan Inlet SP	-	-0.24"
Fan Discharge SP	-	ATM

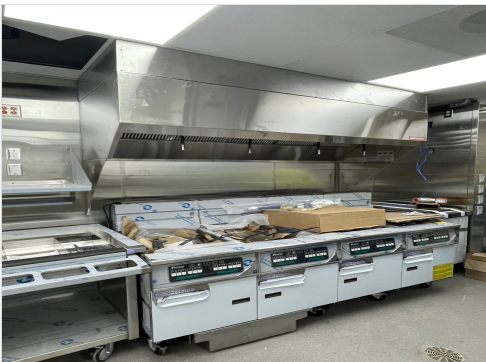
Asset: HD1

Unit Data		
	Design	Actual
MFG	CAPTIVEAIRE	CAPTIVEAIRE
Model Num	3347 BD-2	3347 BD-2
Job / Serial Num	-	7272747
Type	TYPE I - LOW PROXIMITY	TYPE I CANOPY
Hood length	84"	84"
Hood Width	33"	33"

Test Data Exhaust		
	Design	Actual
Filter Type	CAPTRATE SOLO FILTER	CAPTRATE SOLO FILTER
Filter Size 1	16"X16"	16"X16"
Filter Qty 1	5	5
Filter AK factor size 1	1.62	1.62
Filter Total AK Area	8.10	8.10
Filter1 FPM	-	196
Filter2 FPM	-	207
Filter3 FPM	-	199
Filter4 FPM	-	182
Filter5 FPM	-	175
Filter Ave FPM(corr)	-	191
CFM	1500	1547

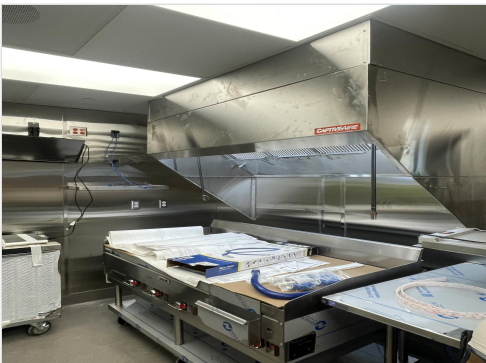
Asset: HD2

Unit Data		
	Design	Actual
MFG	CAPTIVAIRE	CAPTIVAIRE
Model Num	3347 BD-2	3347 BD-2
Job / Serial Num	-	7272747
Type	TYPE I - LOW PROXIMITY	TYPE I CANOPY
Hood length	66"	66"
Hood Width	33"	33"

Test Data Exhaust		
	Design	Actual
Filter Type	CAPTRATE SOLO FILTER	CAPTRATE SOLO FILTER
Filter Size 1	16"X16"	16"X16"
Filter Qty 1	4	4
Filter AK factor size 1	1.62	1.62
Filter Total AK Area	6.48	6.48
Filter1 FPM	-	239
Filter2 FPM	-	243
Filter3 FPM	-	205
Filter4 FPM	-	245
Filter Ave FPM(corr)	-	233
CFM	1500	1510
