**Report: Prelim Report**  
**Function: Test, Adjust, & Balance**  
**Date: 06/11/2025**  
**Completed By: National TAB**

## 06-09-26 CULVERS WEST CARROLLTON, OH

1100 Dixie Drive

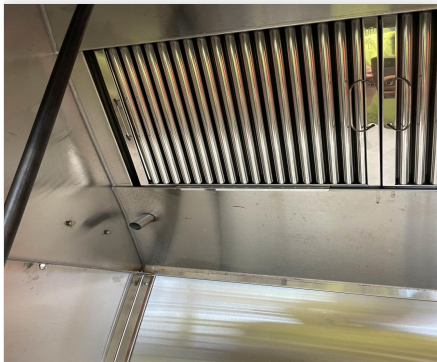
**Issue Name :** Gap in Filter Bank Hoods 1 and 2  
**Description :** Hoods 1 and 2 have a small opening on either end of the filter bank when all filters are installed. Recommend securing a piece of metal (similar to what hood is constructed from) over the gap to ensure unit functions as designed. Gap was taped over during testing.  
**Created By :** National TAB                      **Assigned To :** National TAB - Dan Hertenstein  
**Status :** Open  
**Priority :** High                                      **Asset Tag :**  
**Originated Date :** 06/10/2025 - Jordan Best - National TAB

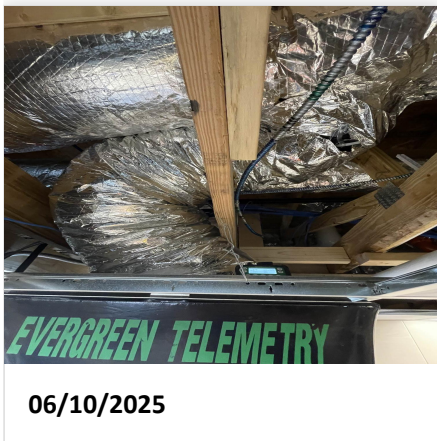
**Issue Name :** RTU-2 Diffuser 1  
**Description :** Diffuser 1 for RTU-2 is below design due to the flex being kinked. In order to reach the specified spot in the ceiling grid, the flex had to be pulled through small spaces in between trusses. This is pinching and linking the flex and reducing the amount of air that exits the diffuser.  
**Created By :** National TAB                      **Assigned To :** National TAB - Dan Hertenstein  
**Status :** Open  
**Priority :** High                                      **Asset Tag :**  
**Originated Date :** 06/10/2025 - Jordan Best - National TAB

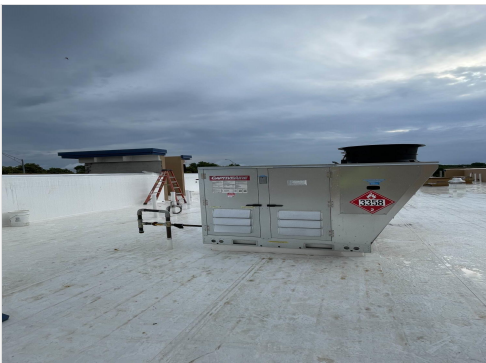
Asset: RTU1

Unit Data		
	Design	Actual
MFG	LENNOX	CAPTIVE-AIRE
Serial Num	-	7272747
Model Num	ENLIGHT	CAS-HVAC3-1.300-24-20T
Type	RTU	RTU
Configuration	VERTICAL	VERTICAL
Num OA Filters 1	-	4
OA Filter Size 1	-	16"X25"X2"
Num Final Filter 1	-	8
Final Filter Size 1	-	20"X25"X2"

Test Data		
	Design	Actual
SF CFM	6150	6262
SF RPM	-	1638
RA CFM	4400	4530
OA CFM	1750	1732
RL Voltage	-	184 VFD
RL Amperage	-	24.1
SF Rotation	-	CCW
SF System SetPt	-	56 HZ
Min OA Damper Position	-	4.3 VDC
Min OA Damper Type	-	MOTORIZED
OA Enthalpy Setpt	-	DEFAULT

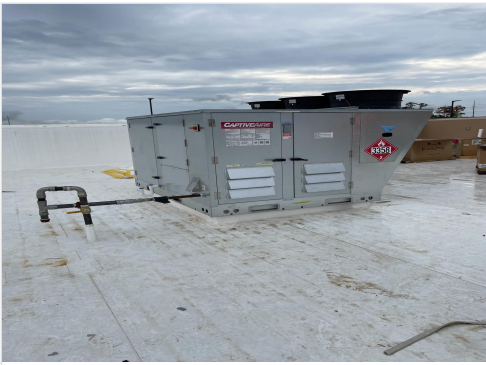
Asset: RTU2

Unit Data		
	Design	Actual
MFG	LENNOX	CAPTIVE-AIRE
Serial Num	-	7272747
Model Num	ENLIGHT	CAS-HVAC3-1.250-24-20T
Type	RTU	RTU
Configuration	VERTIC AL	VERTICAL
Num OA Filters 1	-	4
OA Filter Size 1	-	16"X25"X2"
Num Final Filter 1	-	8
Final Filter Size 1	-	20"X25"X2"

Test Data		
	Design	Actual
SF CFM	6150	6046
SF RPM	-	1608
RA CFM	4450	4357
OA CFM	1700	1689
RL Voltage	-	170 VFD
RL Amperage	-	24.2 VFD
SF Rotation	-	CCW
SF System SetPt	-	55 HZ
Min OA Damper Position	-	4.1 VDC
Min OA Damper Type	-	MOTORIZED
OA Enthalpy Setpt	-	DEFAULT

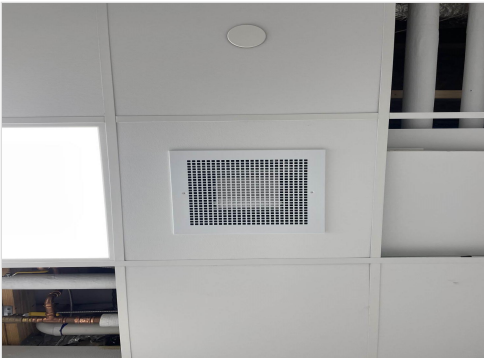
Asset: EF1

Unit Data		
	Design	Actual
MFG	CAPTIVEAIRE	CAPTIVEAIRE
Model Num	CFA 100CA	CFA 100CA
Serial Num	-	7272747
Type	INLINE	INLINE
Configuration	VERTICAL	VERTICAL

Test Data		
	Design	Actual
CFM	75	81
Fan Rotation	-	CCW
System SetPt	-	FIXED SPEED
Fan Discharge SP	-	ATM

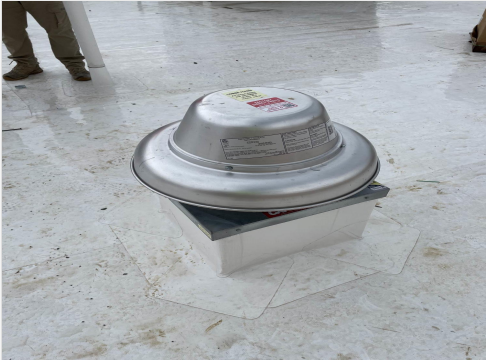
Asset: PRV 1

Unit Data		
	Design	Actual
MFG	CAPTIVEAIRE	CAPTIVEAIRE
Model Num	DR12HFA	DR12HFA
Serial Num	-	7272747
Type	DOWNBLAST	DOWNBLAST
Configuration	VERTICAL	VERTICAL

Test Data		
	Design	Actual
CFM	375	370
Fan RPM	-	1373
Fan Rotation	-	CCW
Motor RPM	-	1373
System SetPt	-	69
Total ESP	.50"	0.24"
Fan Inlet SP	-	-0.24"
Fan Discharge SP	-	ATM

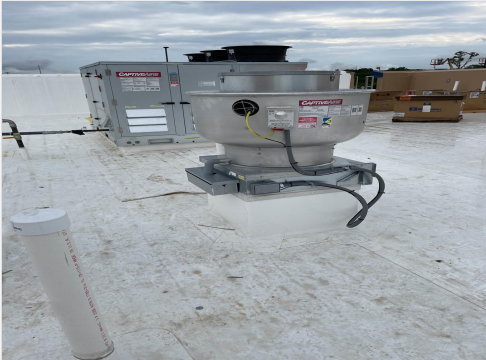
Asset: PRV2

Unit Data		
	Design	Actual
MFG	CAPTIVEAIRE	CAPTIVEAIRE
Model Num	DU85HFA	DU85HFA
Serial Num	-	7272747
Type	UPBLAST/CEILING	CEILING
Configuration	VERTICAL	VERTICAL

Test Data		
	Design	Actual
CFM	1500	1510
Fan RPM	-	1008
Fan Rotation	-	CCW
Motor RPM	-	1008
System SetPt	-	50%
RL Voltage	-	118.6
RL Amperage	-	3.9
Total ESP	1.412"	0.57
Fan Inlet SP	-	-0.57"
Fan Discharge SP	-	ATM

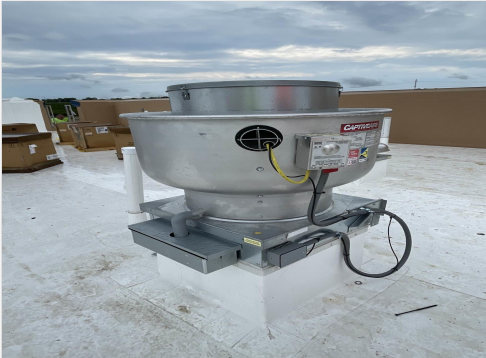
Asset: PRV3

Unit Data		
	Design	Actual
MFG	CAPTIVEAIRE	CAPTIVEAIRE
Model Num	DU85HFA	DU85HFA
Serial Num	-	7272747
Type	UPBLAST/CEILING	CEILING
Configuration	VERTICAL	VERTICAL

Test Data		
	Design	Actual
CFM	1500	1547
Fan RPM	-	985
Fan Rotation	-	CCW
Motor RPM	-	985
System SetPt	-	49%
RL Voltage	-	118.8
RL Amperage	-	4.1
Total ESP	1.250"	0.48"
Fan Inlet SP	-	-0.48"
Fan Discharge SP	-	ATM

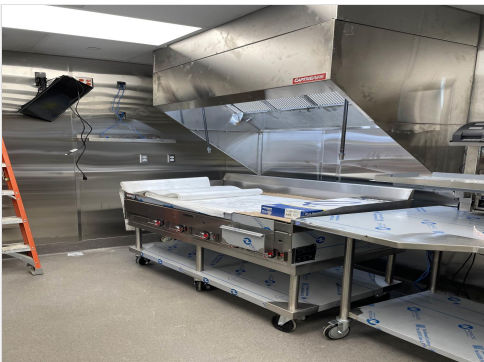
Asset: HD1

Unit Data		
	Design	Actual
MFG	CAPTIVEAIRE	CAPTIVEAIRE
Model Num	3347 BD-2	3347 BD-2
Job / Serial Num	-	7272747
Type	TYPE I - LOW PROXIMITY	TYPE I CANOPY
Hood length	84"	84"
Hood Width	33"	33"

Test Data Exhaust		
	Design	Actual
Filter Type	CAPTRATE SOLO FILTER	CAPTRATE SOLO FILTER
Filter Size 1	16"X16"	16"X16"
Filter Qty 1	5	5
Filter AK factor size 1	1.62	1.62
Filter Total AK Area	8.10	8.10
Filter1 FPM	-	196
Filter2 FPM	-	207
Filter3 FPM	-	199
Filter4 FPM	-	182
Filter5 FPM	-	175
Filter Ave FPM(corr)	-	191
CFM	1500	1547

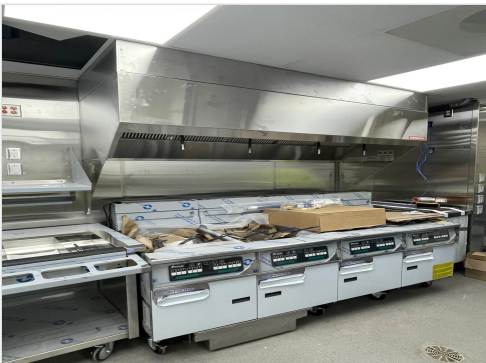
Asset: HD2

Unit Data		
	Design	Actual
MFG	CAPTIVAIRE	CAPTIVAIRE
Model Num	3347 BD-2	3347 BD-2
Job / Serial Num	-	7272747
Type	TYPE I - LOW PROXIMITY	TYPE I CANOPY
Hood length	66"	66"
Hood Width	33"	33"

Test Data Exhaust		
	Design	Actual
Filter Type	CAPTRATE SOLO FILTER	CAPTRATE SOLO FILTER
Filter Size 1	16"X16"	16"X16"
Filter Qty 1	4	4
Filter AK factor size 1	1.62	1.62
Filter Total AK Area	6.48	6.48
Filter1 FPM	-	239
Filter2 FPM	-	243
Filter3 FPM	-	205
Filter4 FPM	-	245
Filter Ave FPM(corr)	-	233
CFM	1500	1510
