**Report: TAB REPORT**  
**Function: Test, Adjust, & Balance**  
**Date: 01/27/2025**  
**Completed By: National TAB**

**PROJECT**  
**12-09-24 LORO DOMAIN AUSTIN, TX**

HAI Hospitality

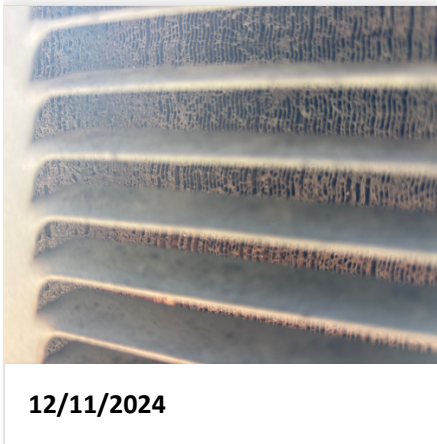
**Issue Name :** RTU-1 Condenser Coil  
**Description :** RTU-1 condenser coil has dirt build up. Coil should be cleaned to ensure the unit will cool properly.  
**Created By :** National TAB                      **Assigned To :** National TAB - Wesley John  
**Status :** Closed  
**Priority :** Medium                                      **Asset Tag :** RTU1  
**Originated Date :** 12/11/2024 - Wesley John - National TAB

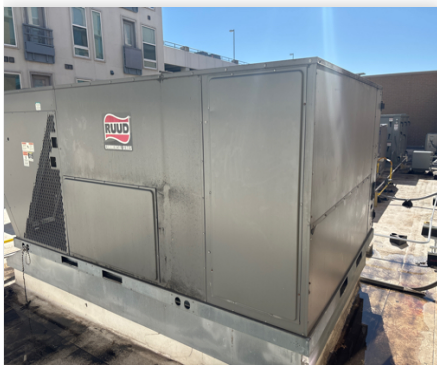
**Issue Name :** RTU-1 Economizer  
**Description :** RTU-1 is designed for 2000 CFM of outside air flow, but is not equipped with an economizer. Recommend installing economizer to allow unit to operate as designed and to pressurize the building as designed. The building pressure is highly negative as a result.

- **01/27/2025 National TAB - Oscar Ventura**
  - Economizer has been installed and set to 98% of design CFM.

ACTUAL NET AIRFLOW AND MEASURED PRESSURE ARE NEGATIVE DUE TO RTU-1 NOT BEING EQUIPPED WITH ECONOMIZER. SEE ISSUES.

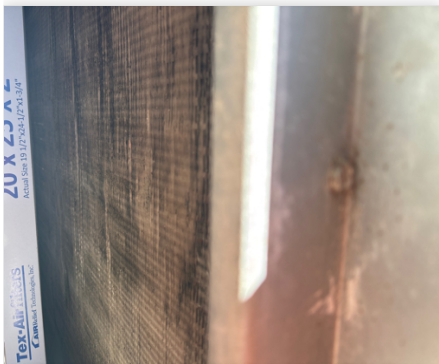
**Issue Name :** RTU-1 Evaporator coil  
**Description :** Supply air from RTU-1 smells of mildew. Recommend cleaning evaporator coil.  
**Created By :** National TAB                      **Assigned To :** National TAB - Wesley John  
**Status :** Closed  
**Priority :** Urgent                                      **Asset Tag :** RTU1  
**Originated Date :** 12/11/2024 - Wesley John - National TAB

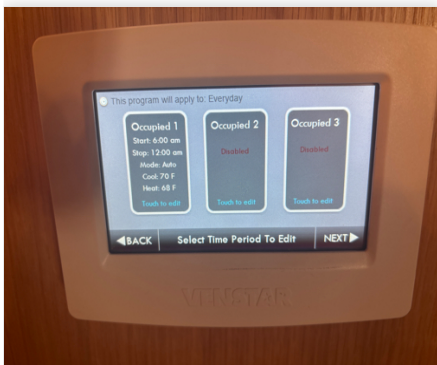
**Issue Name :** RTU-1 Thermostat  
**Description :** RTU-1 thermostat is not able to program fan functionality. Recommend replacing with model that will allow for fan functionality programming. This will allow, once RTU-1 economizer is installed and set, to maintain building pressure during occupied hours.  
**Created By :** National TAB      **Assigned To :** National TAB - Wesley John  
**Status :** Closed  
**Priority :** **Urgent**      **Asset Tag :** RTU1  
**Originated Date :** 12/11/2024 - Wesley John - National TAB

- **01/27/2025 National TAB - Oscar Ventura**
  - Thermostat for RTU 1 has been replaced and it's programmed.

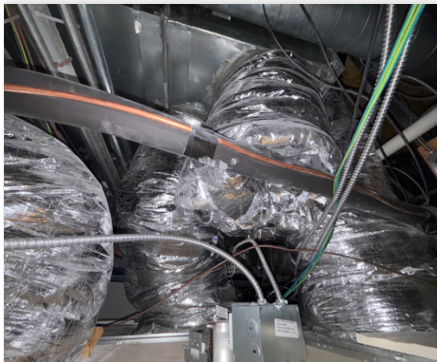
**Issue Name :** RTU-2 Return Tap  
**Description :** RTU-2 has an unused return tap with flex duct. Flex duct is closed off at end. Recommend blocking off unused return tap.  
**Created By :** National TAB                      **Assigned To :** National TAB - Wesley John  
**Status :** Closed  
**Priority :** Medium                                      **Asset Tag :** RTU2  
**Originated Date :** 12/09/2024 - Wesley John - National TAB

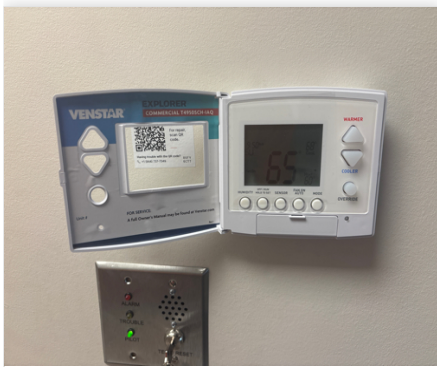
**Issue Name :** RTU-2 Thermostat  
**Description :** RTU-2 thermostat is not programmable. Recommend replacing with a model that allows for schedule to be programmed so that fan functionality can change over between occupied and unoccupied times.  
**Created By :** National TAB                      **Assigned To :** National TAB - Wesley John  
**Status :** Closed  
**Priority :** Urgent                                      **Asset Tag :** RTU2  
**Originated Date :** 12/11/2024 - Wesley John - National TAB

- **01/27/2025 National TAB - Oscar Ventura**
  - RTU-2 Thermostat has been replaced, and it's programmed.

RTU-2 THERMOSTAT NOT PROGRAMMABLE. SEE ISSUES.

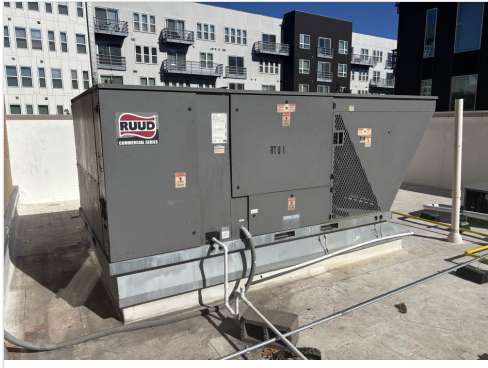
## Unit Data - PHOTO LOG

Unit Data		
	Design	Actual
MFG	NA	RUUD
Serial Num	-	F291601181
Model Num	NA	RLNL-B300CL
Type	-	RTU
Configuration	-	VERTICAL DISCHARGE
Num OA Filters 1	-	3
OA Filter Size 1	-	24x24
Num Final Filter 1	-	8
Final Filter Size 1	-	20x25x2

Notes:  
MOTOR PULLEY SET POINT 1 TURN OPEN.

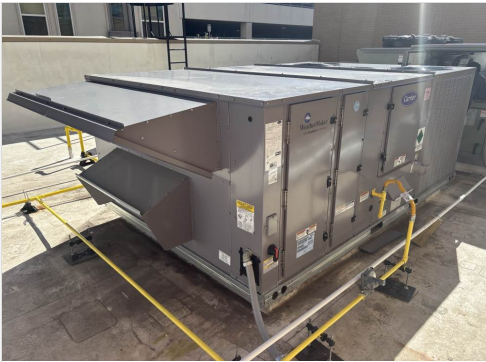
## Unit Data - PHOTO LOG

Unit Data		
	Design	Actual
<b>MFG</b>	ACCUREX	ACCUREX
<b>Model Num</b>	XCUE-120-VG	XCUE-120-5-VG-1-19-X
<b>Serial Num</b>	-	25137426
<b>Type</b>	-	CENTRIFUGAL
<b>Configuration</b>	-	UPBLAST

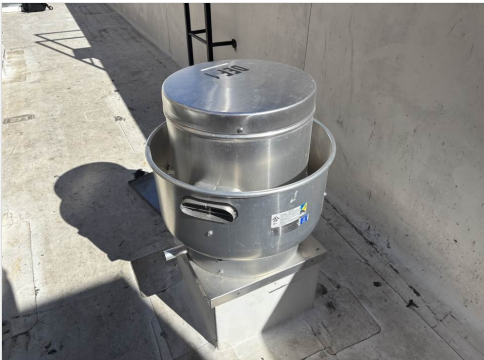
## Unit Data - PHOTO LOG

Unit Data		
	Design	Actual
MFG	ACCUREX	ACCUREX
Model Num	XUEF-18	XUEF-18-3-B7-00-02-02
Serial Num	-	25136412
Type	-	CENTRIFUGAL
Configuration	-	UTILITY

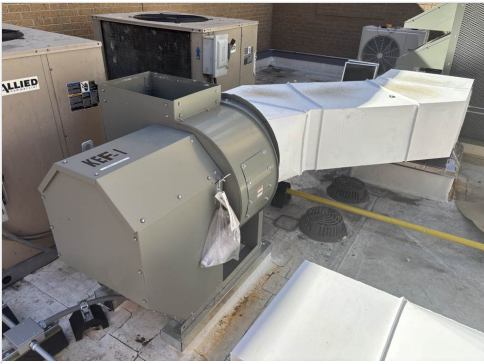
## Unit Data - PHOTO LOG

Unit Data		
	Design	Actual
MFG	ACCUREX	ACCUREX
Model Num	XUEF-15	XUEF-15-3-B7-00-02-02
Serial Num	-	25136411
Type	-	CENTRIFUGAL
Configuration	-	UTILITY

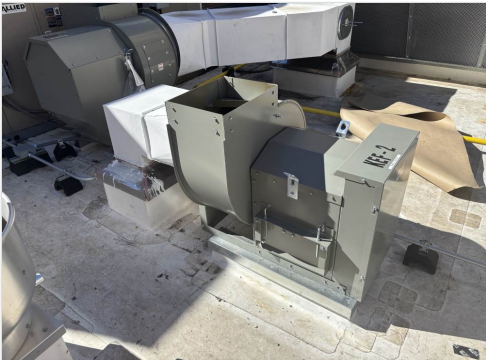
## Unit Data - PHOTO LOG

Unit Data		
	Design	Actual
MFG	ACCUREX	ACCUREX
Model Num	XRUE-140-A	XCUE-140-A-10-1-26-G
Serial Num	-	25137436
Type	-	CENTRIFUGAL
Configuration	-	UPBLAST

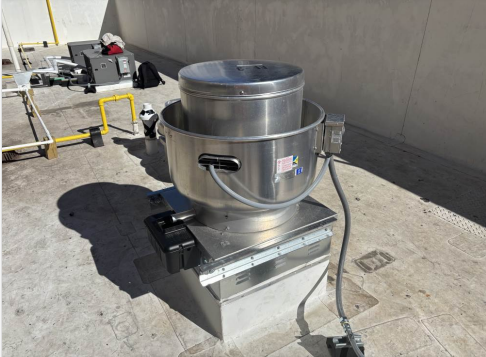
## Unit Data - PHOTO LOG

Unit Data		
	Design	Actual
MFG	GREENHECK	GREENHECK
Model Num	G-090-VC	G-080-VG-1-17-X
Serial Num	-	25174675
Type	-	CENTRIFUGAL
Configuration	-	DOWNBLAST

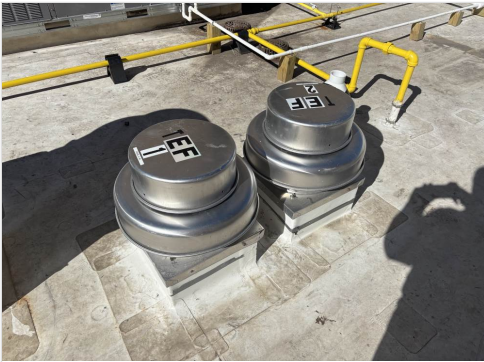
## Unit Data - PHOTO LOG

Notes:  
UNIT OPERATING AT 69% OF DESIGN AIR FLOW AND SET TO HIGH SPEED.
