Report: TAB REPORT
Function: Test, Adjust, & Balance
Date: 12/12/2024
Completed By: National TAB

PROJECT
12-09-24 LORO DOMAIN AUSTIN, TX

HAI Hospitality

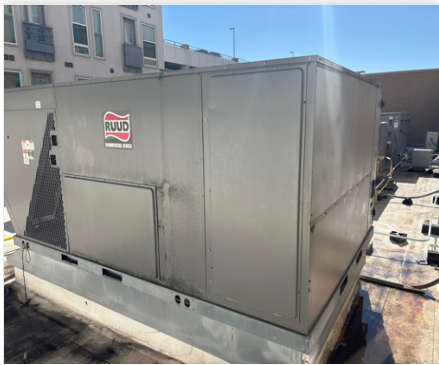
Issue Name : RTU-1 Economizer
Description : RTU-1 is designed for 2000 CFM of outside air flow, but is not equipped with an economizer. Recommend installing economizer to allow unit to operate as designed and to pressurize the building as designed. The building pressure is highly negative as a result.
Created By : National TAB **Assigned To :** National TAB - Wesley John
Status : Closed
Priority : Urgent **Asset Tag :** RTU1
Originated Date : 12/09/2024 - Wesley John - National TAB

- **01/27/2025 National TAB - Oscar Ventura**
 - Economizer has been installed and set to 98% of design CFM.

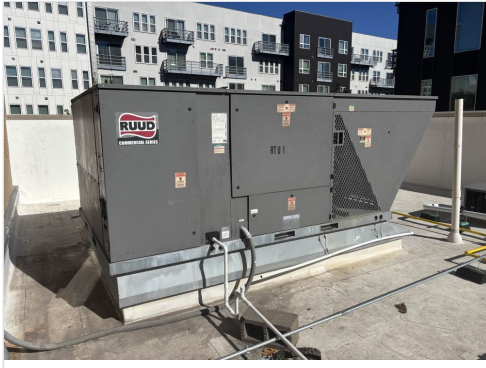
Unit Data - PHOTO LOG

Unit Data		
	Design	Actual
MFG	NA	RUUD
Serial Num	-	F291601181
Model Num	NA	RLNL-B300CL
Type	-	RTU
Configuration	-	VERTICAL DISCHARGE
Num OA Filters 1	-	3
OA Filter Size 1	-	24x24
Num Final Filter 1	-	8
Final Filter Size 1	-	20x25x2

Notes:
MOTOR PULLEY SET POINT 1 TURN OPEN.
UNIT NOT EQUIPPED WITH ECONOMIZER. SEE ISSUES.

1) ECONOMIZER HAS BEEN INSTALLED. 3 FILTERS (24X24) EACH.
