**Report: TAB REPORT**  
**Function: Test, Adjust, & Balance**  
**Date: 12/12/2024**  
**Completed By: National TAB**

**PROJECT**  
**12-09-024 LORO DOMAIN AUSTIN, TX**

HAI Hospitality

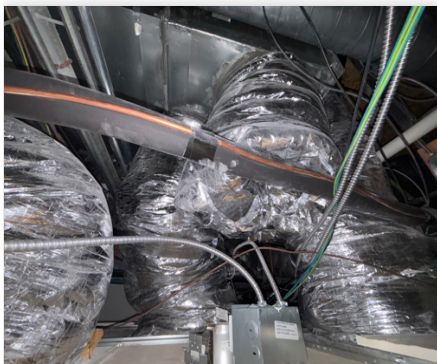
**Issue Name :** RTU-2 Return Tap  
**Description :** RTU-2 has an unused return tap with flex duct. Flex duct is closed off at end. Recommend blocking off unused return tap.  
**Created By :** National TAB                      **Assigned To :** National TAB - Wesley John  
**Status :** Open  
**Priority :** Medium                                      **Asset Tag :** RTU2  
**Originated Date :** 12/09/2024 - Wesley John - National TAB

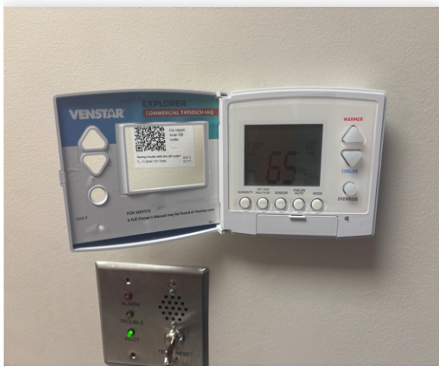
**Issue Name :** RTU-2 Thermostat  
**Description :** RTU-2 thermostat is not programmable. Recommend replacing with a model that allows for schedule to be programmed so that fan functionality can change over between occupied and unoccupied times.  
**Created By :** National TAB                      **Assigned To :** National TAB - Wesley John  
**Status :** Open  
**Priority :** **Urgent**                                      **Asset Tag :** RTU2  
**Originated Date :** 12/11/2024 - Wesley John - National TAB

RTU-2 THERMOSTAT NOT PROGRAMMABLE. SEE ISSUES.

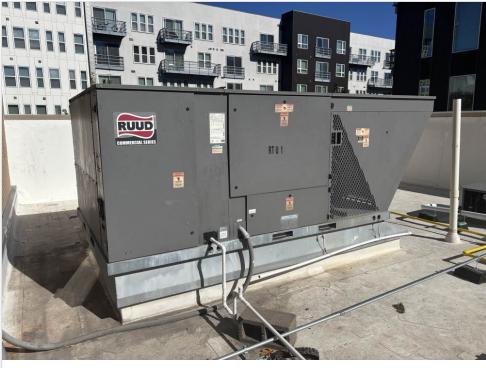
Asset: RTU1

Test Data		
	Design	Actual
SF CFM	9500	8928
SF RPM	-	923
RA CFM	7500	8928
OA CFM	2000	0
RL Voltage	-	210/210/210
RL Amperage	-	14.9/14.6/14.7
SF Rotation	-	CCW
RA Damper Position	-	N/A
Min OA Damper Position	-	N/A
Min OA Damper Type	-	N/A

Notes:  
MOTOR PULLEY SET POINT 1 TURN OPEN.  
UNIT NOT EQUIPPED WITH ECONOMIZER. SEE ISSUES.

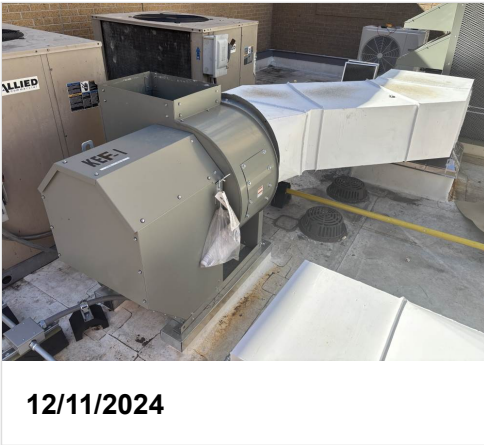
Asset: KEF1

Test Data		
	Design	Actual
CFM	3752	3653
Fan RPM	-	1392
Fan Rotation	-	CW
Motor RPM	-	1392
System SetPt	-	72.0 Hz
RL Voltage	-	232 VFD
RL Amperage	-	6.8 VFD
Total ESP	-	NA
Fan Inlet SP	-	NA
Fan Discharge SP	-	ATM

Notes:  
SPEED SET POINT OKAYED BY ACCUREX TECHNICAL SUPPORT.

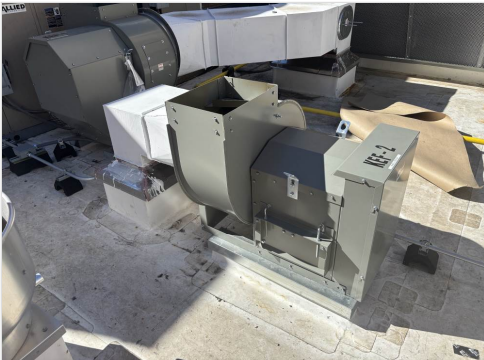
Asset: KEF2

Test Data		
	Design	Actual
CFM	1900	1879
Fan RPM	-	2242
Fan Rotation	-	CW
Motor RPM	-	2242
System SetPt	-	76 Hz
RL Voltage	-	242 VFD
RL Amperage	-	3.1 VFD
Total ESP	-	NA
Fan Inlet SP	-	NA
Fan Discharge SP	-	ATM

Notes:  
SPEED SET POINT OKAYED BY ACCUREX TECHNICAL SUPPORT.

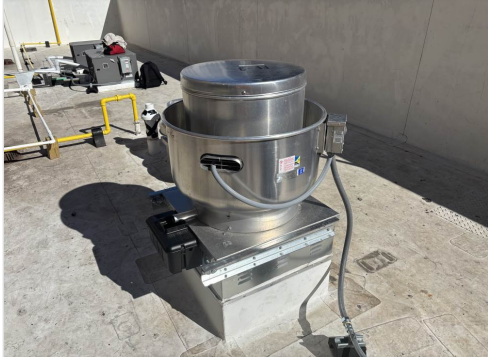
Asset: KEF3

Test Data		
	Design	Actual
CFM	2000	1968
Fan RPM	-	1467
Fan Rotation	-	CW
Motor RPM	-	1467
System SetPt	-	50 Hz
RL Voltage	-	218/218/217
RL Amperage	-	3.1/3.1/3.1
Total ESP	-	0.81"
Fan Inlet SP	-	-0.81"
Fan Discharge SP	-	ATM

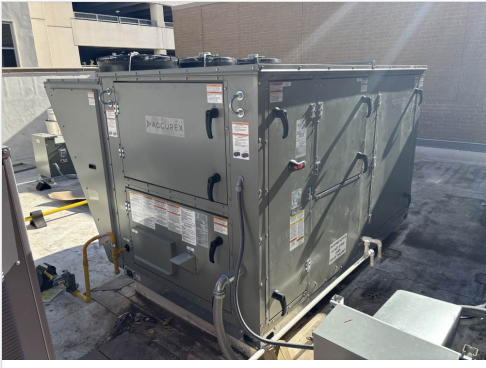
Asset: MUA1

Test Data		
	Design	Actual
CFM	6120	6129
SF RPM	-	2095
Motor RPM	-	2095
SF System SetPt	-	7.4 VDC
RL Voltage	-	231 VFD
RL Amperage	-	12.2 A
Total ESP	-	0.58"
Fan Discharge SP	-	0.58"

Notes:  
7.4 VDC ON CONTROLLER CORRESPONDS TO 71 Hz ON VFD.

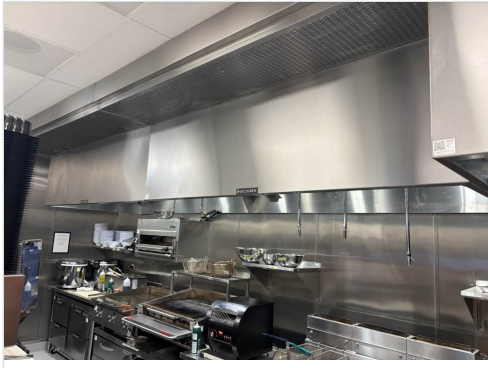
Asset: HD1

Test Data Supply		
	Design	Actual
CFM	1501	1422

Test Data Exhaust		
	Design	Actual
Filter Type	-	BAFFLE
Filter Size 1	-	20x16
Filter Size 2	-	20x20
Filter Qty 1	-	2
Filter Qty 2	-	3
Filter AK factor size 1	-	1.96
Filters AK factor size 2	-	2.40
Filter Total AK Area	-	11.12
Filter1 FPM	-	143
Filter2 FPM	-	148
Filter3 FPM	-	159
Filter4 FPM	-	162
Filter5 FPM	-	158
Filter Ave FPM(corr)	-	154
CFM	1752	1713

Notes:  
VELOCITY READINGS AT ACCUREX PSP INACCURATE. PERFORMED DUCT TRAVERSE TO MEASURE SUPPLY AIR TO HOOD.

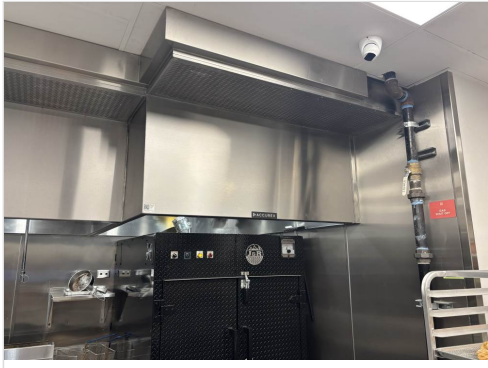
Asset: HD3

Test Data Supply		
	Design	Actual
CFM	1520	1476
