**Report: TAB Report**  
**Function: Test, Adjust, & Balance**  
**Date: 01/30/2026**  
**Completed By: National TAB**

**PROJECT**  
**01-26-26 CHIPOTLE #5381 EASTON, MA**

Project: 01-26-26 CHIPOTLE #5381 EASTON, MA

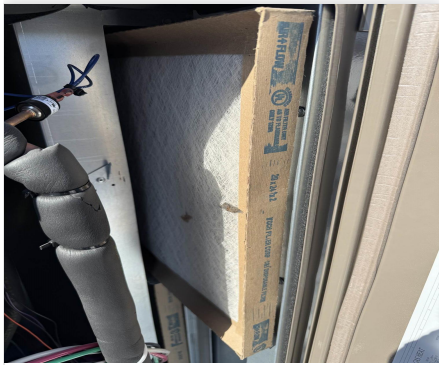
**Issue Name :** CONSTRUCTION FILTERS INSTALLED IN RTU-2  
**Description :** There are construction filters installed in RTU-2. Recommend installing proper final filters prior to store opening.  
**Created By :** National TAB                      **Assigned To :** National TAB - Dan Hertenstein  
**Status :** Open  
**Priority :** Low                                      **Asset Tag :**  
**Originated Date :** 01/30/2026 - Ryan Ash - National TAB

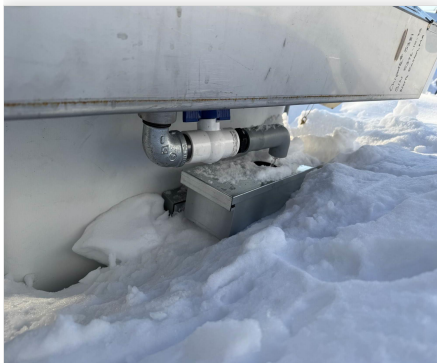
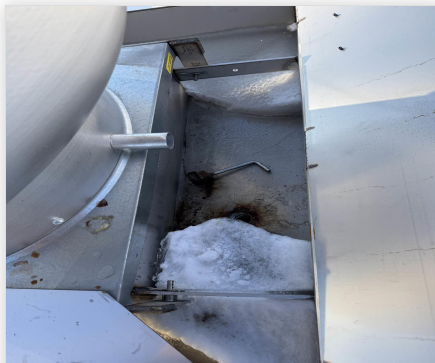
**Issue Name :** HOOD EXHUAST FAN GREASE CUP INSTALLED INCORRECTLY  
**Description :** The grease cup on the hood exhaust fan has been installed incorrectly. The grease cup is supposed to be installed in the trough, and the elbow is attached at the fan and feeds into the grease cup. Recommend installing per plans and requirements.  
**Created By :** National TAB                      **Assigned To :** National TAB - Dan Hertenstein  
**Status :** Open  
**Priority :** Low                                      **Asset Tag :**  
**Originated Date :** 01/29/2026 - Ryan Ash - National TAB

Grease cup installed improperly. See Remarks section for further detail.
