Report: TAB Report
Function: Test, Adjust, & Balance
Date: 01/30/2026
Completed By: National TAB

PROJECT
01-26-26 CHIPOTLE #5381 EASTON, MA

Project: 01-26-26 CHIPOTLE #5381 EASTON, MA

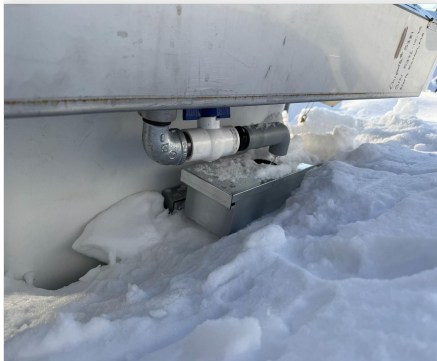
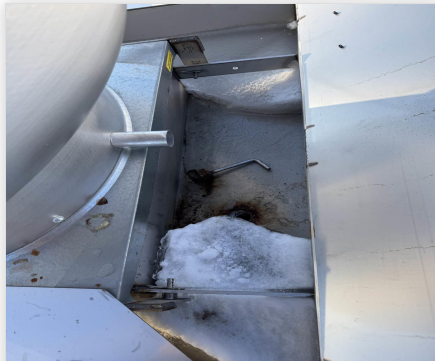
Issue Name : HOOD EXHUAST FAN GREASE CUP INSTALLED INCORRECTLY
Description : The grease cup on the hood exhaust fan has been installed incorrectly. The grease cup is supposed to be installed in the trough, and the elbow is attached at the fan and feeds into the grease cup. Recommend installing per plans and requirements.
Created By : National TAB **Assigned To :** National TAB - Dan Hertenstein
Status : Open
Priority : Low **Asset Tag :**
Originated Date : 01/29/2026 - Ryan Ash - National TAB

Grease cup installed improperly. See Remarks section for further detail.

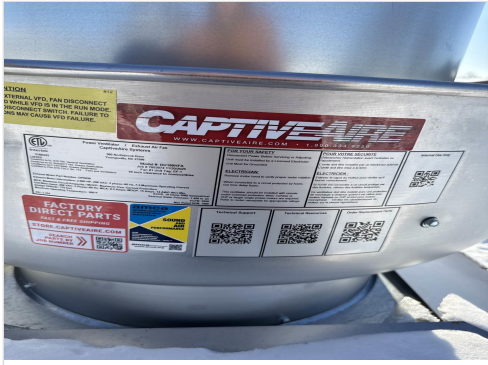
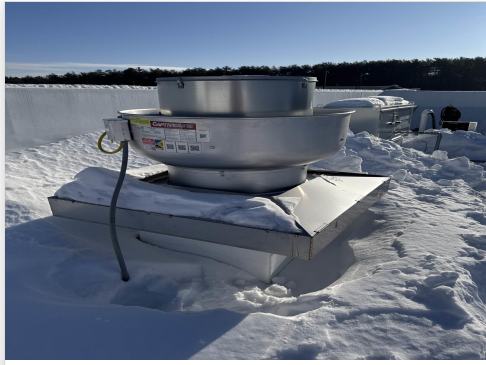
Unit Data - PHOTO LOG

Asset: EF1

AREA:KITCHEN HD

Unit Data		
	Design	Actual
MFG	CAPTIVE-AIRE	CAPTIVE-AIRE
Model Num	DU180HFA	DU180HFA
Serial Num	-	7653074
Type	UPBLAST	UPBLAST
Configuration	VERTICAL	VERTICAL

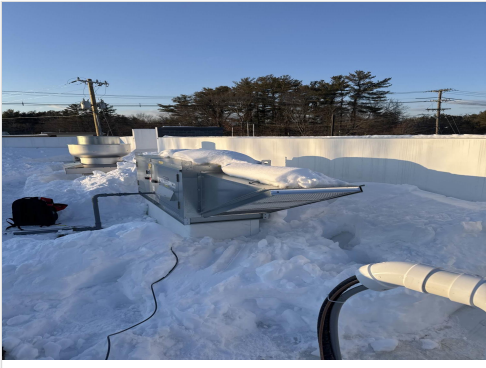
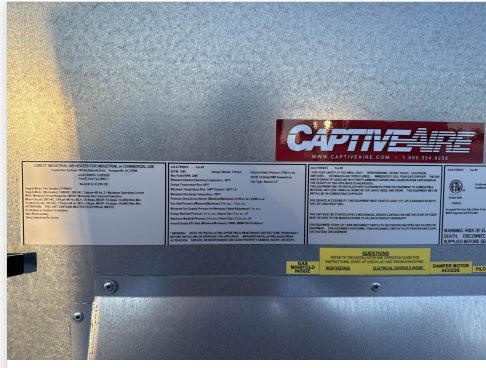
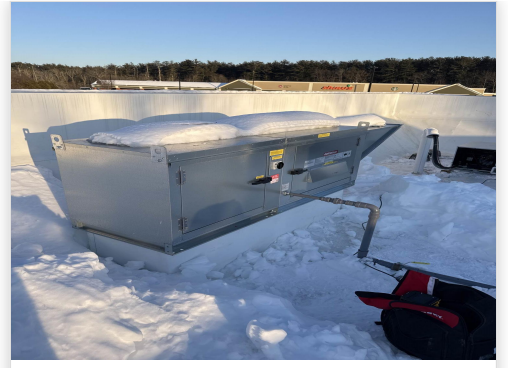
Unit Data - PHOTO LOG

Asset: MAU1

AREA: KITCHEN HD

Unit Data		
	Design	Actual
MFG	CAPTIVE-AIRE	CAPTIVE-AIRE
Model Num	A1-D.250-15D	A1-D.250-15D
Serial Num	-	7653074
Type	MAU	MAU
Configuration	VERTICAL	VERTICAL

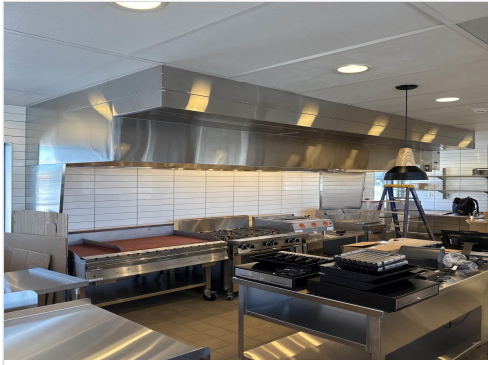
Unit Data - PHOTO LOG

Asset: HD1

AREA:KITCHEN

Unit Data		
	Design	Actual
MFG	CAPTIVE-AIRE	CAPTIVE-AIRE
Model Num	5424 ND-2-ACPSP-F	5424 ND-2-ACPSP-F
Job / Serial Num	-	7653074
Type	TYPE 1 CANOPY	TYPE 1 CANOPY
Hood length	153"	153"
Hood Width	54"	54"
Supply Plenum Type	-	ACPSP
Supply Plenum Width	9"	9"
Supply Plenum Length	165"	165"
