Report: TAB REPORT
Function: Test, Adjust, & Balance
Date: 10/22/2024
Completed By: National TAB

10-21-24 CHIPOTLE #5229 MEADVILLE, PA

Project: 10-21-24 CHIPOTLE #5229 MEADVILLE, PA

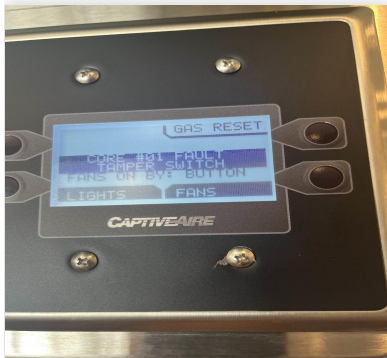
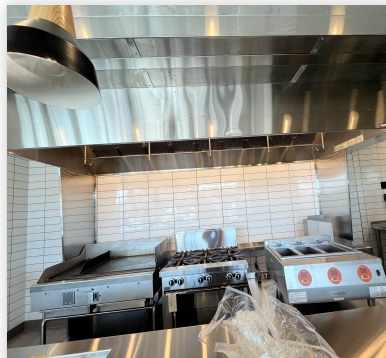
Issue Name : HD-1 Alarms
Description : HD-1 has two alarms showing: 1. Core #01 Fault 2. Tamper Switch
Created By : National TAB **Assigned To :** National TAB - Dylan Crisman
Status : Open
Priority : High **Asset Tag :**
Originated Date : 10/22/2024 - Dylan Crisman - National TAB

2 alarms, Issue created.

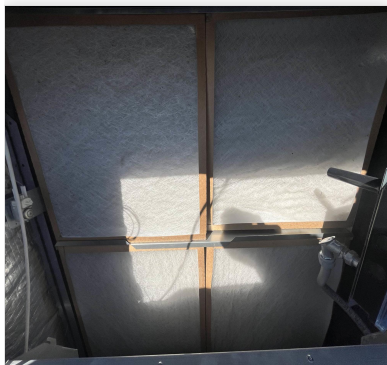
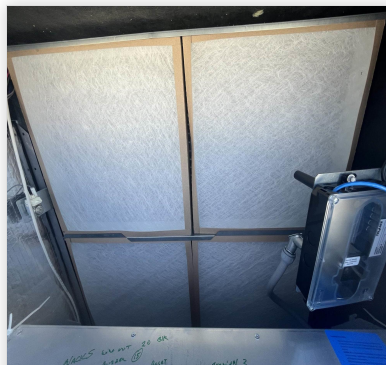
Issue Name : RTU-1/RTU-2 Final Filters
Description : Construction filters still installed on RTU-1/RTU-2. Recommend replacing with correct size (20x20x2) Merv 8 Rated Pleated filters.
Created By : National TAB **Assigned To :** National TAB - Dylan Crisman
Status : Open
Priority : Low **Asset Tag :**
Originated Date : 10/22/2024 - Dylan Crisman - National TAB

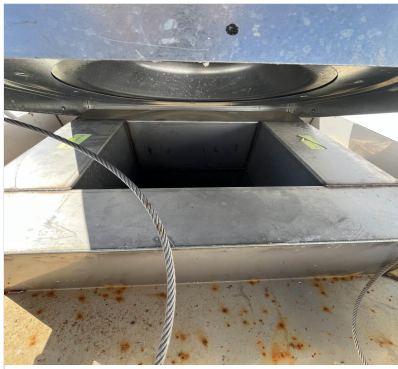
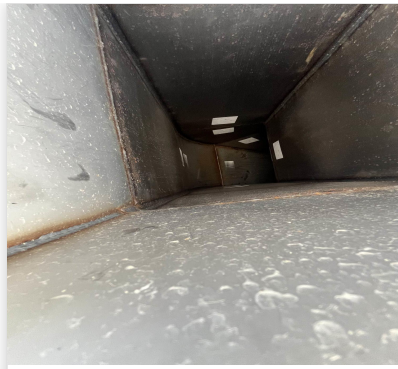
Lean fan back. Is grease duct installation adequate and is duct ran all the way to the base of the fan?	Yes
--	-----

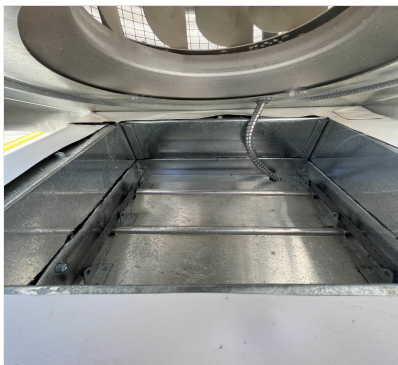
For restroom fan(s) is the back draft damper installed and can it fully open?

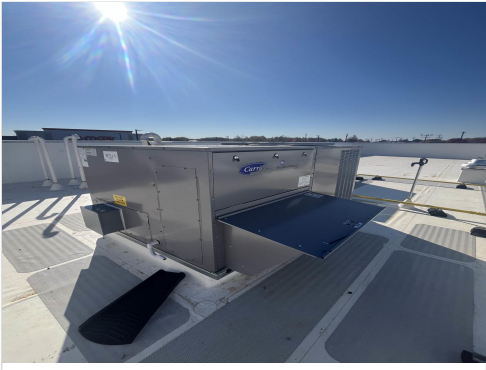
IMG_5941_1411389379.j..

Asset: RTU1

Unit Data		
	Design	Actual
MFG	CARRIER	CARRIER
Serial Num	-	0524P63188
Model Num	48FC-M	48FCFN09D3M5A6W4F0
Type	-	RTU
Configuration	-	VERTICAL
Num OA Filters 1	-	1
OA Filter Size 1	-	35x19.5
Num Final Filter 1	-	4
Final Filter Size 1	-	20x20x2
Num Final Filter 2	-	
Final Filter Size 2	-

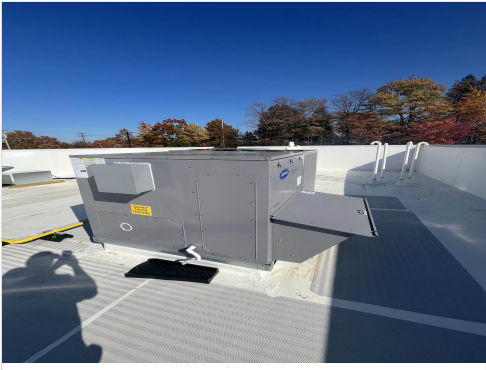
IMG_5944_970937501.jp..

Asset: RTU2

Unit Data		
	Design	Actual
MFG	CARRIER	CARRIER
Serial Num	-	0424P62916
Model Num	48FC-M	48FCN12D3M5A6W4F0
Type	-	RTU
Configuration	-	VERTICAL
Num OA Filters 1	-	1
OA Filter Size 1	-	35x19.5
Num Final Filter 1	-	4
Final Filter Size 1	-	20x20x2
Num Final Filter 2	-	
Final Filter Size 2	-

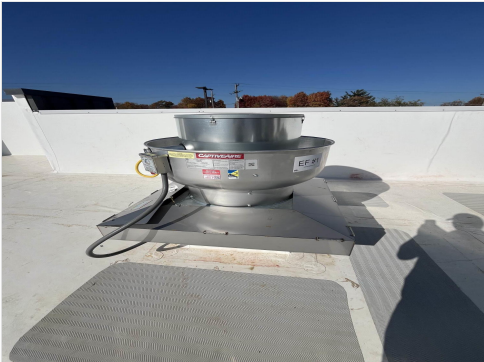
IMG_5953_576647146.jp..

Asset: EF1

Unit Data		
	Design	Actual
MFG	CAPTIVAIRE	CAPTIVAIRE
Model Num	DU180HFA	DU180HFA
Serial Num	-	6765907
Type	UPBLAST	UPBLAST
Configuration	VERTICAL	VERTICAL

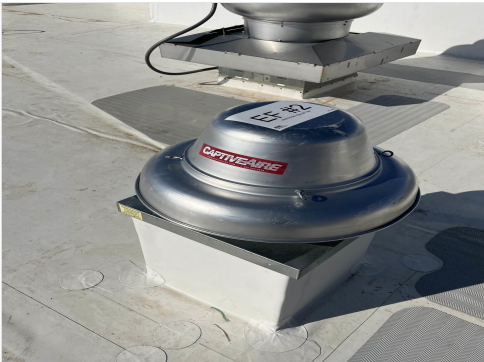
IMG_5947_1791906599.j..

Asset: EF2

Unit Data		
	Design	Actual
MFG	CAPTIVEAIRE	CAPTIVEAIRE
Model Num	DR12HFA	DR12HFA
Serial Num	-	6765907
Type	DOWNBLAST	DOWNBLAST
Configuration	VERTICAL	VERTICAL

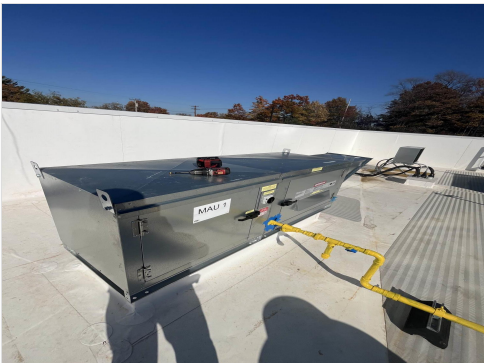
IMG_5950_1251633659.j..

Asset: MAU1

Unit Data		
	Design	Actual
MFG	CAPTIVEAIRE	CAPTIVEAIRE
Model Num	A1-D250-15D	A1-D250-15D
Serial Num	-	6765907
Type	-	MUA
Configuration	-	VERTICAL
