Report: TAB REPORT
Function: Test, Adjust, & Balance
Date: 02/21/2025
Completed By: National TAB

PROJECT
02-17-25 CULVERS ALMA, MI

Project: 02-17-25 CULVERS ALMA, MI

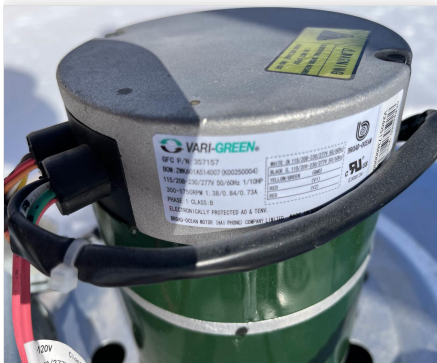
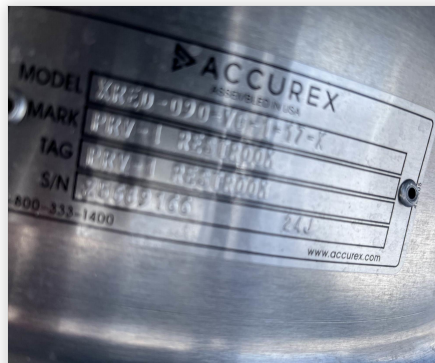
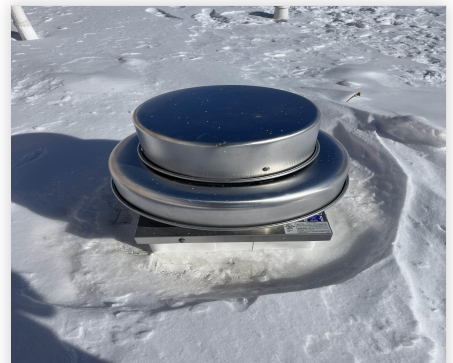
Issue Name : PRV-1 RR Exhaust not operational
Description : PRV-1 Restroom Exhaust fan is not operational. Getting voltage at the breaker as well as at the fan but fan will not operate, motor will not kick on. Recommend electrician/mechanical inspection to diagnose problems with PRV-1.

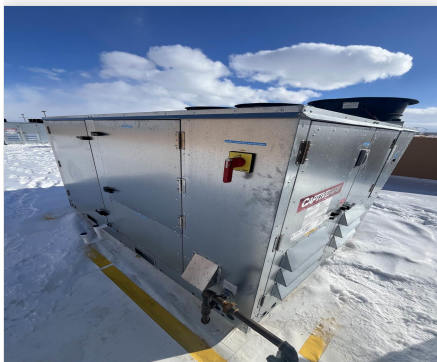
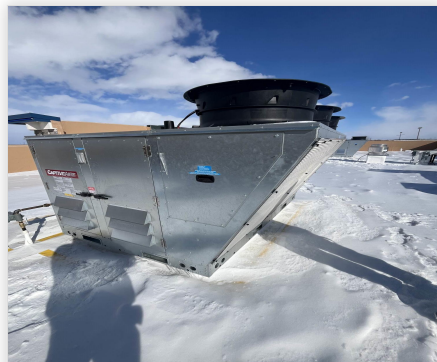
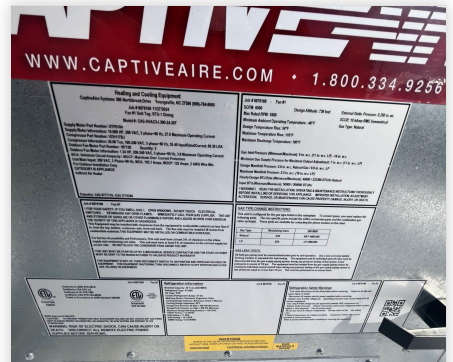
Issue Name : RTU-1 not operational
Description : RTU-1 (Dining Unit) is not operational due to an electrical wiring issue, the control board has shorted out. We were able to get an initial airflow reading before the unit shut down but were unable to balance diffusers, total airflow, and OA airflow to design. Captive aire is scheduled by the GC to be here tomorrow to diagnose and correct RTU-1.

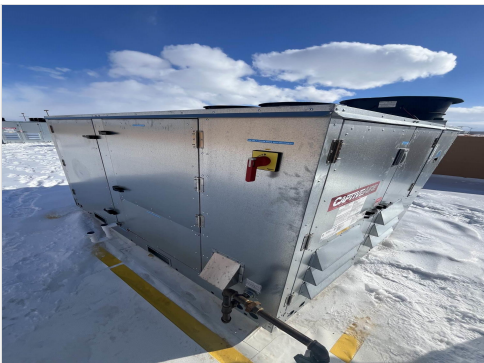
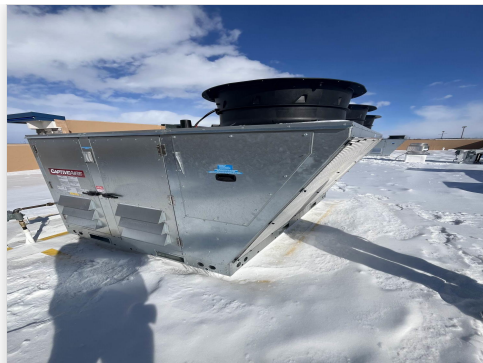
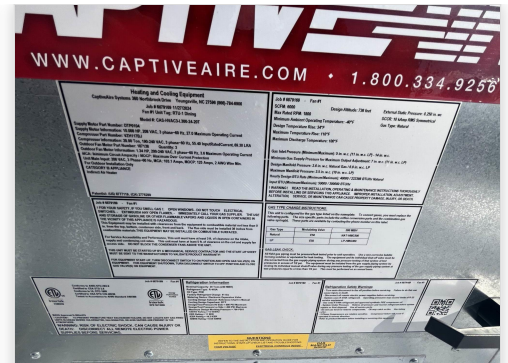
Asset: RTU1

Unit Data		
	Design	Actual
MFG	Lennox	CAPTIVE-AIRE
Serial Num	-	6879169
Model Num	Enlight LGT	CAS-HVAC3-1.300-24-20T
Type	RTU	RTU
Configuration	VERTICAL	VERTICAL
Num OA Filters 1	-	4
OA Filter Size 1	-	16X25X2
Num Final Filter 1	-	8
Final Filter Size 1	-	20X25X2

Test Data		
	Design	Actual
SF CFM	6150	5376
SF RPM	-	
RA CFM	4400	
OA CFM	1750	
RL Voltage	-	
RL Amperage	-	
SF Rotation	-	CW
SF System SetPt	-	
RA Damper Position	-	MECHANICAL LINKAGE
Min OA Damper Position	-	
Min OA Damper Type	-	ECONOMIZER

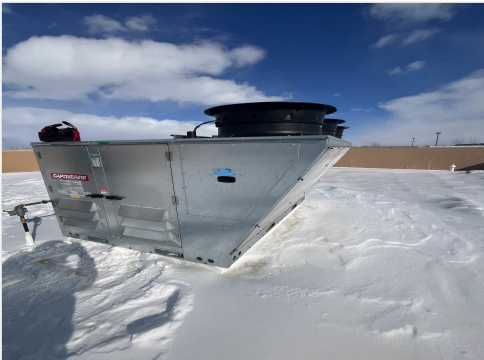
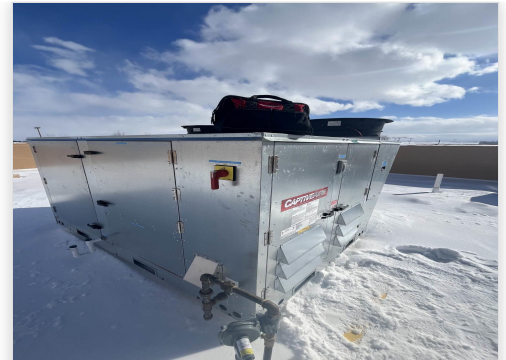
Asset: RTU2

Unit Data		
	Design	Actual
MFG	Lennox	CAPTIVE-AIRE
Serial Num	-	687916911
Model Num	Enlight LGT	CAS-HVAC3-1.300-24-20T
Type	RTU	RTU
Configuration	VERTICAL	VERTICAL
Num OA Filters 1	-	4
OA Filter Size 1	-	16x25x2
Num Final Filter 1	-	8
Final Filter Size 1	-	20x25x2

Test Data		
	Design	Actual
SF CFM	6225	6559
SF RPM	-	1655
RA CFM	4525	4779
OA CFM	1700	1780
RL Voltage	-	186
RL Amperage	-	24.2
SF Rotation	-	CW
SF System SetPt	-	56.6Hz
RA Damper Position	-	MECHANICAL LINKAGE
Min OA Damper Position	-	4.0V
Min OA Damper Type	-	ECONOMIZER

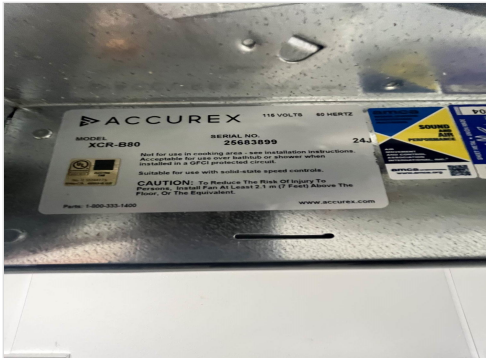
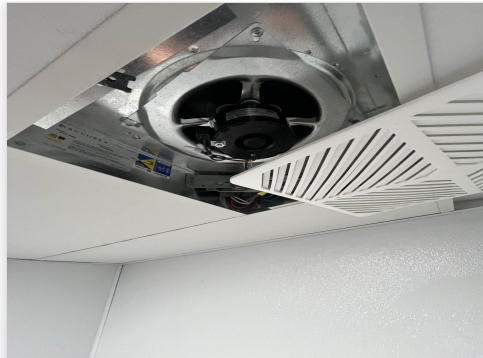
Asset: EF-A1

Unit Data		
	Design	Actual
MFG	ACCUREX	ACCUREX
Model Num	XCR-B80	XCR-B80
Serial Num	-	25683899
Type	CEILING	CEILING
Configuration	VERTICAL	VERTICAL

Test Data		
	Design	Actual
CFM	75	75
Fan RPM	881	900
Fan Rotation	-	CCW
Motor RPM	-	900
System SetPt	-	MAX SPEED @ SPEED DIAL
Fan Discharge SP	-	ATM

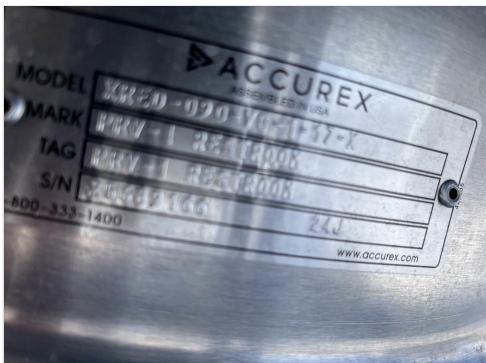
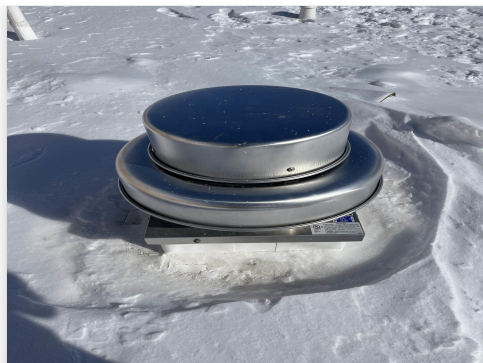
Asset: PRV1

Unit Data		
	Design	Actual
MFG	ACCUREX	ACCUREX
Model Num	XRED-090-VG	XRED-090-VG
Serial Num	-	26689166
Type	DOWNBLAST	DOWNBLAST
Configuration	VERTICAL	VERTICAL

Test Data		
	Design	Actual
CFM	375	0
Fan RPM	1466	0
Fan Rotation	-	CCW
Fan Discharge SP	-	ATM

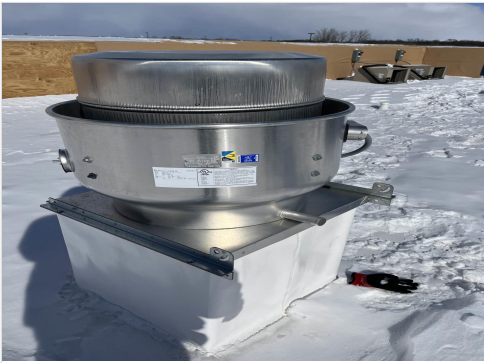
Asset: PRV3

Unit Data		
	Design	Actual
MFG	ACCUREX	ACCUREX
Model Num	XCUE-140-VG	XCUE-140-VG-1-26-G
Serial Num	-	25699764
Type	UPBLAST	UPBLAST
Configuration	VERTICAL	VERTICAL

Test Data		
	Design	Actual
CFM	1500	1530
Fan RPM	1365	1069
Fan Rotation	-	CCW
Motor RPM	-	1069
System SetPt	-	6.2VDC
RL Voltage	-	119
RL Amperage	-	5.5
Total ESP	1	0.77"
Fan Inlet SP	-	-0.77"
Fan Discharge SP	-	ATM

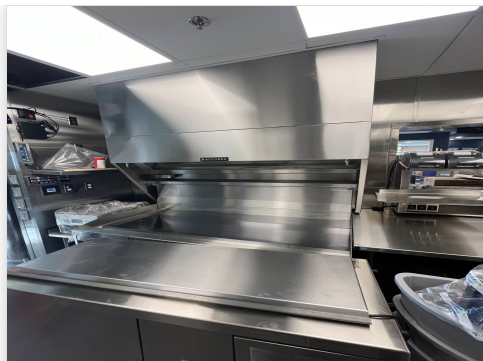
Asset: HD1

Unit Data		
	Design	Actual
MFG	ACCUREX	ACCUREX
Model Num	XGEP-64-S	XGEP-64-S
Job / Serial Num	-	25725078
Type	TYPE I -LOW PROXIMITY	TYPE I LOW PROXIMITY
Hood length	64	64"
Hood Width	23	23"

Test Data Exhaust		
	Design	Actual
Filter Type	GREASE GRABBER	GREASE GRABBER
Filter Size 1	16x16	16X16
Filter Qty 1	4	4
Filter AK factor size 1	1.53	1.53
Filter Total AK Area	6.12	6.12
Filter1 FPM	-	263
Filter2 FPM	-	236
Filter3 FPM	-	227
Filter4 FPM	-	249
Filter Ave FPM(corr)	-	243
CFM	1500	1487

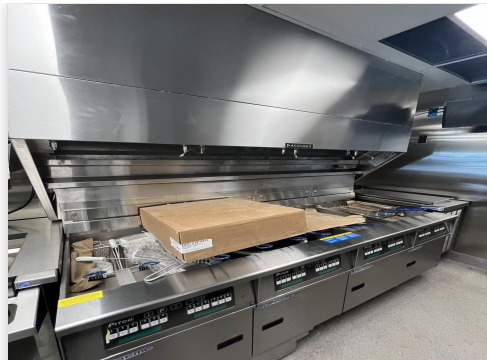
Asset: HD2

Unit Data		
	Design	Actual
MFG	ACCUREX	ACCUREX
Model Num	XXEP-83-S	XXEP-83-S
Job / Serial Num	-	25725077
Type	TYPE I LOW PROXIMITY	TYPE I LOW PROXIMITY
Hood length	83"	83"
Hood Width	23"	23"

Test Data Exhaust		
	Design	Actual
Filter Type	X-TRACTOR	X-TRACTOR
Filter Size 1	16x16	16X16
Filter Qty 1	5	5
Filter AK factor size 1	1.53	1.53
Filter Total AK Area	7.65	7.65
Filter1 FPM	-	210
Filter2 FPM	-	192
Filter3 FPM	-	190
Filter4 FPM	-	184
Filter5 FPM	-	225
Filter Ave FPM(corr)	-	200
CFM	1500	1530
