**Report: TAB**

**Function: Test, Adjust, & Balance**

## 10-06-25 QT #0518 DES MOINES, IA

QUIKTRIP

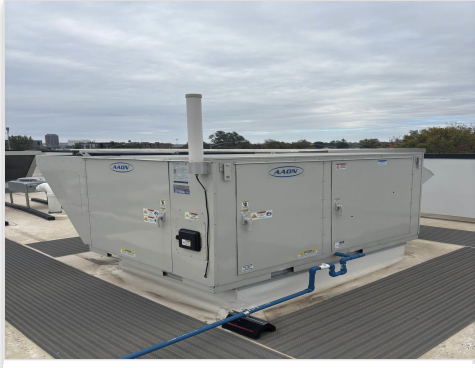
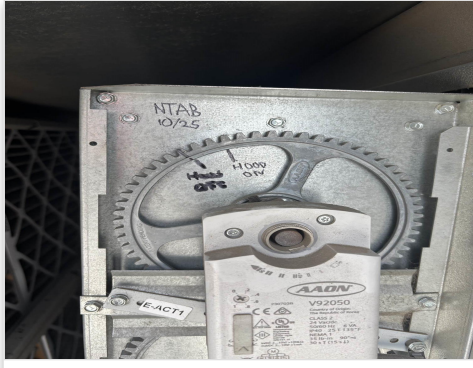
# Unit Data - PHOTO LOG

- RTU balanced for total flow and diffusers balanced for comfort
- COULD NOT ACCESS DAMPERS FOR DIFFUSERS 1, 2, 7, 8, AND 9. UNABLE TO BALANCE SYSTEM.
- HOOD OFF OA: 302 CFM
- HOOD OFF OA DAMPER POSITION: 15% (0.0625" OPEN)

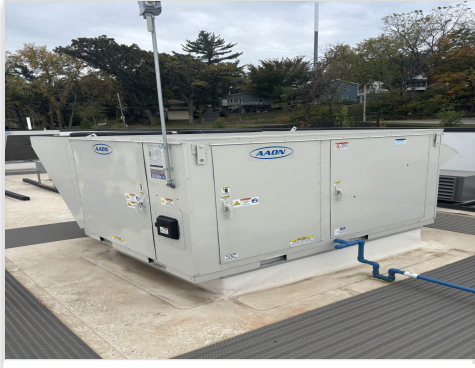
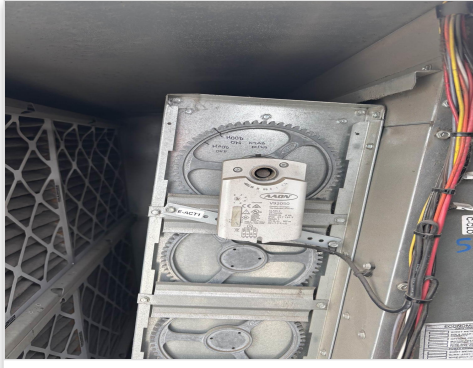
**Unit Data - PHOTO LOG**

- RTU balanced for total flow and diffusers balanced for comfort
- HOOD OFF OA: 316
- HOOD OFF DAMPER POS: 19% (0.125" OPEN)

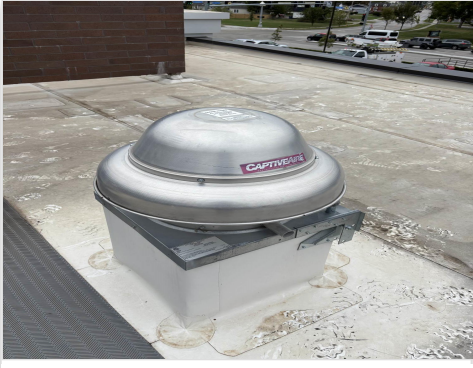
**Unit Data - PHOTO LOG**

Notes:  
-COULD NOT ACCESS SP READINGS.

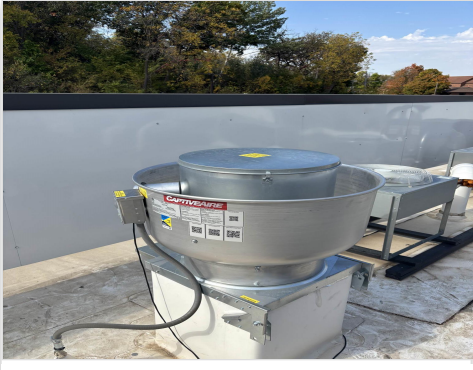
## Unit Data - PHOTO LOG

- UNABLE TO ADJUST FAN SPEEDS USING EMERSON. FAN SPEEDS SET USING HMI IN HOOD CONTROL PANEL.
- MIN AIRFLOW: 811 CFM
- MIN AIRFLOW FREQUENCY: 39.8 Hz
- AIRFLOW STAYING AT CONSTANT SPEED (1373 CFM). DOES NOT MODULATE TO LOW SPEED

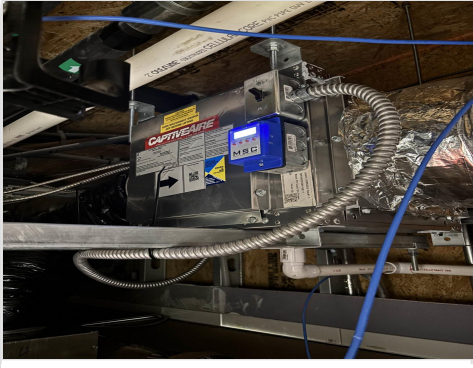
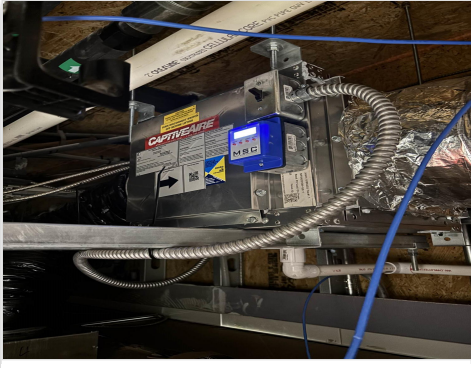
## Unit Data - PHOTO LOG

-COULD NOT SAFELY ACCESS VOLTAGE AND AMPERAGE READINGS.

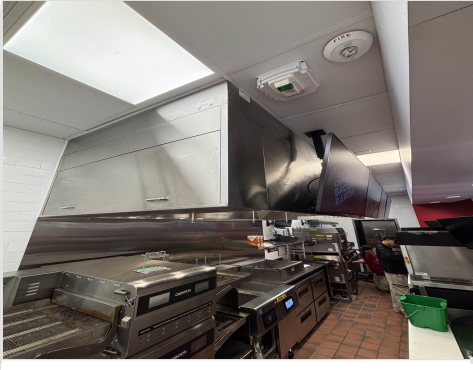
**Unit Data - PHOTO LOG**

- UNABLE TO ADJUST FAN SPEEDS USING EMERSON. FAN SPEEDS SET USING HMI IN HOOD CONTROL PANEL.
- MIN AIRFLOW CHECK: 811 CFM
- MIN AIRFLOW FREQUENCY: 39.8 Hz
- AIRFLOW STAYING AT CONSTANT SPEED (1373 CFM). DOES NOT MODULATE TO LOW SPEED.
