PlanGrid Task Report - Jun 6, 2025

L05457_Treetops FSU (MS)

2520 Lakeland Drive, Flowood, Mississippi

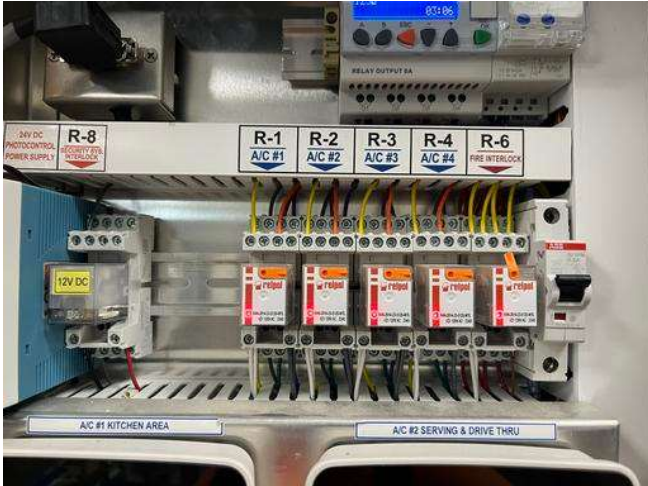
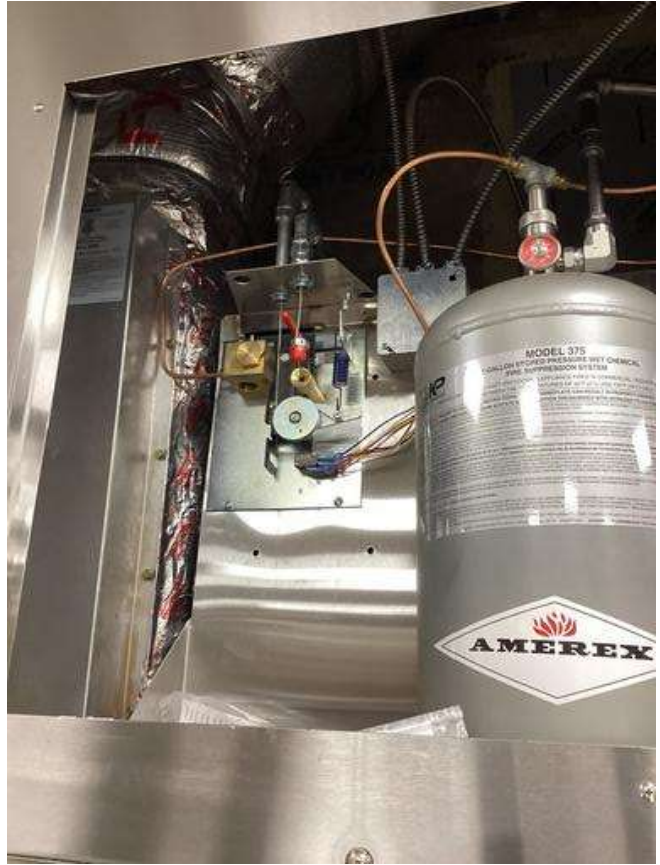
#238 [CNTL 511] [NEW] Ansul system controls.

Ansul wiring incomplete at cans or panel interlock still jumped out at time of TAB inspection.

Fire relay is still bypassed.

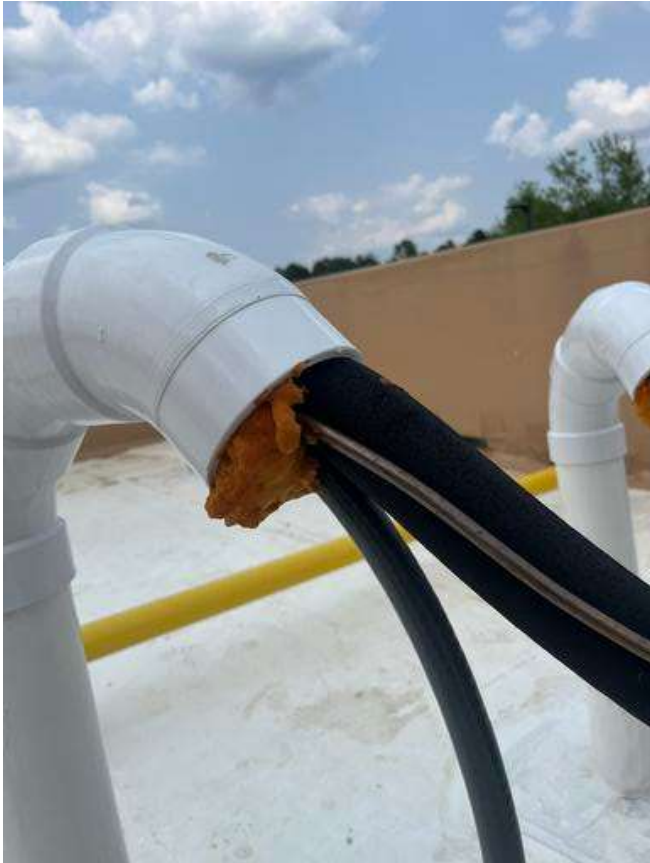
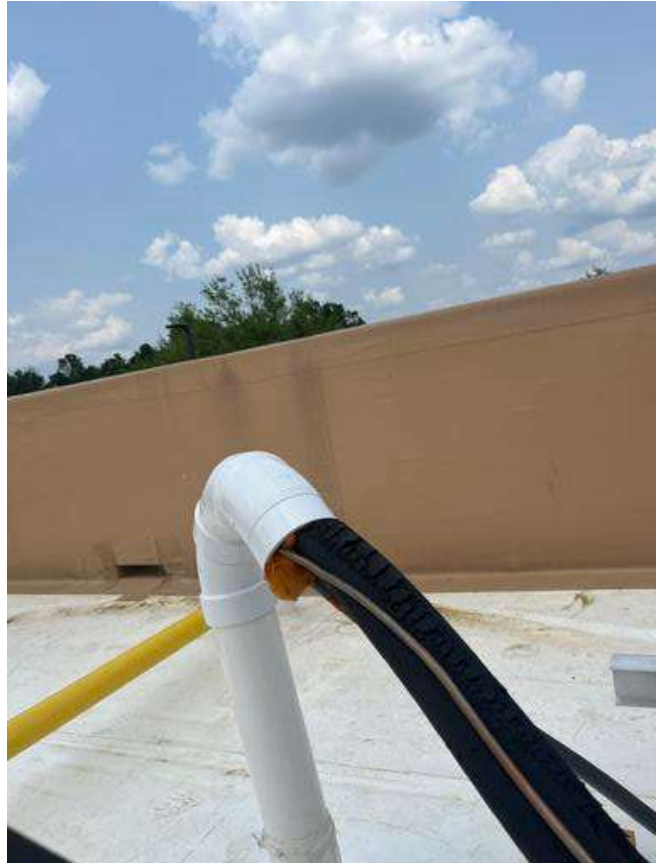
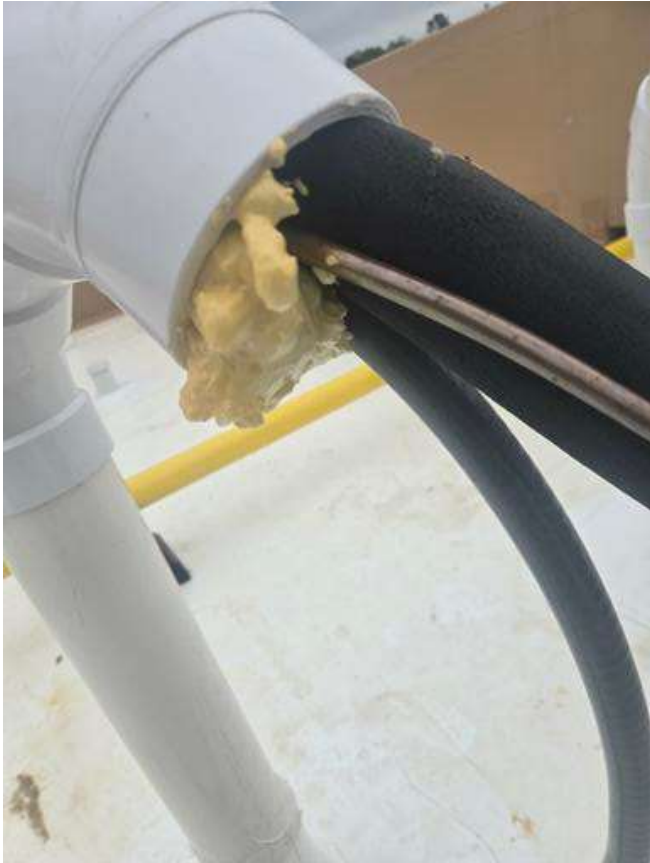
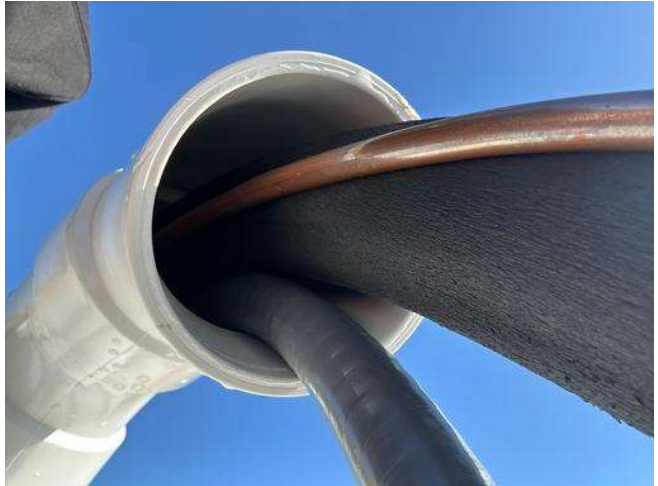
#230 [REFG 511] [NEW] PVC pipe chase (gooseneck) installation.

PVC pipe chase risers are not sealed with spray foam and silicone to prevent weather/pest infiltration. The spray foam should be cut flush to the piping with a layer of silicone over the top.

The risers still need silicone over the foam

No silicone nor is the foam cut flush.

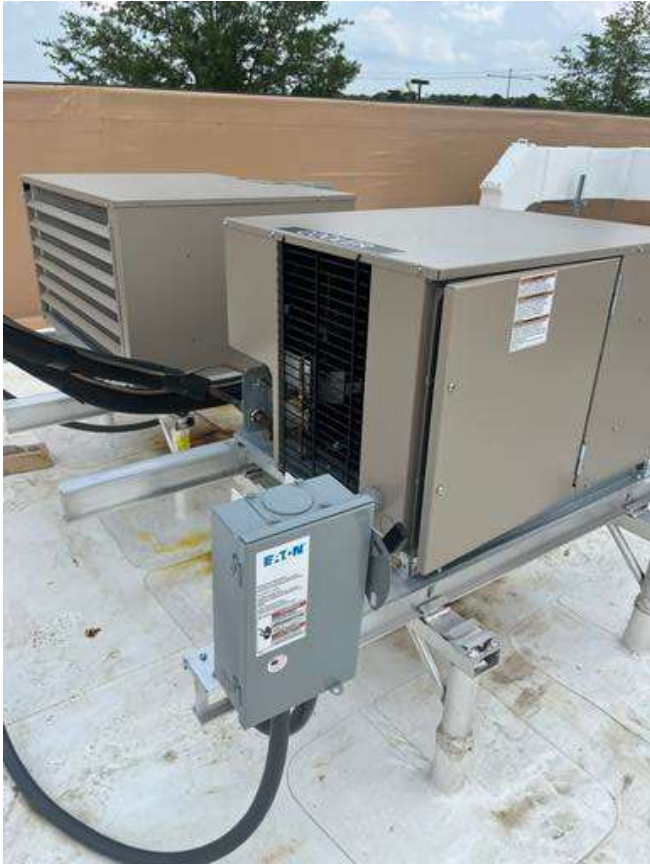
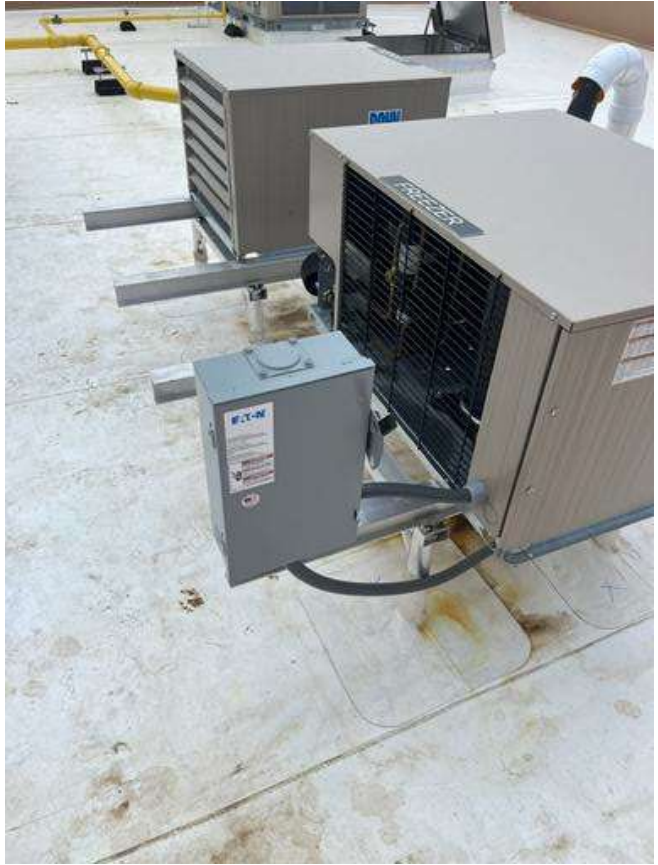
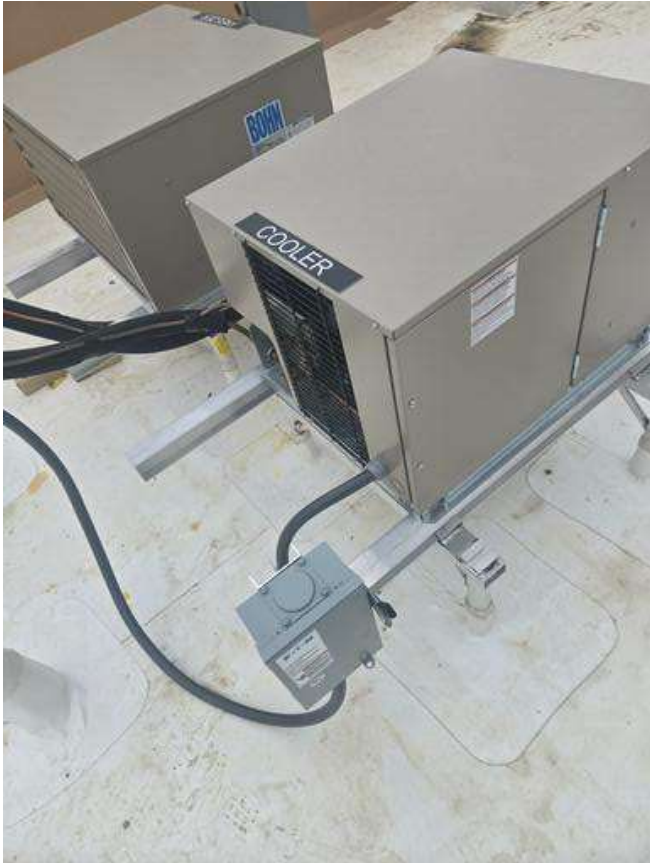
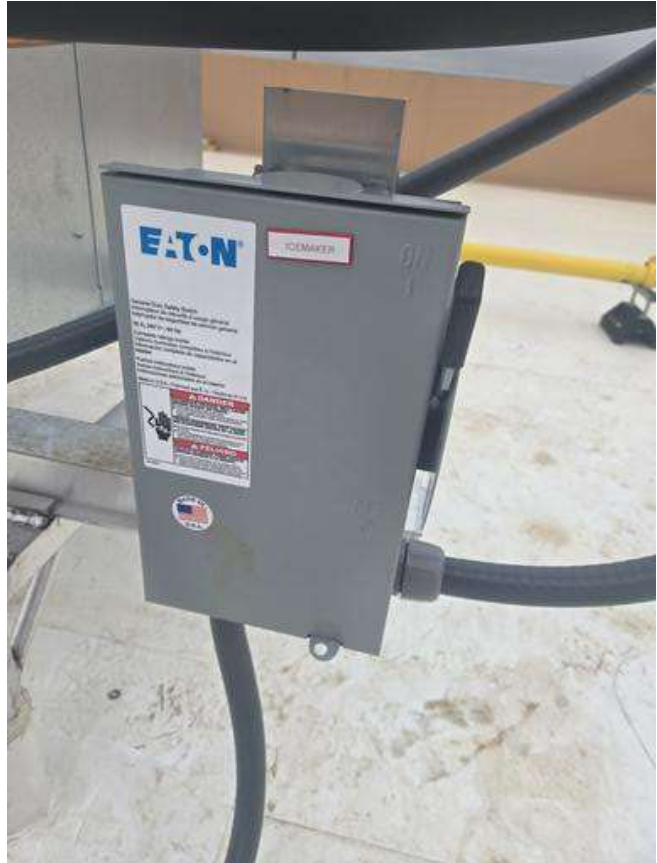
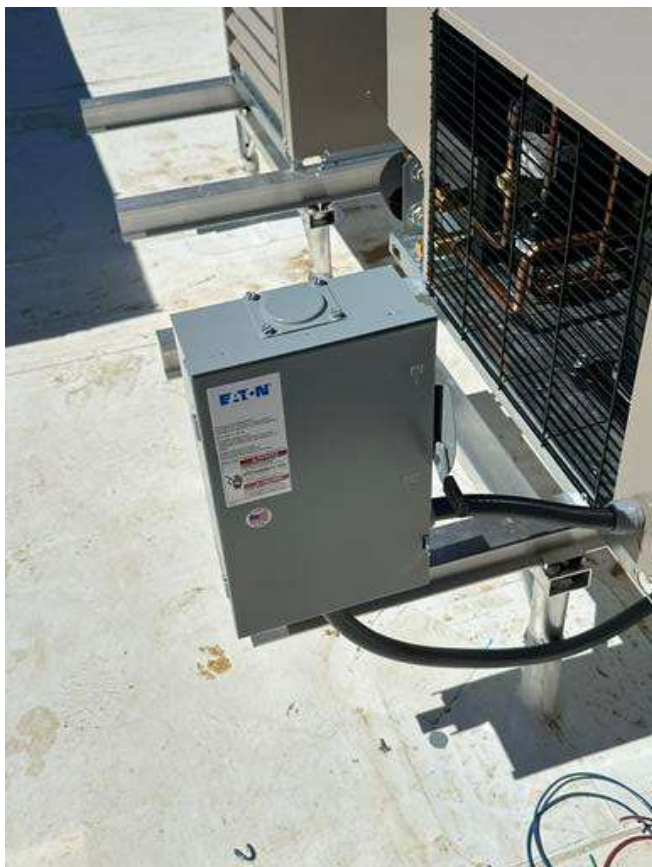
#229 [REFG 516] [NEW] Condenser electrical disconnects.

Electrical disconnects are not properly labeled to indicate which equipment they serve.

Disconnects themselves are not labeled.
