Report: TAB Report
Function: Test, Adjust, & Balance
Date: 06/11/2024

PROJECT
06-03-24 CULVERS JACKSONVILLE, FL

Project: 06-03-24 CULVERS JACKSONVILLE, FL

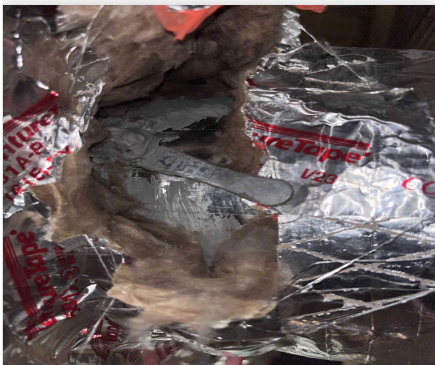
Diffuser_Mastic
06/03/2024

Issue Name : Diffuser 2-9 Damper Handle Jammed
Description : Damper 2-9 damper handle is jammed with mastic and locked in the fully open position. This diffuser was not balanced as a result. Recommend freeing damper from mastic and ensuring it has full range of motion.
Created By : National TAB **Assigned To :** National TAB - Will Turnbough
Status : Open
Priority : Urgent **Asset Tag :**
Originated Date : 06/03/2024 - Stephen Tassinaro - National TAB

Asset	Notes	Date	Written By
RTU2-SGRD9	DAMPER STUCK FULL OPEN - MASTIC ON HANDLE	06/11/2024	Stephen Tassinaro

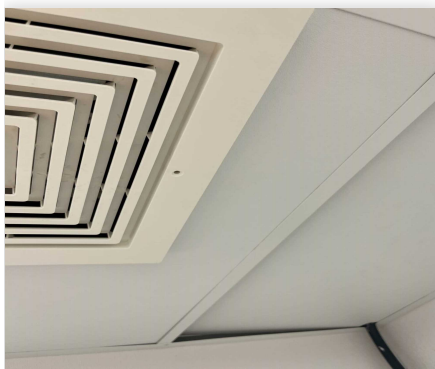
EF_1_Hardware
06/03/2024

Issue Name : EF 1 Missing Hardware
Description : EF 1 (Mop Sink Exhaust Fan) is missing some of the hardware to attach the grille cover to the fan. Recommend sourcing and installing hardware.
Created By : National TAB **Assigned To :** National TAB - Will Turnbough
Status : Open
Priority : Low **Asset Tag :**
Originated Date : 06/03/2024 - Stephen Tassinaro - National TAB

[1] MOTOR LABEL REMOVED. UNABLE TO RETRIEVE DATA.
