**Report: TAB Report for CFA 1143**

**Function: Test, Adjust, & Balance**

**01-13-25 CHICK-FIL-A #01143 BIRMINGHAM,  
AL (TRUSSVILLE FSU) CUSTOM**

Project: 01-13-25 CHICK-FIL-A #01143 BIRMINGHAM, AL (TRUSSVILLE FSU) CUSTOM

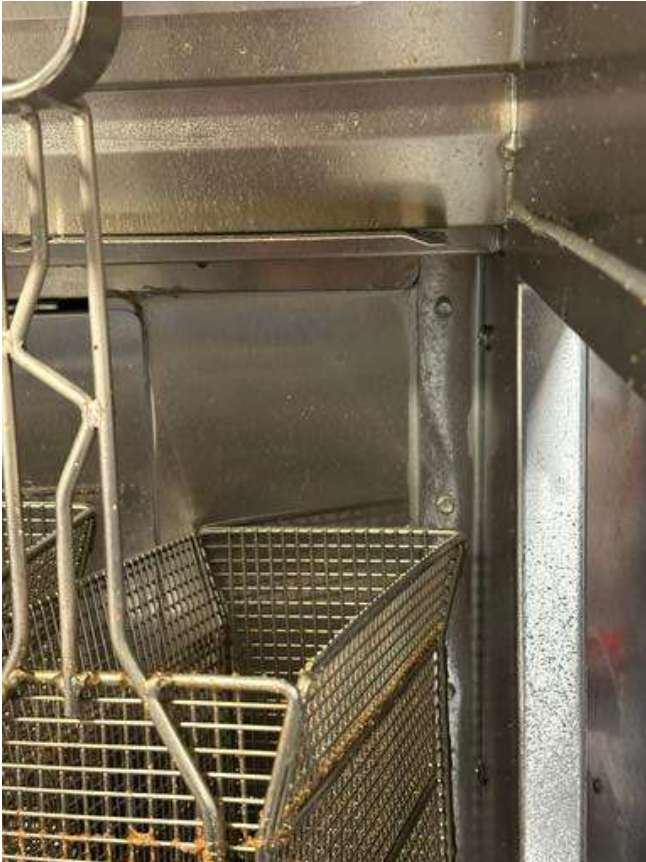
IMG\_0027

## #263 [HOOD 512] [NEW] Grease cup and fry chute.

<b>Status</b> Open	<b>Start Date</b> Jan 18, 2025
<b>Type</b> Planned Work	<b>Created</b> Jan 23, 2025 6:53 PM bens@nationaltab.com
<b>Description</b> Hood 3 is missing its grease cup.	<b>Last Updated</b> Jan 23, 2025 6:58 PM

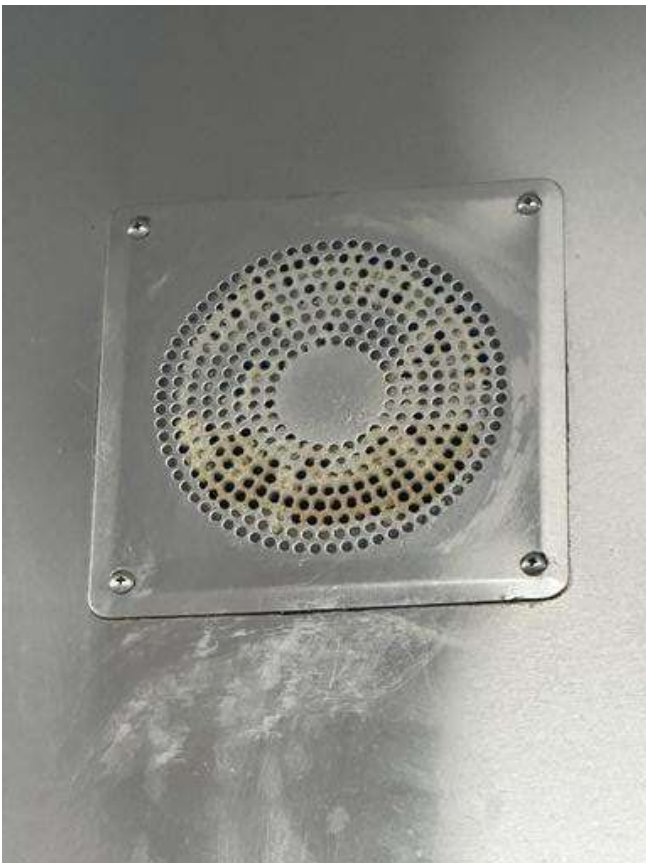
IMG\_0028

## #262 [HOOD 999] [EXIST] Capture jet intake is dirty

Capture jet intake is dirty and recommended to be cleaned.

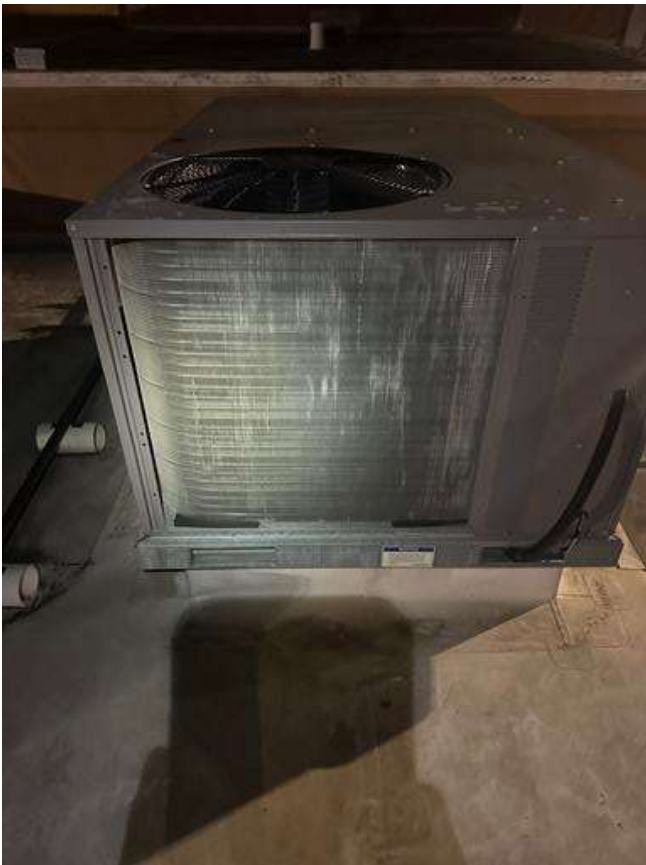
IMG\_0025

## #261 [UNIT 512] [EXIST] Equipment hail guards.

Equipment hail guards are missing or installed incorrectly. No severe damage can be seen.
