Report: TAB REPORT
Function: Test, Adjust, & Balance
Date: 03/18/2024

**03-04-24 CHIPOTLE #25-5076 THE HEIGHTS,
MT (BILLINGS)**

548 Main Street

BILLINGS, MT 59101

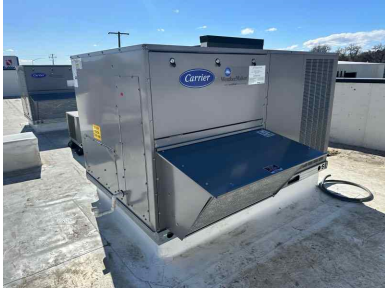
SYSTEM/UNIT: RTU-01

Final Airflow (CFM)	
Actual Total CFM	3564
Actual Grille Total CFM	3564
Actual Return Air CFM	2417
Actual Min O/A CFM	1147
Fan CFM Test Method	Supply Outlet Total
OA Method/Instrument	Face Velocity/RVA
OA Ak (sq ft)	4.150
OA Damper % (High Spd)	10% Open
RA Damper % (High Spd)	90% Open

Unit Data	
Make (tag)	Carrier
Model # (tag)	48FCFM09C2M5-6W4F0
Serial # (tag)	2323P62783
Location	Roof
Unit Discharge	Downblast
Cooling Coil Location	Unit / Drawthru
Coil Area (sq ft)	11.1
Clg Coil Vel (FPM)	321
Fan Service	Supply
Fan Type	Centrifugal (AF)
Fan Discharge	Downblast
Fan Arrangement	SWSI

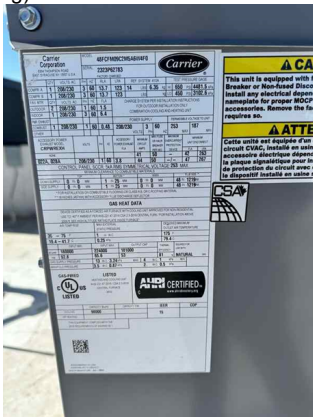
Make (tag) Photo:

Name: Make (tag).jpg
Captured: 3/8/2024 1:43 AM
Caption:

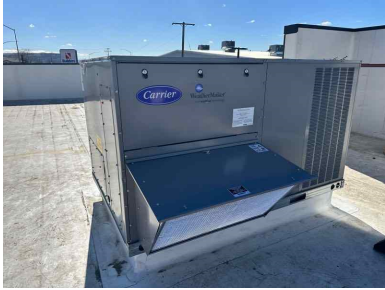
SYSTEM/UNIT: RTU-02

Final Airflow (CFM)	
Actual Total CFM	3628
Actual Grille Total CFM	3628
Actual Return Air CFM	2441
Actual Min O/A CFM	1187
Fan CFM Test Method	Supply Outlet Total
OA Method/Instrument	Face Velocity/RVA
OA Ak (sq ft)	4.150
OA Damper % (High Spd)	10% Open
RA Damper % (High Spd)	90% Open

Unit Data	
Make (tag)	Carrier
Model # (tag)	48FCFM09C2M5-6W4F0
Serial # (tag)	2323P62889
Location	Roof
Unit Discharge	Downblast
Cooling Coil Location	Unit / Drawthru
Coil Area (sq ft)	11.1
Clg Coil Vel (FPM)	327
Fan Service	Supply
Fan Type	Centrifugal (AF)
Fan Discharge	Downblast
Fan Arrangement	SWSI

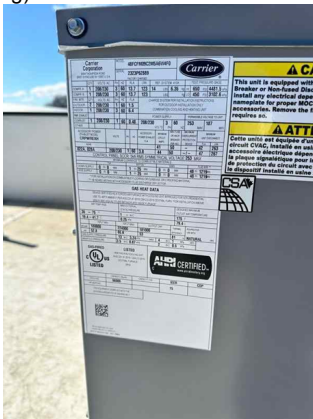
Make (tag) Photo:

Name: Make (tag).jpg
Captured: 3/8/2024 1:43 AM
Caption:

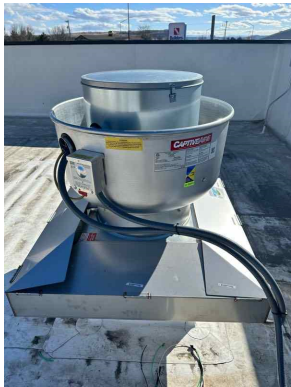
SYSTEM/UNIT: EF-01

Final Airflow (CFM)	
Actual Airflow	1963
Actual Grille Airflow	1963
Fan CFM Test Method	Face Velocity - Velgid/ADM
Test Method Ak (sq ft)	Not Applicable

Unit Data	
Make (tag)	Captive Aire
Model # (tag)	DU85HFA
Serial # (tag)	6151563
Unit Location	Roof
Unit Discharge	Upblast
Fan Service	Exhaust
Fan Type	Centrifugal (AF)
Fan Discharge	Upblast
Fan Arrangement	SWSI

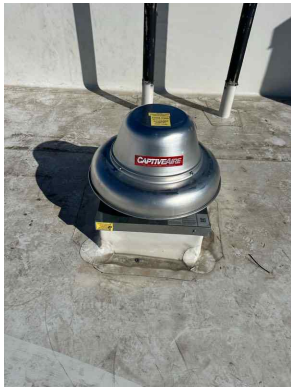
SYSTEM/UNIT: EF-02

Final Airflow (CFM)	
Actual Airflow	210
Actual Grille Airflow	210
Fan CFM Test Method	Inlet Total
Test Method Ak (sq ft)	Not Applicable

Unit Data	
Make (tag)	Captive Aire
Model # (tag)	DR12HFA
Serial # (tag)	6151563
Unit Location	Roof
Unit Discharge	Upblast
Fan Service	Exhaust
Fan Type	Centrifugal (AF)
Fan Discharge	Upblast
Fan Arrangement	SWSI
