Report: TAB Report
Function: Test, Adjust, & Balance
Date: 04/02/2026
Completed By: National TAB

PROJECT
03-30-26 QT #1076 CHARLOTTE, NC

Project: 03-30-26 QT #1076 CHARLOTTE, NC

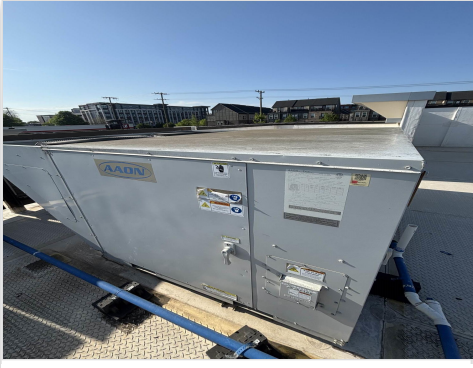
Unit Data - PHOTO LOG

Asset: RT-2

Test Data		
	Design	Actual
SF CFM	4200	4425
SF RPM	-	DD
OA CFM (Hoods On)	800	810
OA CFM (Hoods Off)	350	339
RL Voltage	-	211/211/211
RL Amperage	-	5.9/6.0/6.0
VFD Max SetPt	-	36.8Hz
VFD Min SetPt	-	24Hz
OA Damper Position (Hoods On)	-	46%
OA Damper Position (Hoods Off)	-	26%
