Report: TAB Report
Function: Test, Adjust, & Balance
Date: 04/02/2026
Completed By: National TAB

PROJECT
03-30-26 QT #1076 CHARLOTTE, NC

116 CLANTON RD

Project: 03-30-26 QT #1076 CHARLOTTE, NC

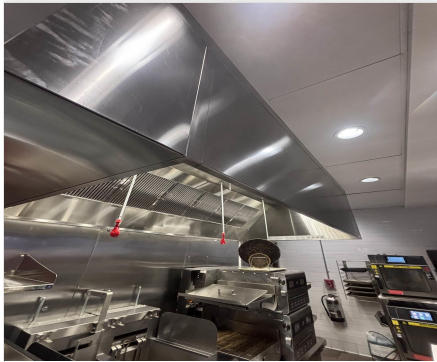
Issue Name : Hood in alarm
Description : The hood is showing a pressure switch fault. This did not affect balancing, hood is at design.
Created By : National TAB **Assigned To :** National TAB - Brianna Biggs
Status : Open
Priority : Low **Asset Tag :** HD1
Originated Date : 04/02/2026 - Christian Moller - National TAB

Has a pressure switch fault

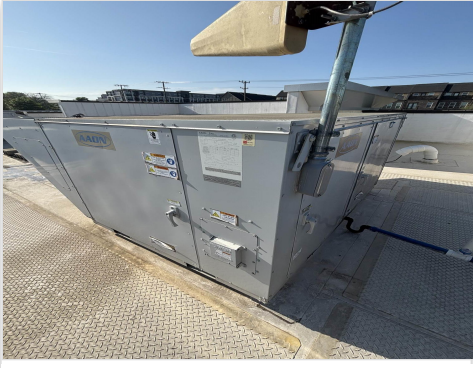
Asset: RT-1

Test Data		
	Design	Actual
SF CFM	4200	4347
SF RPM	-	DD
OA CFM (Hoods On)	800	815
OA CFM (Hoods Off)	350	347
RL Voltage	-	212/212/212
RL Amperage	-	5.6/5.6/5.6
VFD Max SetPt	-	36.6Hz
VFD Min SetPt	-	24Hz
OA Damper Position (Hoods On)	-	46%
OA Damper Position (Hoods Off)	-	26%

Performance Data		
	Design	Actual
MA Plenum SP	-	-0.25"
Fan Suction SP	-	-0.47"
Fan Discharge SP	-	0.46"
Total ESP	-	0.72"
Fan Total SP	-	0.93"

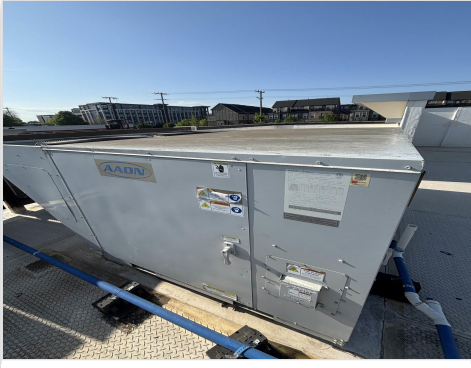
Asset: RT-2

Test Data		
	Design	Actual
SF CFM	4200	4425
SF RPM	-	DD
OA CFM (Hoods On)	800	810
OA CFM (Hoods Off)	350	339
RL Voltage	-	211/211/211
RL Amperage	-	5.9/6.0/6.0
VFD Max SetPt	-	36.8Hz
VFD Min SetPt	-	24Hz
OA Damper Position (Hoods On)	-	46%
OA Damper Position (Hoods Off)	-	26%

Performance Data		
	Design	Actual
MA Plenum SP	-	-0.32"
Fan Suction SP	-	-0.58"
Fan Discharge SP	-	0.36"
Total ESP	-	0.9"
Fan Total SP	-	0.94"

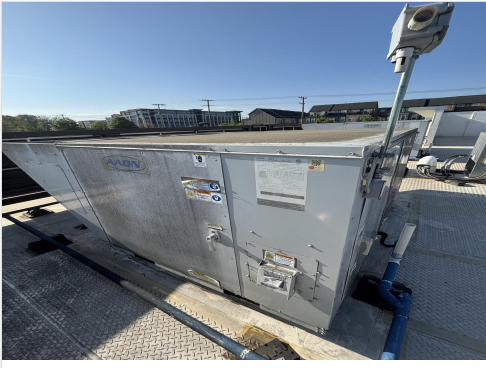
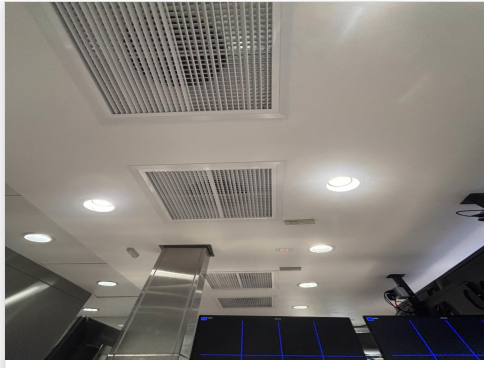
Asset: RT-3

Test Data		
	Design	Actual
SF CFM	4200	4147
SF RPM	-	DD
OA CFM (Hoods On)	800	861
OA CFM (Hoods Off)	350	336
RL Voltage	-	212/212/212
RL Amperage	-	8.3/8.5/8.2
VFD Max SetPt	-	43.2Hz
VFD Min SetPt	-	24Hz
OA Damper Position (Hoods On)	-	46%
OA Damper Position (Hoods Off)	-	30%

Performance Data		
	Design	Actual
MA Plenum SP	-	-0.39"
Fan Suction SP	-	-0.77"
Fan Discharge SP	-	0.52"
Total ESP	-	1.16"
Fan Total SP	-	1.29"

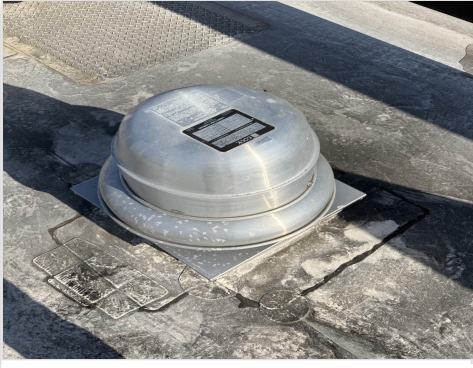
Asset: EF1

Test Data		
	Design	Actual
CFM	225	207
Fan RPM	-	DD
Fan Rotation	-	CORRECT
Motor RPM	-	DD
System SetPt	-	SPEED CONTROLLER / MEDIUM SPEED
RL Voltage	-	110
RL Amperage	-	1.1
Total ESP	-	0.21"
Fan Inlet SP	-	-0.21"
Fan Discharge SP	-	ATM

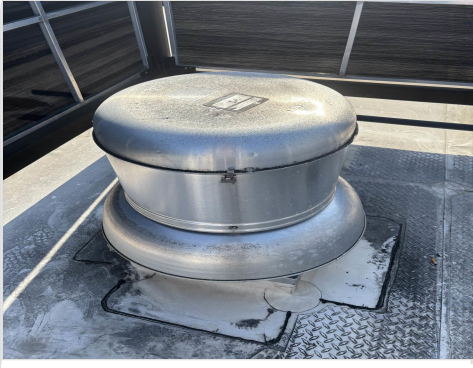
Asset: EF2

Test Data		
	Design	Actual
CFM	525	517
Fan RPM	-	DD
Fan Rotation	-	CORRECT
Motor RPM	-	DD
System SetPt	-	SPEED CONTROLLER / MEDIUM SPEED
RL Voltage	-	115
RL Amperage	-	3.7
Total ESP	-	0.47"
Fan Inlet SP	-	-0.47"
Fan Discharge SP	-	ATM

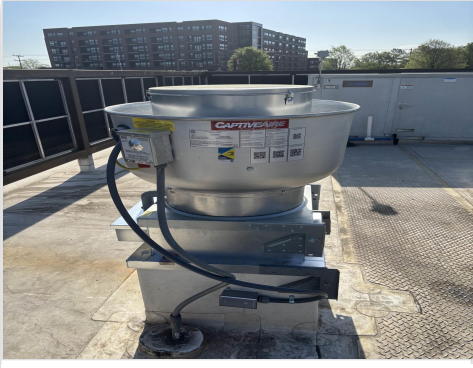
Asset: EF3

Test Data		
	Design	Actual
CFM	1350	1347
Fan RPM	-	DD
Fan Rotation	-	CORRECT
Motor RPM	-	DD
System SetPt	-	HMI / 54.8Hz
RL Voltage	-	212
RL Amperage	-	3.4
Total ESP	-	0.72"
Fan Inlet SP	-	-0.72"
Fan Discharge SP	-	ATM

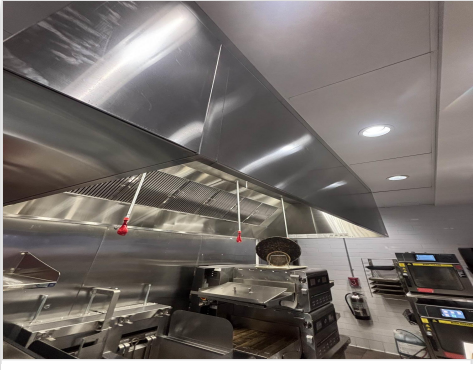
Asset: HD1

Design	Actual
Filter Type	CAPTRATE SOLO FILTER	BAFFLE FILTERS
Filter Size 1	20X16	20X16
Filter Qty 1	6	6
Filter AK factor size 1	2.08	2.08
Filter Total AK Area	12.48	12.48
Filter1 FPM	-	105
Filter2 FPM	-	121
Filter3 FPM	-	112
Filter4 FPM	-	107
Filter5 FPM	-	98
Filter6 FPM	-	106
Filter7 FPM	-	
Filter8 FPM	-	
Filter9 FPM	-	
Filter10 FPM	-	
Filter11 FPM	-	
Filter12 FPM	-	
Filter Ave FPM(corr)	-	108
CFM	1350	1347
