Report: TAB Report
Function: Test, Adjust, & Balance
Date: 01/30/2026
Completed By: National TAB

PROJECT
02-09-26 QT #1131 SPARTANBURG, SC

Project: 02-09-26 QT #1131 SPARTANBURG, SC

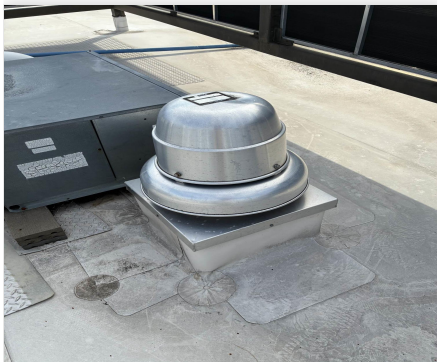
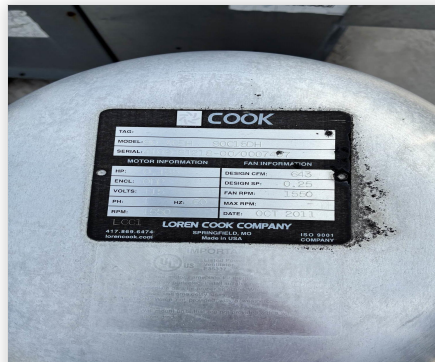
Issue Name : EF-1 Not Operational
Description : EF-1 is not running. The speed dial does not turn on the fan like it should and the breaker is switched on. It is recommended an electrician inspects the fan motor or wiring.

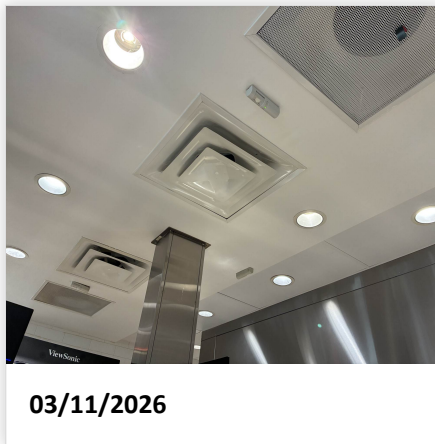
Issue Name : Incorrect Kitchen Diffusers
Description : The kitchen diffusers 3-1 through 3-4 are the incorrect type. The need to be the TITUS 300FS diffuser with the installed deflection blades.
Created By : National TAB **Assigned To :** National TAB - Dan Hertenstein
Status : Open
Priority : High **Asset Tag :** RT-3
Originated Date : 03/11/2026 - Alex Bauer - National TAB

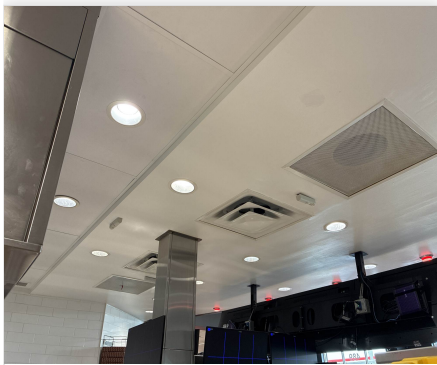
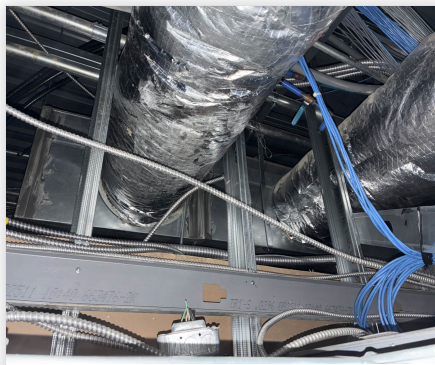
Issue Name : Kitchen Dampers Inaccessible
Description : Diffusers 3-1 through 3-4 have inaccessible dampers because the lights in the ceiling tiles are blocking the ceiling tiles from being pushed out of the way to access the dampers.
Created By : National TAB **Assigned To :** National TAB - Dan Hertenstein
Status : Open
Priority : High **Asset Tag :** RT-3
Originated Date : 03/11/2026 - Alex Bauer - National TAB

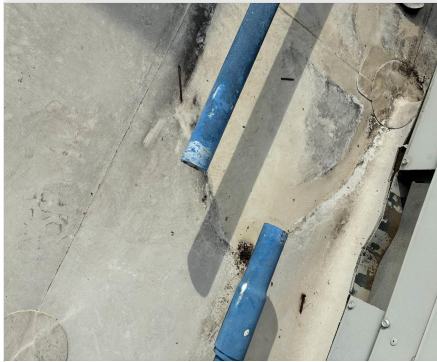
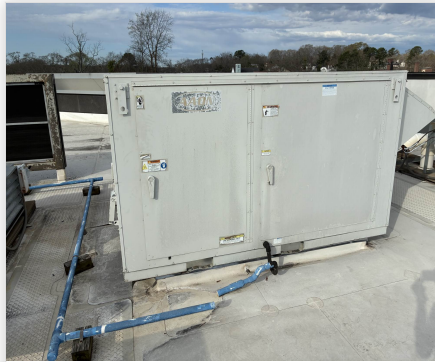
Issue Name : RTU-2 Condensate Drain
Description : The condensate pipe for RTU-2 is missing a coupling and is not fitted together.
Created By : National TAB **Assigned To :** National TAB - Dan Hertenstein
Status : Open
Priority : Low **Asset Tag :** RT-2
Originated Date : 03/11/2026 - Alex Bauer - National TAB

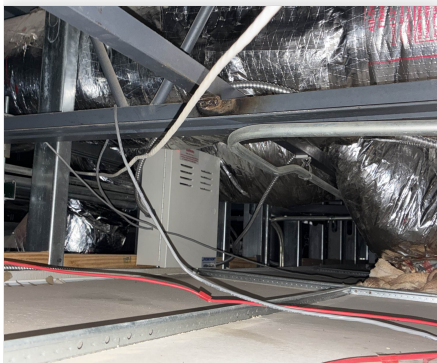
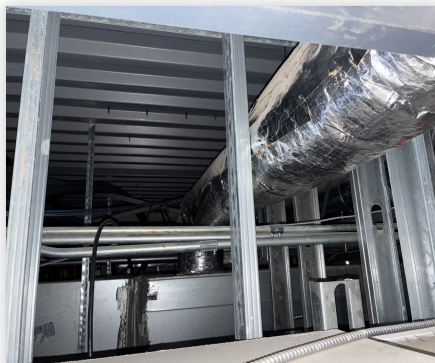
Issue Name : RTU-3 Inaccessible Dampers
Description : The dampers for diffusers 3-5 and 3-6 are inaccessible. They are located above a solid ceiling where they cannot be reached to be adjusted.
Created By : National TAB **Assigned To :** National TAB - Dan Hertenstein
Status : Open
Priority : High **Asset Tag :** RT-3
Originated Date : 03/11/2026 - Alex Bauer - National TAB

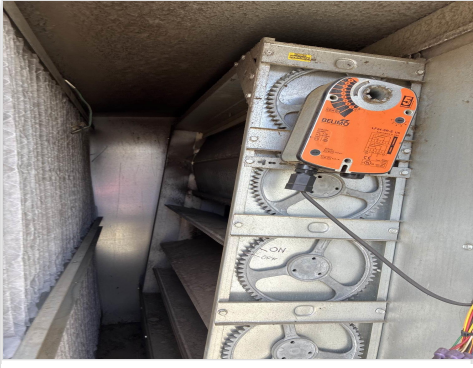
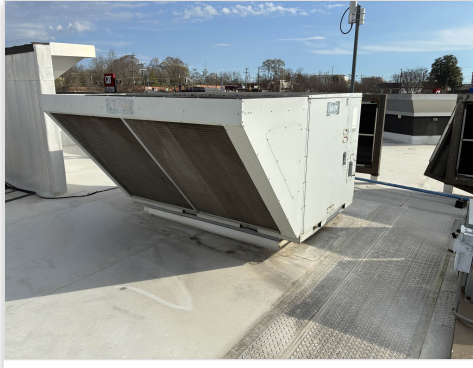
Unit Data - PHOTO LOG

Notes:
Labeled as RTU-3 in the field.

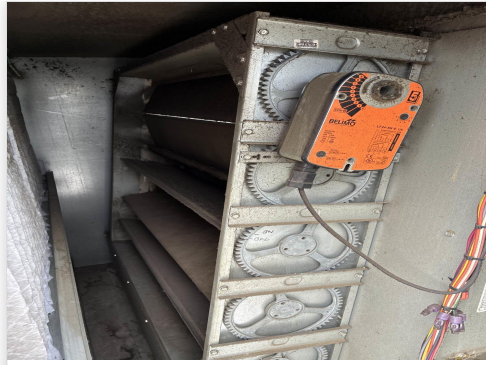
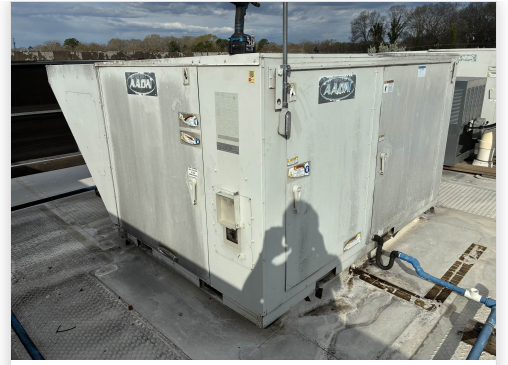
Unit Data - PHOTO LOG

This is RTU-2 in the field.

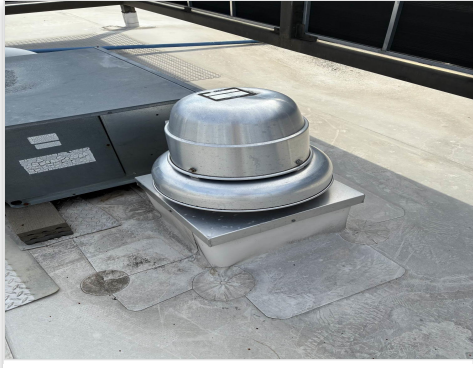
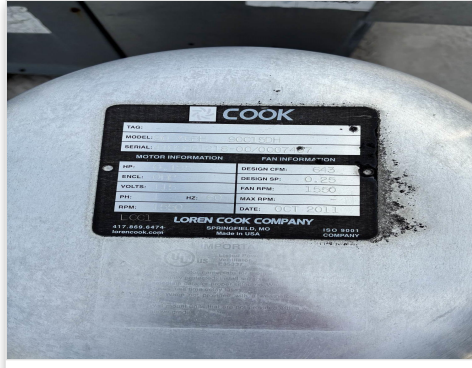
Unit Data - PHOTO LOG

The fan is not running - see issues list.

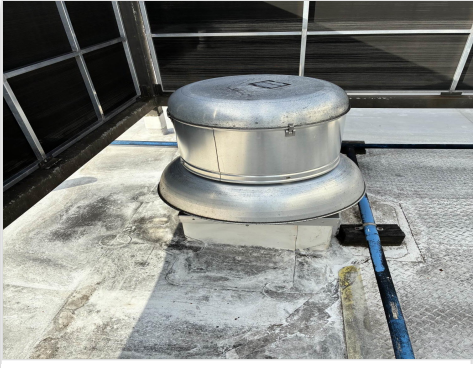
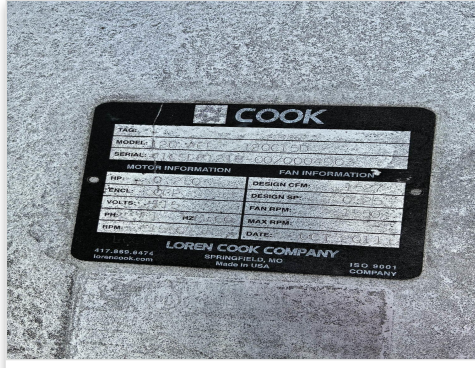
Unit Data - PHOTO LOG

The combi-oven diffuser does not have a damper.

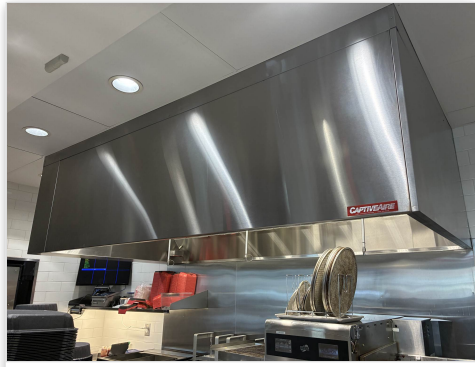
Unit Data - PHOTO LOG

Unit Data		
	Design	Actual
MFG	CAPTIVEAIRE	CAPTIVEAIRE
Model Num	6030ND-2-F	6030ND-2
Job / Serial Num	-	8318543
Type	-	TYPE I CANOPY
Hood length	-	108"
Hood Width	-	60"

Test Data Exhaust		
	Design	Actual
Filter Type	-	BAFFLE FILTERS
Filter Size 1	-	16X20
Filter Qty 1	-	6
Filter AK factor size 1	-	2.08
Filter Total AK Area	-	12.48
Filter1 FPM	-	112
Filter2 FPM	-	113
Filter3 FPM	-	129
Filter4 FPM	-	80
Filter5 FPM	-	103
Filter6 FPM	-	103
Filter Ave FPM(corr)	-	106
CFM	1350	1323
