Report: TAB Report
Function: Test, Adjust, & Balance
Date: 12/21/2022

PROJECT
12-19 PENN STATION - JASPER, IN

Project: 12-19 PENN STATION - JASPER, IN

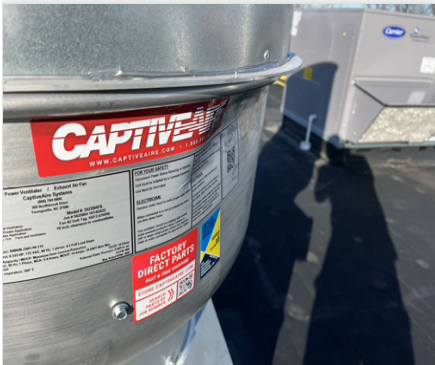
FuselTe8bf2b78a1d746....

Issue Name : EF2 Fan Casing Damage

Description : There are a few points in the outside of the fan that are bent inwards. See picture attached. No issues with fan rotation.

Status : Open
