PlanGrid Task Report - Sep 19, 2024

L05224 Coconut Palm FSU [Princeton (FL) FSU]

11250 Southwest 248th Street, Homestead, Florida

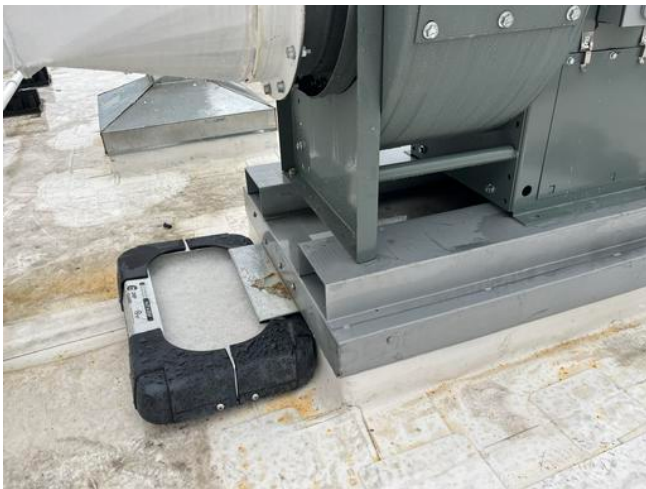
IMG_8388

#8 [EXHA 124] Exhaust fan drain line.

Exhaust fan drain is not installed. Once installed pvc pipe shuld be glued together and routed to center of drip guard.

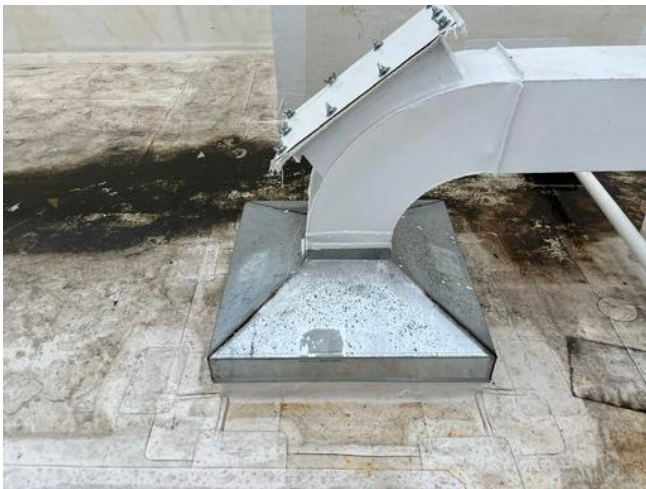
IMG_8389

#7 [EXHA 126] Grease exhaust duct is not painted.

Exposed grease exhaust duct is to be painted per specification on kitchen hood exhaust fan detail. Duct curb caps should be painted.

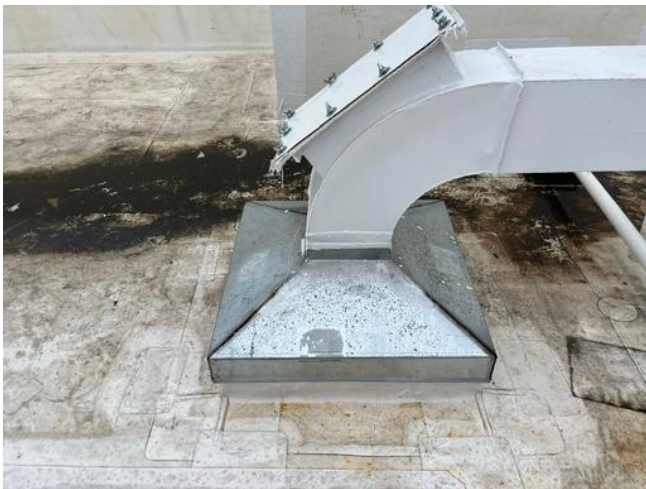
IMG_8389

#6 [EXHA 128] Grease exhaust duct curb cap.

Grease duct curb cap is to be screwed at all corners along with a full perimeter weld between curb cap and duct.

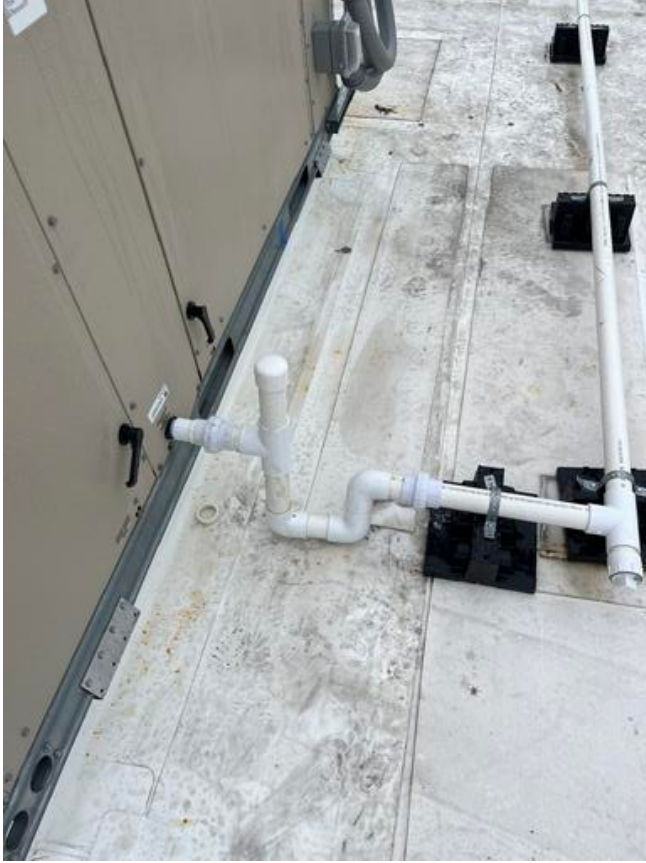
IMG_8390

#5 [UNIT 167] Condensate piping construction.

Equipment condensate piping or p-trap is not constructed per normal CFA specifications as shown on P-250. Upper and lower T needs to be added on opposite side of trap.. Celanout plug needs to be added at lower t once installed.

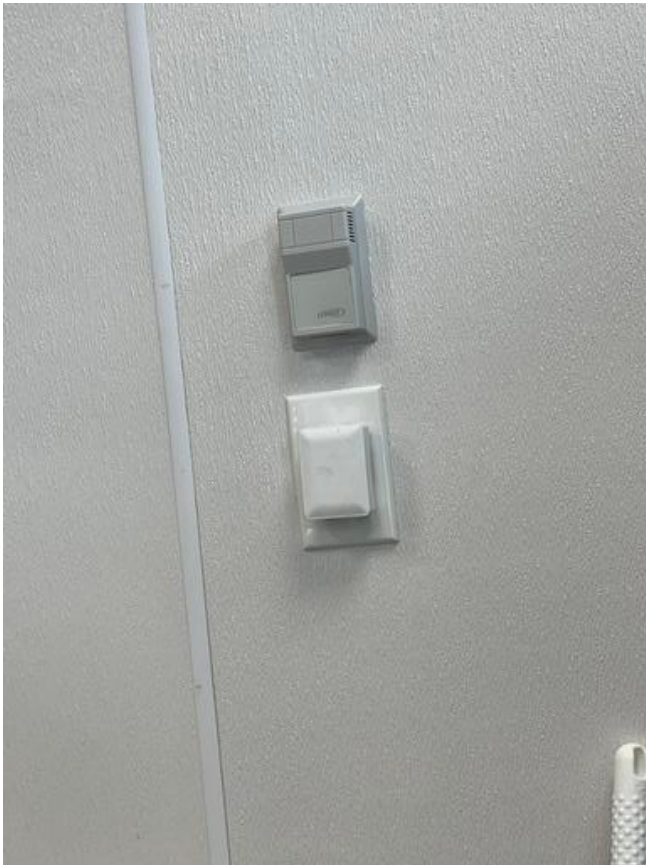
IMG_8378

#4 [CNTL 097] Controls labeling.

Label all sensors,
humidistats on AC#2

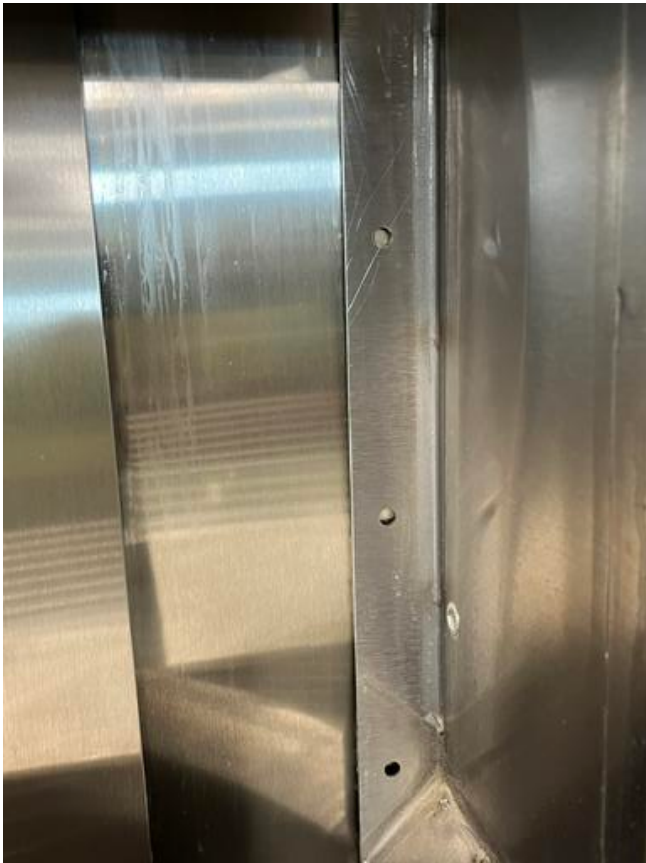
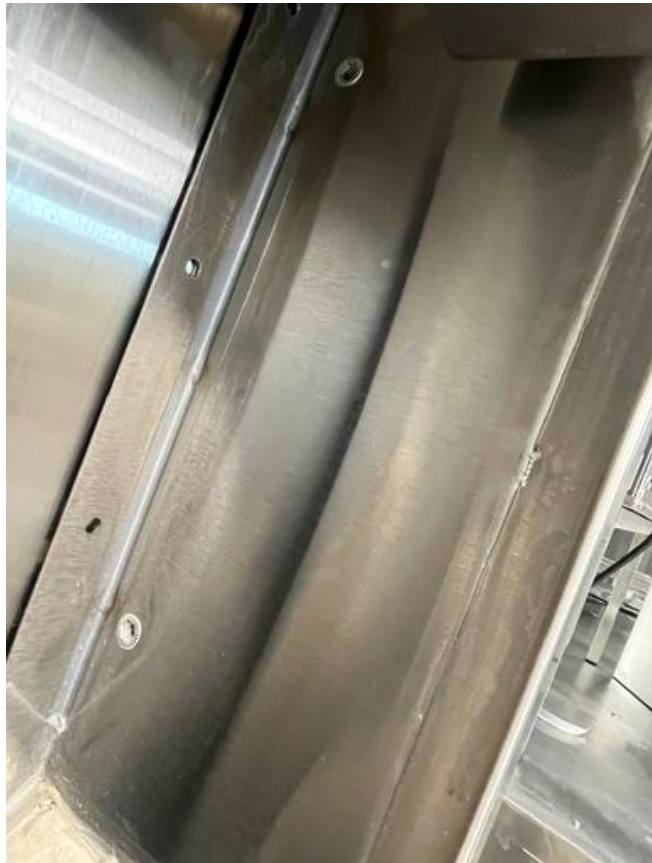
IMG_8374

#3 [HOOD 143] Hood back panes.

Hoods are to be secured to back panes via pre-punch holes with stainless steel screws.

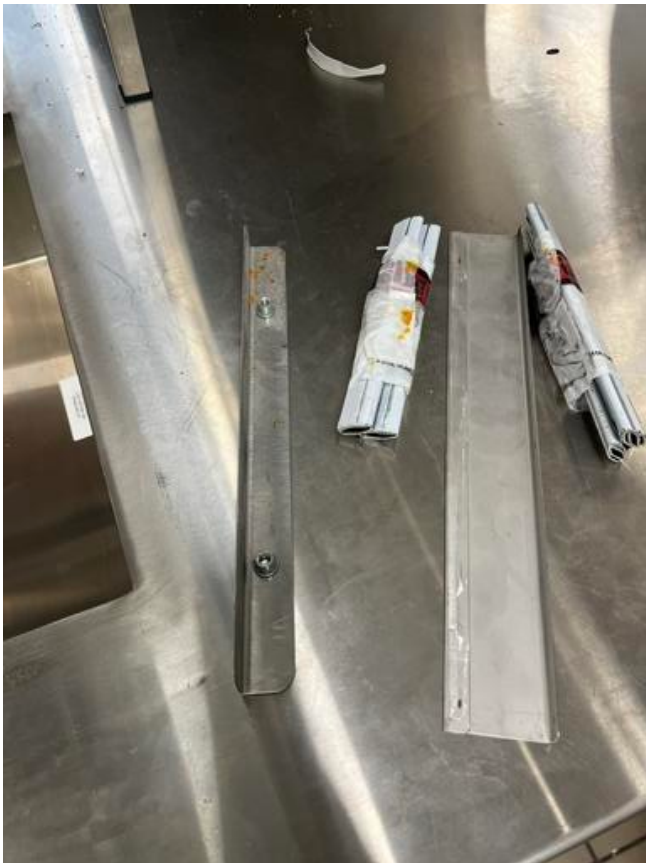
IMG_8377

#2 [HOOD 145] Hood 1L/1R hardware.

Hoods 1L/1R are missing bolting hardware to secure in place slider filter brackets. Screws switched around hoods during balancing in order to get accurate data.
